平成 27 年 6 月 23 日
運輸安全委員会

米国連邦航空局（FAA）に対する安全勧告に関するフォローアップについて

SPECIAL AIRWORTHINESS INFORMATION BULLETIN

SAIB: NM-15-03

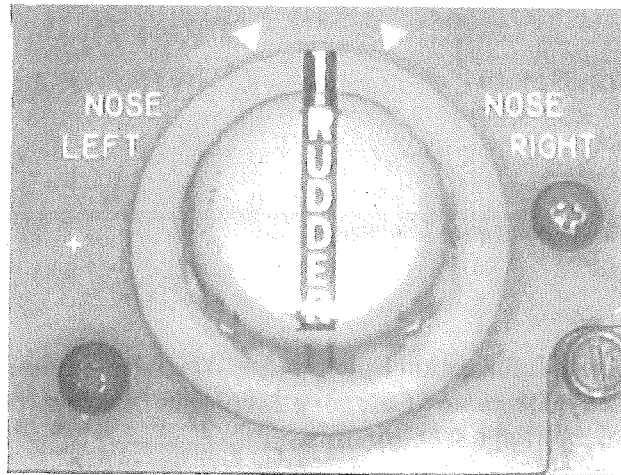
Figure 1 – Rudder Trim Switch

During the investigation of this incident, numerous aisle stand configurations were identified due to the multitude of supplemental type certificate installations and significant variability in the Boeing-delivered configurations. On the incident airplane (Model 737-700), the rudder trim switch is in approximately the same location as the flight deck door control switch on the operator's Model 737-500 airplane. This creates a potential for confusion when pilots transition between aircraft. Positive training on one model can become negative when the pilot transfers to a different model. Although the rudder trim switch (Figure 1) and flight deck door control switch (Figure 2) are different in size and shape (cylindrical vs. blade shaped), and the flight deck door unlock side of the switch must be depressed before turning, the general feel (spring force) to actuate the switches is similar; both are spring loaded to the center position. In this incident, the negative transfer error allowed the pilot to think he had operated the correct control, and the similarity of the control's operation exacerbated the situation.

Having a consistent position for the rudder trim switch is paramount because it provides a direct input to the aircraft rudder and can induce both yaw and roll into the aircraft flight attitude. Because both the rudder trim switch and the flight deck door control switch have a similar feel and action (turn and hold), a standard location and sufficient separation between these controls is recommended. Placing the controls in the recommended locations is consistent with most Boeing-delivered airplanes and creates a distinctive reach posture, provides sufficient separation in relation to reach direction from both seats, and provides adjacent tactile landmarks. This includes the railing in the corner of the aisle stand and the guarded stabilizer trim switch located between the rudder trim switch and the flight

1. Place the rudder trim switch in the center column as far aft as possible.
2. Place the flight deck door control switch in the far right column (first officer side) aft position.
3. Do not place the flight deck door control switch in the center column.

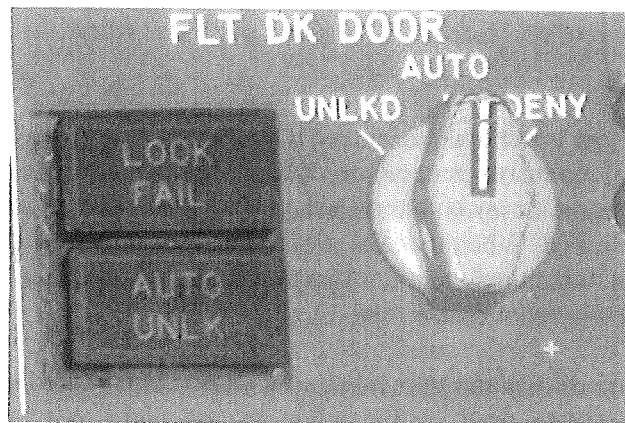
Figure 2 – Flight Deck Door Control Switch

In response to this incident, Boeing analyzed modifying the shape of the flight deck door control switch; however, they determined the position of the switch is more important than the shape of the switch from a human factors perspective. Position of a switch that affects pilot reach/posture provides better feedback to the pilot than the shape of the switch that the pilot feels. Boeing determined the most important factor to minimize inadvertent activation of the control switches is aisle stand configuration consistency within an operator's fleet.
