Chapter 2 Aircraft accident and serious incident investigations

1. Aircraft accidents and serious incidents to be investigated

3. Statistics of investigations of aircraft accidents and serious incidents

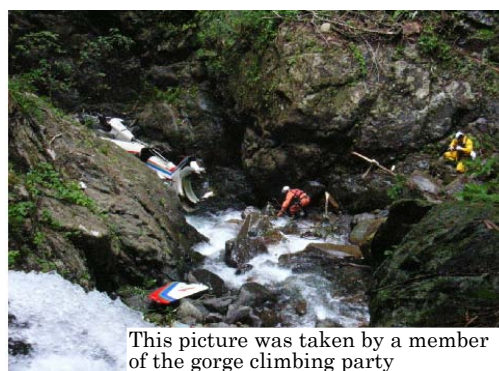
Just after Occurrence of Accident

(1) Many scratch marks seemingly caused by induced foreign objects were observed in the inside of the Fenestron, while pieces of wood were found trapped in the tail rotor assy. Based on these findings, it is very likely that the first abnormal phenomenon occurred when the tail rotor hit trees.

(2) Several trees on the right bank of the accident site had been broken, while a fragment of the black blade was found at the root of the tree on the right bank about 23 m above the rescuers' landing point. Further, broken trees with scratch marks were found in the plunge pool, and there were trees with branches chopped on the right bank. Based on the findings, it is very likely that the Aircraft had its main rotor hit against trees while spinning.

(3) It is not certain whether the pilot in command took actions for confirming or made instructions for confirming obstacles in the aft on the left side before having the aircraft hover to the left to adjust its position, but it is very likely that the looking out toward the left aft was not appropriate.

Probable causes: It is very likely that the aircraft crashed when it hovered to the left to adjust the hoist descent position without appropriate looking out, the Fenestron's tree contact developed into a loss of yaw control followed by main rotor tree strike.

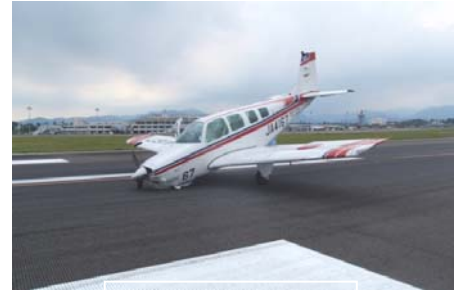
Accident Aircraft

As a result, it is probable that the aircraft bounced at touchdown due to the improper reduction in airspeed and rate of descent, thus touched down with residual lift and the impact of the landing gear as it hit the runway.

It is probable that in the following touchdown, the aircraft touched down on the nose gear in the steep nose down attitude, which caused the nose gear to sustain damage, and the aircraft then skidded about 292 m on the runway with the nose pushed against the runway surface before becoming immobile.

Probable causes: It is highly probable that the accident occurred as follows: the aircraft bounced at touchdown, and subsequently fell into a state of porpoising without performing a go-around, eventually touched down with the nose gear severely hitting the runway first, sustained damage to the airframe and then became immobile on the runway.

Regarding the reason why the aircraft bounced at touchdown, it is probable that, with the airspeed still slightly faster than it should have been, after reducing the engine power to idle on passing the runway threshold, the trainee judged that performing a flare in an ordinary manner under the circumstances would cause the aircraft to fly over the intended touchdown point and therefore he eased up on the flare. As a result, it is probable that neither airspeed nor rate of descent was reduced and the aircraft touched down with residual lift, which resulted in bouncing at touchdown due to the impact of the landing gear as it hit the runway.

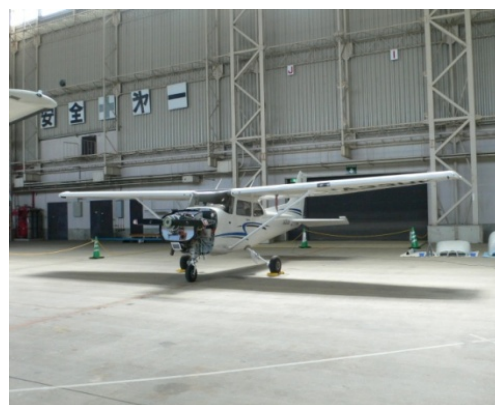
Accident Aircraft

Probable causes: It is very likely that the aircraft bounced upon landing, followed by a nose-low hard contact with the runway, resulting in damage of propeller blades and fuselage structure.

The student pilot's possible pushing of the control wheel or failure to apply back elevator pressure resulted in the nose-low contact with the runway upon the second settling.

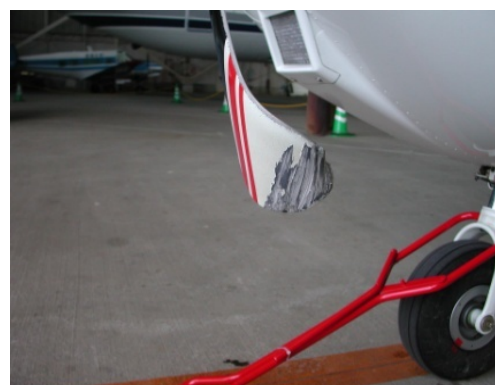
Damaged Propeller Blade

As 70 mm inward bending of the blade tip needs at least 17.2° of pitch-down attitude, the student pilot had possibly pushed the control wheel or failed to apply back elevator pressure to hold the pitch-down attitude, resulting in the nose-low contact with the runway.

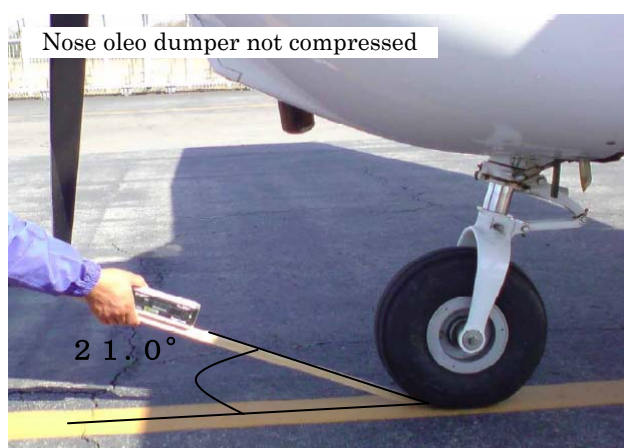
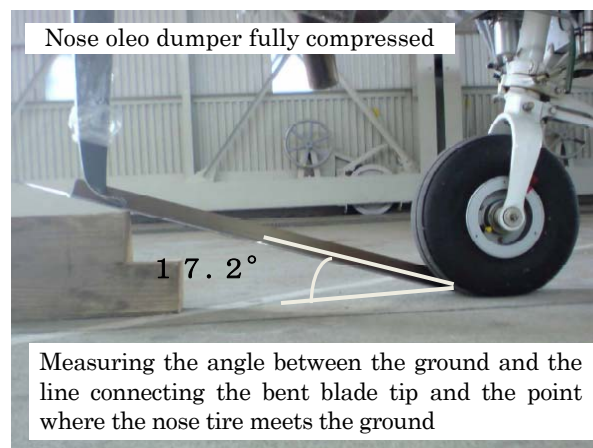
Nose oleo dumper not compressed

Nose oleo dumper fully compressed

Measuring the angle between the ground and the line connecting the bent blade tip and the point where the nose tire meets the ground

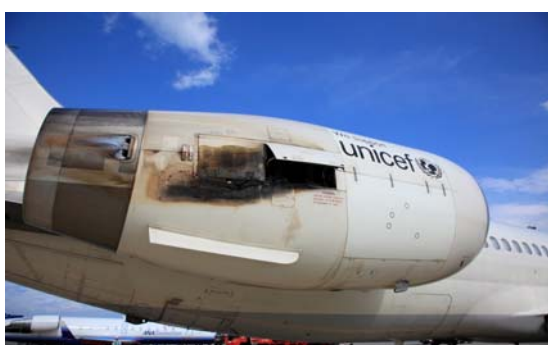
Right Engine Exterior

Summary of the serious incident: A McDonnell Douglas MD-90-30, registered JA002D, operated by Japan Airlines International Co., Ltd. took off from Sendai Airport for Fukuoka Airport as the scheduled flight 3538 at 16:08 Japan Standard Time on August 15 (Sunday), 2010. While climbing around 16:10, the aircraft declared a state of emergency upon the activation of the right engine fire warning alarm at about 5,500 ft. The right engine was shut down, while the fire-extinguishing system was activated; consequently, the aircraft returned to Sendai Airport and landed there at 16:23. Heat damage inside the cowling of the right engine was confirmed after landing.

It is probable that because the tube fractured at the bend, the straight portion lost its support; broke loose from the case to make an opening, and from which the engine oil blew out into the high temperature section of the engine to get ignited.

Probable causes: It is probable that this serious incident occurred as follows: the aircraft No. 4 bearing scavenge tube of the right engine fractured during take-off, resulted in the tube breaking loose from the diffuser case letting the engine oil blow out through an opening where it broke loose, and subsequently the oil contact with the engine high temperature section developed into an engine fire.

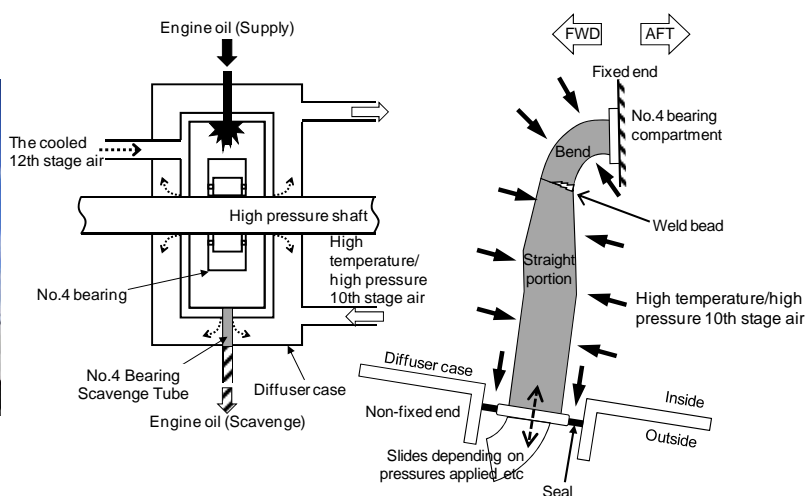
In the serious incident, it is highly probable that the fatigue crack originating from the outer diameter of the No.4 Bearing Scavenge Tube progressed into the fracture, whereas the Tube is covered with the heat shield, making it impossible to have a direct inspection of the relevant spot during a regular maintenance work. Therefore, it is recommended that the manufacturer review the tube design and overhaul inspection method thereof in order to prevent the recurrence of similar cases.

It is highly probable that the region around the bend of the No. 4 bearing scavenge tube gets repeated stress associated with engine operations when the sealed end is pushed outwards as the pressure and the temperature inside the diffuser case rise in proportion to the engine thrust. It is highly probable that the repeated stress generated the fracture origins, from which further repeated stress caused the progress of the fatigue crack followed by the final fracture.

It is highly probable that the repeated stress associated with engine operations generated the crack origins in the No.4 bearing scavenge tube and the fatigue crack grew into the fracture of the tube.

In view of the result of this serious incident investigation, the JTSB recommends that the FAA urge the engine manufacturer to take the following measures:
