Chapter 1 Summary of Recommendations and Opinions Issued in 2015

Aircraft Serious Incident Involving a Bombardier CL-600-2B19 Registered JA206J, Operated by J-AIR Corporation

Opinions on the improvement of safety of the freight train operation

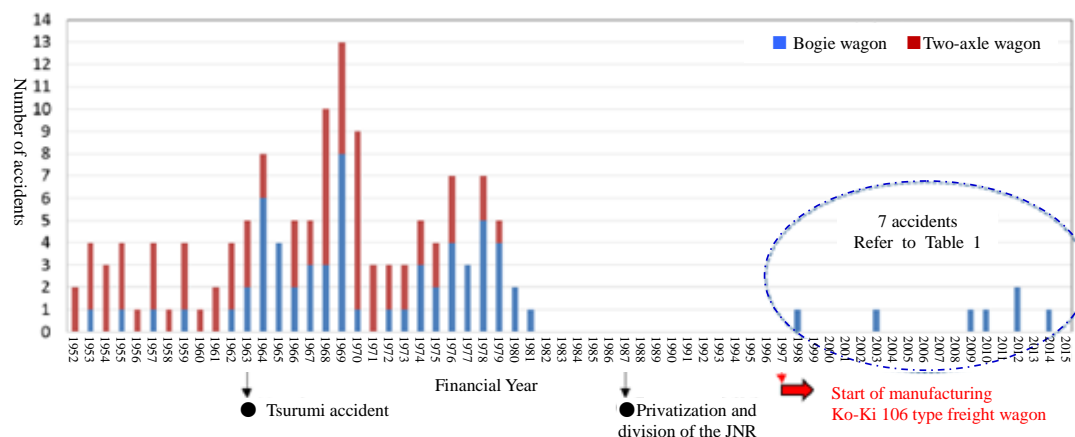
Figure 1 Changes of flange climb derailment and similar derailment accidents of freight wagon.

Figure 1 shows the data about flange climb derailment accidents and the similar accidents occurred after 1952[4]-[6]. The flange climb derailment accidents of freight wagons at main tracks had occurred frequently until around 1980, and probable causes of these accidents were determined as combination of various factors while the vehicles and the tracks were maintained within the criterion values for control, and so called as "multiple-factor derailments". The Tsurumi accident, occurred in Tokaido Main Line in November, 1963, was the multiple collision accident originated by derailment of freight wagon, and became to the disastrous accident killing 161 people. To respond this accident, Japan national railway, at that time, established the investigate committee to conduct a variety of examination including on-track tests, and implemented the measures to prevent multi-factor derailments from the view points of both vehicle and track[7], i.e., softened spring constants of the secondary suspension of the TR-41 series bogie, remodeled to use with oil dampers, added the combination of alignment and cross-level to the items in the management of track irregularity, etc. As the results of implementation of these measures, there was no multiple-factor derailment accident after 1982, however, in recent years, the same sort of derailment accidents came to happen again.

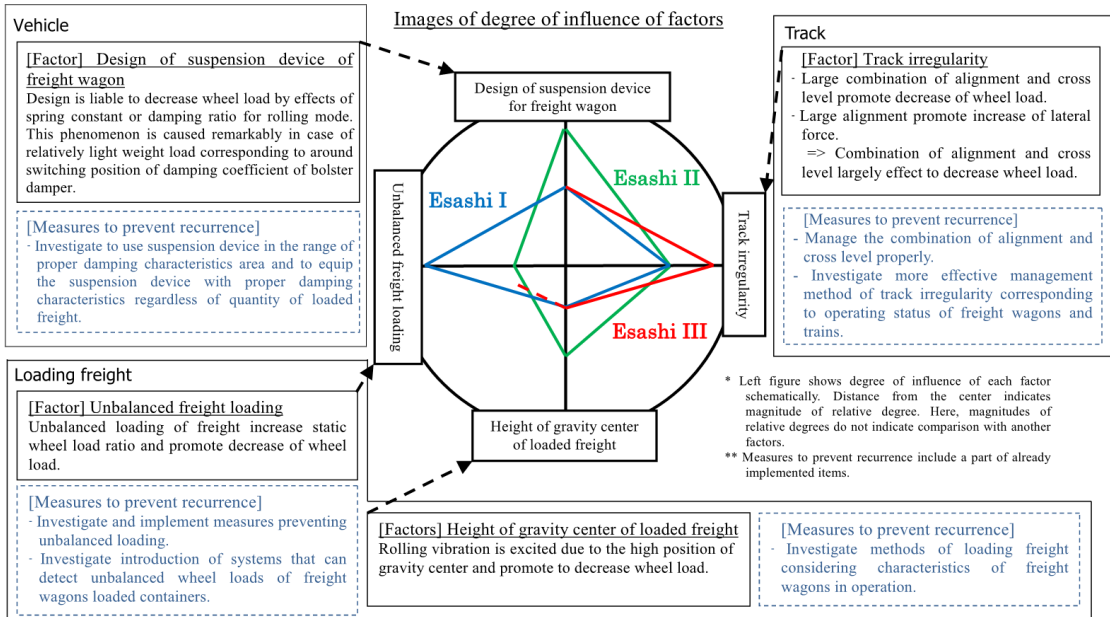
Attached diagram. Factors of the Esashi Line derailment accidents and their degrees of influence, etc.

- A series of the derailment accidents of freight trains occurred in Esashi Line have the common situation that the outer rail side wheels of the freight wagon in the freight train running in relatively sharp curve at near the limited speed, derailed by flange climbing.
- It is somewhat likely that these accidents were caused by the combination of the factors such as vehicles, track, and loading freight, etc., in the worse direction, while each factor would not cause the derailment.
- Here, degrees of influence of the factors to a series of derailment accidents differ as shown in the followings.
