Chapter 5 Marine accident and incident investigations

11 Summaries of major marine accident investigation reports (Case studies)

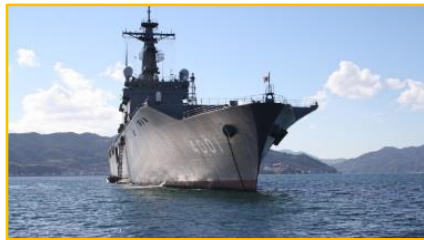
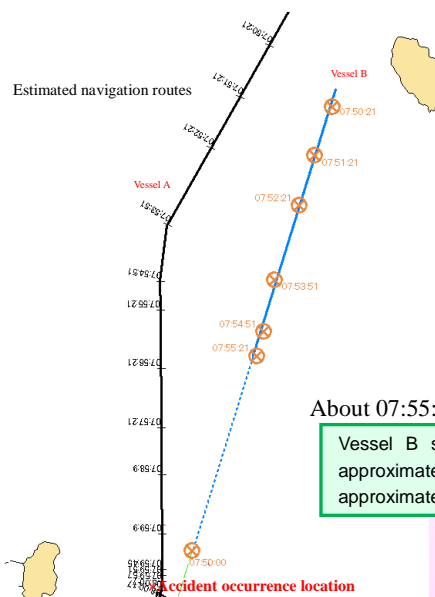
Collision between tank landing ship OSUMI and pleasure boat TOBIUO

For Ship B, the skipper and one passenger died, and one other passenger sustained injuries. In addition, there were abrasions and other damage to the starboard side of the ship, and the ship capsized.

For Ship A, there were abrasions extending from the center part of the port side to the stern, but there were no fatalities.

Probable causes: It is probable that this accident occurred because off the eastern coast of Atata Island, when Vessel A was proceeding south and Vessel B was proceeding south-southwest, Vessel A sailed while maintaining its course and speed, and Vessel B changed course to starboard from ahead of the port side of Vessel A, approaching close to the bow of Vessel A, and when Vessel A attempted to avoid it by reducing its speed and turning to starboard, both ships approached even closer to each other and collided.

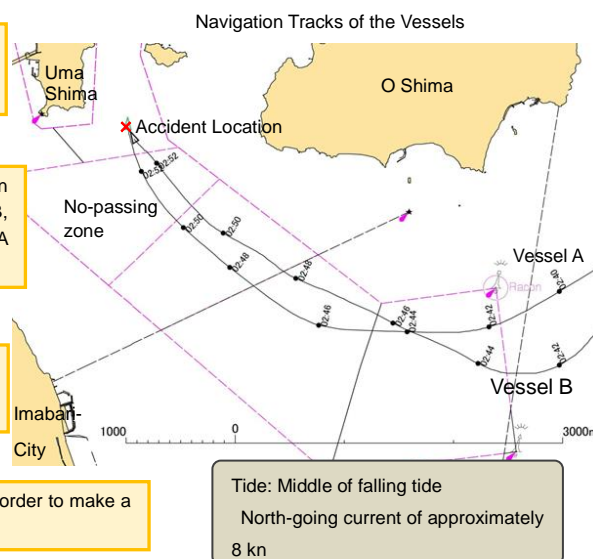
Collision between passenger ferry Ferry Fukuoka 2 and cargo ship RYOFU

vessel A had dents and scratches on the aft part of the starboard shell plate and vessel B had scratches on the port side fore, but there were no fatalities or injuries on both vessels.

Probable Causes: It is considered probable that this accident occurred because, as the speed reduction of the officer B of the vessel B was inadequate, the vessel B continued to approach the vessel A and the vessels collided while both the vessel A and the vessel B were sailing northwest in the no-passing zone in the vicinity of the Naka Suido south entrance in the Kurushima Strait Traffic Route at night.

It is considered somewhat likely that speed reduction by the officer B was inadequate, because the officer B had to carry out all the tasks other than helming without help as the watchkeeping arrangement of the vessel B for safe navigation, such as master's attendance on the bridge and conning the vessel was not ensured during the passage through the Kurushima Strait Traffic Route which is narrow and congested with vessels.

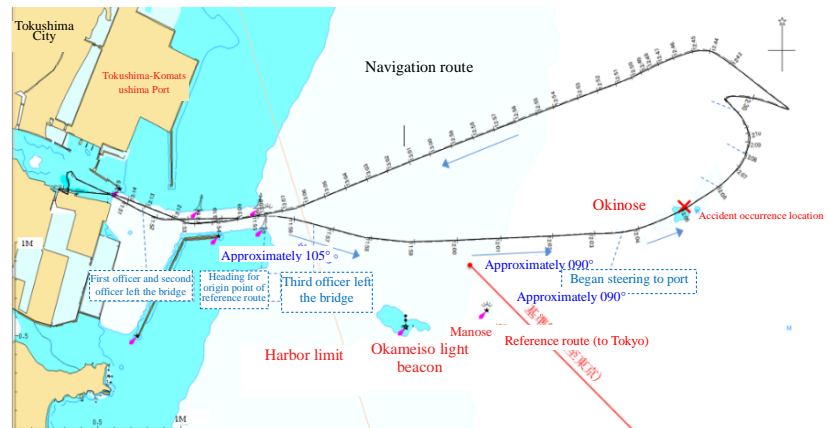
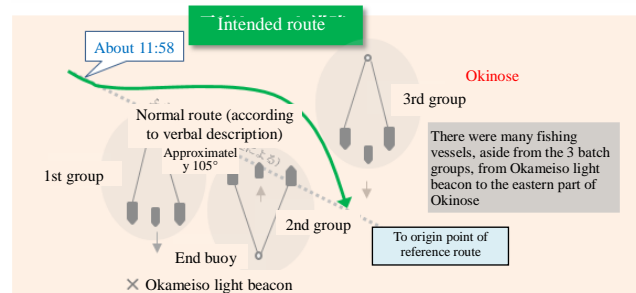
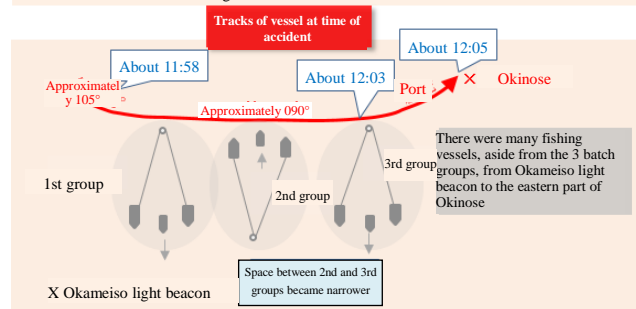
Grounding of passenger ferry OCEAN EAST

Although the vessel suffered damage consisting of a hole and buckling damage at the bottom of its starboard side, as well as water damage to the passenger cars loaded onto it, there were no casualties.

Probable causes: It is probable that this accident occurred because in the area off the east of Tokushima-Komatsushima Port, while proceeding east among approximately 100 fishing and other vessels, when the vessel turned to port to avoid the 3rd of the “groups of 3 vessels, each including 2 fishing vessels using trawl nets to catch young sardines” (“batches”) on the path ahead, the skipper was not confirming the vessel’s position, failing to realize that it was sailing toward Okinose and resulting in the ship grounding at Okinose.

It is probable that the reason the vessel’s position was not confirmed was that the vessel’s skipper was focusing his attention on confirming the buoy marking the end of the 3rd batch’s net and the movement of the fishing vessels in the surrounding area.

It is possible that the situation where, in waters congested with other vessels, the skipper of the vessel ordered the third officer from among the duty officers to leave the bridge, leaving the skipper to conn the vessel, keep a lookout, and perform other tasks by himself, contributed to the occurrence of this accident.

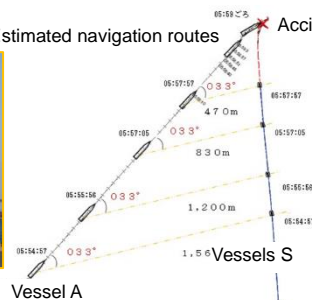
Estimated navigation routes

The master of Vessel B was killed and the vessel had a hole in the stern part of the vessel. Crew of Vessel C was killed and the stern part of the vessel was torn apart.

The Vessel A suffered scratches on the fore part of the vessel, but no one was injured.

Probable Causes: It is probable that the accident was occurred as, while, both Vessel A was sailing northeast under the pilotage of Pilot A and Vessels S was sailing north, both Vessel A and Vessels S sailed maintaining the their courses and speeds until coming close each other, at night off the west coast of Kansai International Airport.

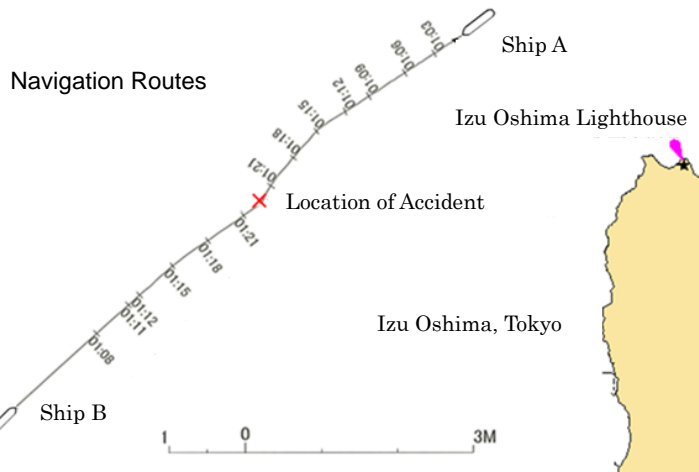
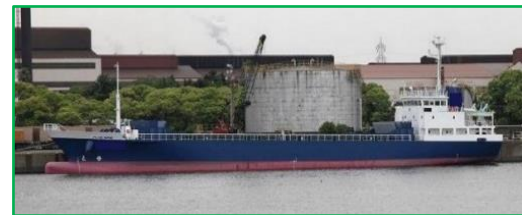
Collision between cargo ship JIA HUI and cargo ship EIFUKU MARU No.18

Summary: The cargo ship JIA HUI (Vessel A, gross tonnage: 2,962 tons) with the master, the officer of the watch and 11 other crew members on board sailing southwest to Busan, South Korea, and the cargo ship EIFUKU MARU No.18 (Vessel B, gross tonnage: 498 tons) with the master, the chief officer and 4 other crew members on board sailing northeast to Chiba port, Chiba prefecture collided off the west of Izu Oshima, Tokyo at about 1:22 on September 27, 2013. Vessel B capsized and all 6 crew members were killed dead, and Vessel A had damage on the bow but no one was injured or killed dead.

The bearing of Vessel B had been changed approximately 3° to port, but the Officer thought that he could pass in front of Ship B and did not confirm the change of bearing of Vessel B with a compass (did not notice the course alteration of Vessel B).

Probable Causes: It is probable that this accident occurred by the collision of both ships at night off the west of Izu Oshima Island, because when Vessel A proceeded to southwest and Ship B proceeded to northeast, Officer A of Vessel A attempted to pass Ship B with the starboard facing it and continued to proceed by repeatedly veering to the port, and Chief Officer B of Ship B proceeded almost the same course and speed.
