Chapter 3 Aircraft accident and serious incident investigations

2 Procedure of aircraft accident/incident investigation

9 Summaries of major aircraft accident and serious incident investigation reports (case studies)

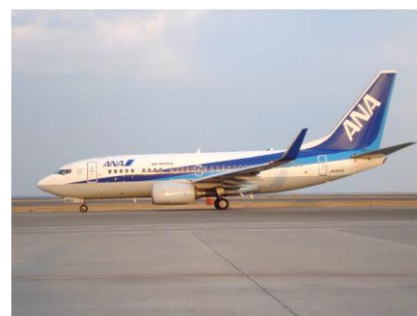
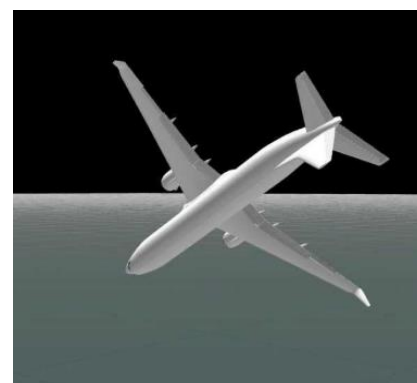
It is probable that the followings contributed to the first officer's erroneous operation of the rudder trim control while having an intention of operating the door lock control; he had

not been fully corrected his memories of operation about the door lock control of the Boeing 737-500 on which he was previously on duty; the door lock control of the Boeing 737-500 series aircraft was similar to the rudder trim control of the Boeing 737-700 series aircraft in their placement, shape, size and operability. It is somewhat likely that his memories of operation about the switch for the door lock control of the Boeing 737-500 aircraft had not been fully corrected because he failed to be fully accustomed with the change in the location of the switch for the door lock control. It is somewhat likely that this resulted from lack of effectiveness in the current system for determining the differences training contents and its check method, under which the Air Nippon Co., Ltd. and other airlines considered and adopted specific training programs to train pilots about how to operate the flight deck switches when their locations changed and the Civil Aviation Bureau of the Ministry of Land, Infrastructure, Transport and Tourism reviewed and approved them. It is probable that the first officer's failure to properly manage tasks contributed to his erroneous operation of the rudder trim control.

It is somewhat likely that the similarities between the switches for the door lock control and the rudder trim control in their operability contributed to the delay in his recognition of the erroneous operation. Moreover, he was excessively dependent on autopilot flight and he failed to be fully aware of monitoring the flight condition.

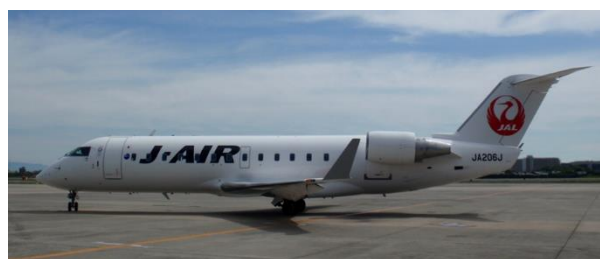
It is highly probable that the cause of this serious incident was that the coupling nut connecting the right engine fuel manifold (fuel supply piping) and fuel injector (fuel injection nozzle) No. 14 was loose, fuel leaked from this area and was ignited by the heat of the engine, which resulted in fire in the designated fire zone.

Although it is somewhat likely that the reason why the coupling nut was loose was the insufficient tightening force of the coupling nut, resulting in gradually loosening caused by factors such as engine vibration, the Japan Transport Safety Board couldn't determine the cause of the loosening.

Enhance education and training involving important system functions for safety and reconsider the contents of training in response to an outbreak of fires.

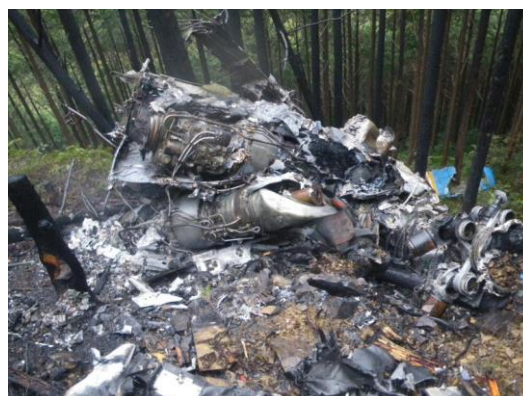
Condition of main components

Probable Causes: In this accident, it is highly probable that the Helicopter did not fly with sufficient distance to power transmission lines stretched in the air when it left and climbed from hovering at the loading site of the forward base, causing the collision with the power transmission lines, which damaged the fuselage and made it crash.

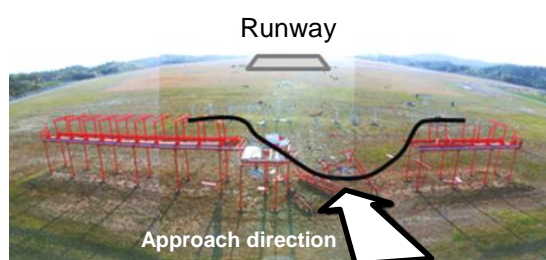
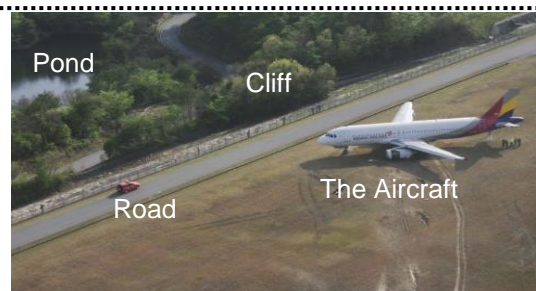
The aircraft was substantially damaged, but there was no fire breakout.

Probable Causes: It is certain that when landing on runway 28 at Hiroshima airport, the aircraft undershot and the PIC commenced executing a go-around; however, it collided with the Aeronautical Radio Navigation Aids located in front of runway 28 threshold, just before turning to climb.

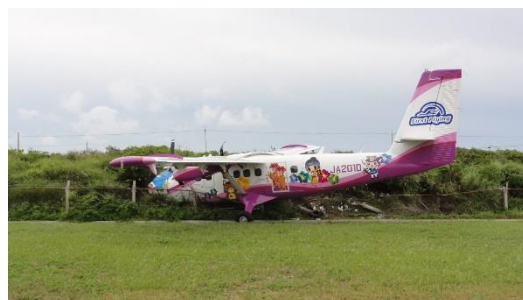
Situation when the Aircraft stopped

Probable Causes: It is highly probable that this accident occurred because, when the aircraft landed, the First Officer, as the PF in charge of flying, could not properly control the aircraft as it started to deflect after touchdown, as a result of which the aircraft departed from the side of the runway and collided with a fence on the airport perimeter.

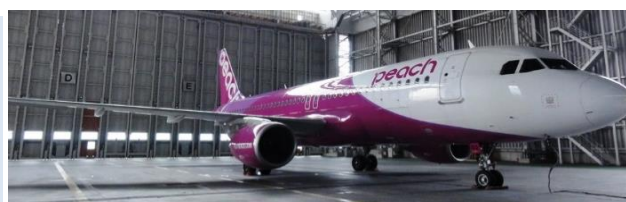
Operation of the VS knob by the PIC

- It is somewhat likely that the PIC intended to stay true to the PAR approach, his first in a while and first in this type of aircraft, and overestimated his impression of the behavior of the aircraft after the glide path convergence.
- It is somewhat likely that, as a result, the PIC did not make a callout, preset the VS knob on the FCU panel to a sink rate of -900fpm, and following this, or some time after this, pulled the VS knob without intending to start the descent.

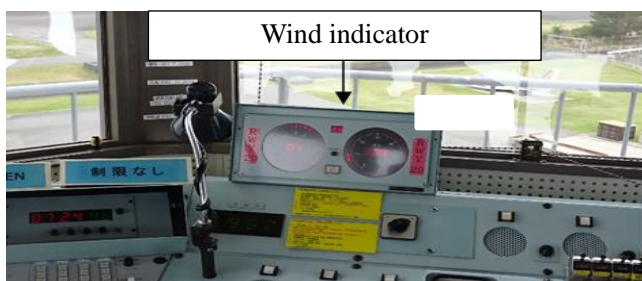
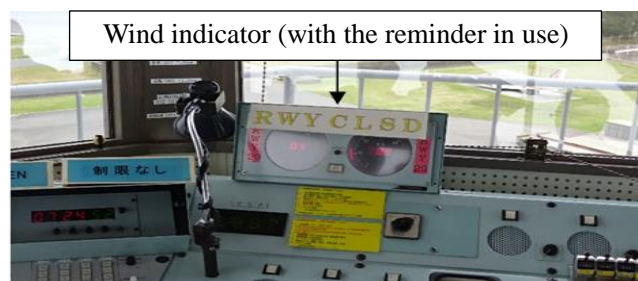
Situation of the reminder in use

The supervisor, thinking that he could cope by memory alone as there were few takeoffs and landings scheduled, did not use the reminder (*).

* A sign used to show broadly that the runway was closed.
