Chapter 4 Railway accident and serious incident investigations

2 Procedure of railway accident/incident investigation

3 Statistics for the investigations of railway accidents and serious incidents

9 Summaries of major railway accident and serious incident investigation reports (case studies)

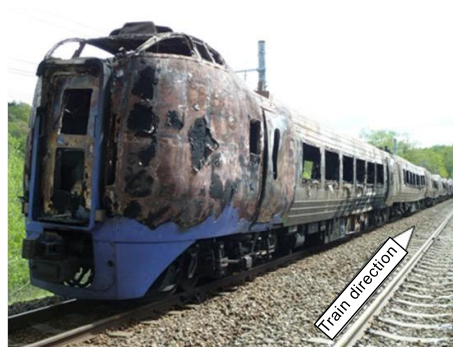
It was found that the first axle of the rear bogie of the fifth vehicle of the train had derailed to the left. There were many parts of the dropped power transmission device, etc. scattered along the track for about 2 km length away from the halted point of the train. Moreover, all the 6 vehicles of the train were burnt by the fire.

Status of the burnt cars

About the damage of the train by fire after the train derailment accident, it is probable that the fallen bevel gear of the reduction gear device hit and broke the fuel tank in the front part of the sixth vehicle, the light oil scattered on the track around the wooden sleeper had caught a fire ignited at around the generator or rear upper part of the engine and spread to the whole train.

According to the results of the overhaul inspection about the under floor equipments that were badly burnt and the equipments to get high temperature during operation, it is probable that all equipments caught fire by the external heat sources, then, the precise point where a fire was outbreak and the cause of outbreak fire were not identified.

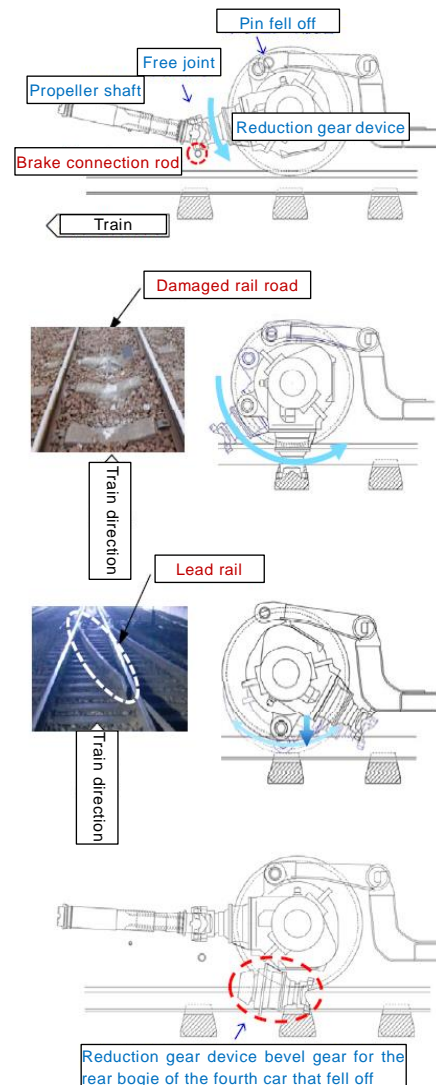
- (1) When the reduction gear device was hung down forward as rotate around the axle, the propeller shaft was also hung down. As a result, the universal joint was broken and finally the reduction gear and the propeller shaft were separated.
- (2) As the separated reduction gear device further rotated, the suspender of the reduction gear device hit the lead rail of the turnout No.12-Ro in the premises of Seifuzan signal station. At this moment, the rear bogie of the fourth vehicle was pushed to the left along the lead rail and the first axle derailed, the second axle of the rear bogie derailed following the first axle. The derailed 2 axles were restored at the turnout No.11-I.
- (3) As the rear bogie of the fifth vehicle hit the bevel gear on the track fallen off from the hanged reduction gear device, the rear bogie was pushed up and the first axle was derailed.

The process of derailment (presumption)

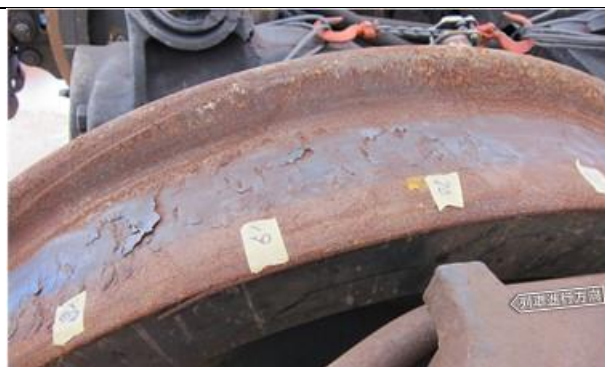
Wheel tread exfoliation condition

Hokkaido Railway Co. should establish the proper inspection system, i.e., inspection period and methods for monitoring the condition of the wheel tread, and should manage the condition of the wheel tread throughout, and never use the wheel which should be treated as the wheel whose size of the tread defects or exfoliation are exceeded the limit to be used.

- (1) Since December 2013, the vehicle related planning division has been handling cases of consecutive occurrences of wheel abrasion, peeling and others as a single issue, in addition to the standard values during normal wheel inspections (including operational and alternating inspection). As a result, wheel turning is carried out before “peeling caused by thermal cracking” extends to the whole circumference of the wheel tread.

- (4) Using the “wheel flat detection device”, vibration (vertical acceleration) due to wheel tread peeling, abrasion and other factors during vehicle motion can be measured. Since the device was installed, we have continuously cross-checked the data obtained from the device with actual wheel tread (in trial operation until June 2016).

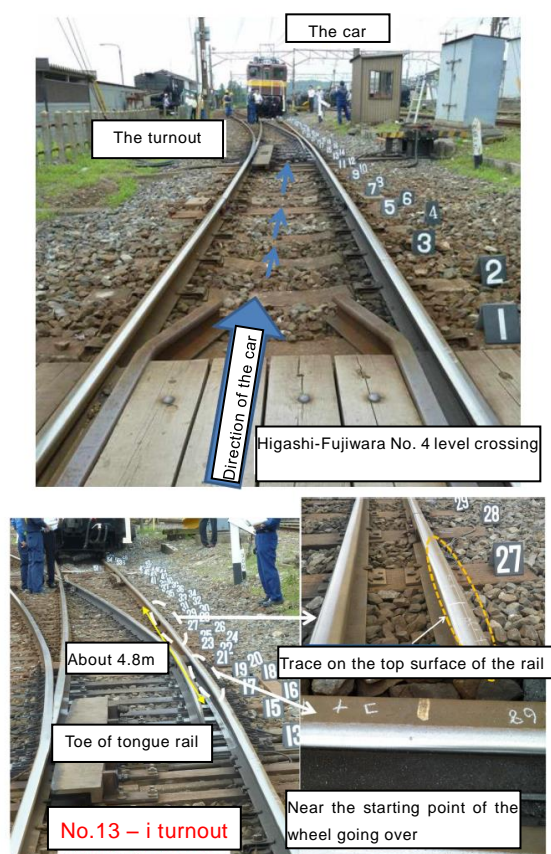
The driver of the train set, noticing an abnormal condition when it was passing the Higashi-Fujiwara No. 13-I turnout, immediately applied the emergency brake to stop the train. The first axle in the front bogie of the second locomotive was derailed to the right.

Derailed site

Since specifications of curves have been clarified for curves of our Sangi main line between each station, we have utilized them for track maintenance. However, some specifications of curves were not clarified in the main line, side lines, and curves with turnouts on the premises of each station.

With regard to turnouts in three locations inside station premises (Tomida Station *Sa* Nos. 60 and 91 and Higashi-Fujiwara Station No. 60), which were adjusted on site due to a lack of specifications (hereinafter referred to as “similar turnouts”), we took steps to remove and replace branches. We have reported on the completion of work on Higashi-Fujiwara Station No. 60 turnout in Sangi Tetsu No. 69 dated August 25, 2015. This time, we report on the completion of measures for Tomida Station *Sa* No. 60 and No. 91 turnouts.

Based on these measurement results, we have prepared line survey maps including the specification of curves in accordance with the implementing standards for construction works. We have applied for approval of modification of railway facilities when replacing turnouts (Sangi tetsu No. 39 dated April 14, 2016) and have received the approval of the Director-General of the Chubu District Transport Bureau (Chu-untetsugi No.19 dated April 26, 2016). In response to this, the turnouts were replaced and curve improvements were completed by August 10, 2016.

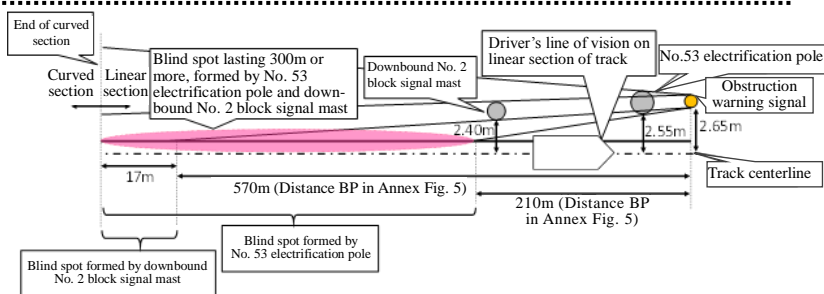
The obstruction warning signal to outbound trains on the level crossing was in a blind spot formed by electrification poles along the track, and there was a section extending to at least 300m in which the outbound train driver could not confirm the indication of the stop signal on the obstruction warning signal.

It is probable that the occurrence of serious injury was caused by the impact of the 2nd or later collision between the truck and the train, and by a collision with objects that appear to have been parts of the frame that broke due to the collision and parts of the train that became scattered inside the vehicle. It is probable that the occurrence of numerous injuries was caused by a strong impact when the train collided with the truck.

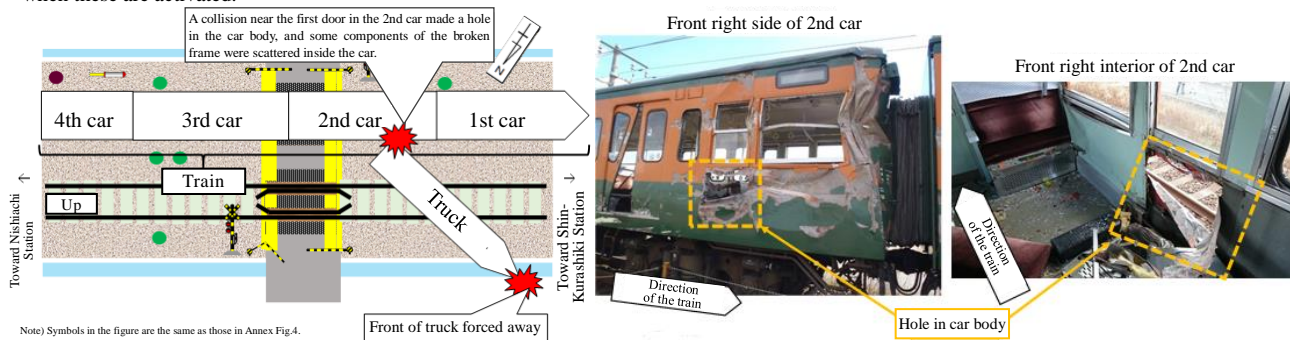
It is somewhat likely that the truck stopped on the level crossing because its engine power could not be transferred owing to an abnormality in the transmission when shifting gears just before this accident occurred. However, it could not be determined why this kind of situation occurred, because the records in the truck's control unit did not include time records, and because the state of the truck's transmission just before this accident occurred is unknown.

Probable causes (Excerpt): It is certain that the accident had occurred because the truck had stopped in Hachinin-yama level crossing road, the approaching train collided with the truck. It is highly probable that the train could not stop before the level crossing because the train driver could not notice the obstacle in the level crossing promptly. It is somewhat likely that the reason why the train driver could not notice the obstacle promptly, was related with that there were over 300 m long section where the driver of the outbound train could not confirm stop signal indication of the obstruction warning signal, as the obstruction warning signal against the outbound trains in the level crossing was in the blind angle by the track side electrification poles.

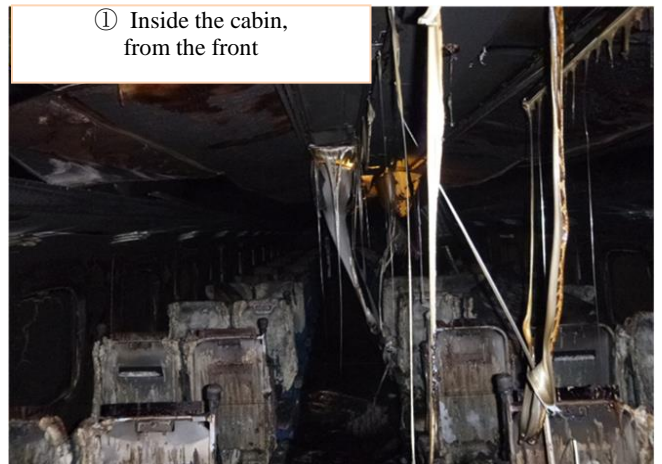
① Inside the cabin, from the front

The seats, floor, side wall, sealing, etc., from the front to the mid part of the first vehicle were burnt by the fire.

Probable causes: It is highly probable that the accident occurred because the passenger onboard the train sprinkled gasoline and ignited fire by himself in the cabin of the first vehicle.

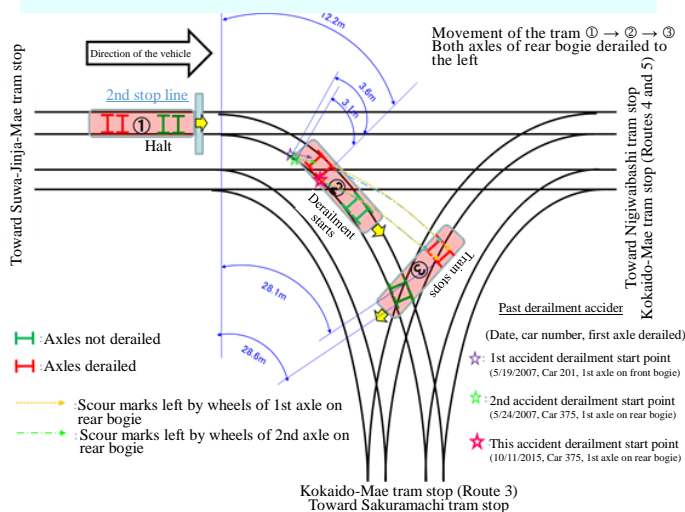
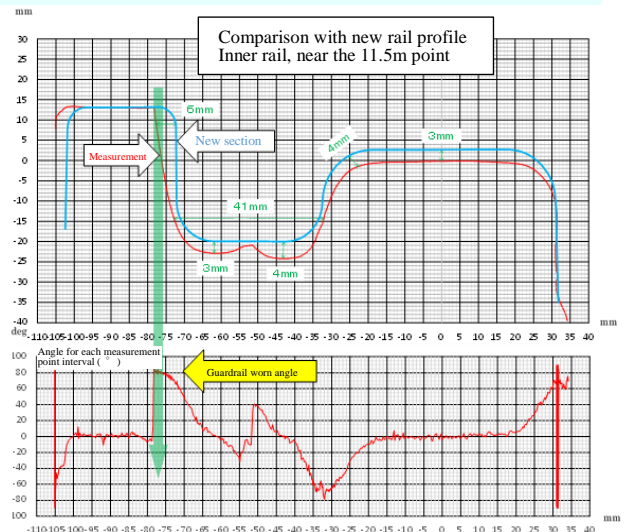
When this accident occurred, the worn angle of the guardrail near the derailment start point was about 80° , smaller than the 90° at new. It is somewhat likely that the occurrence of the derailment was influenced by the resultant decrease in the critical derailment coefficient for the inner wheel back surface derailment.

It is probable that the main cause of both the 1st and 2nd accidents was that the finished state was inappropriate after the tracks were repaired. By contrast, it is somewhat likely that this accident was caused by a combination of factors, such as the train speed, the friction coefficient at points of contact between the wheel back face and the guardrail, the worn angle of the guardrail, and the irregularity of the back gauge, etc.

Probable causes (Excerpt): It is probable that the accident occurred as follows, while the tram was running in the right curved branch line in the turnout, as the back side of the right wheel of the first axle in the rear bogie was contacting with side surface of the rail, having the role of guard rail, in the diamond crossing, the back side of the right wheel climbed up the guard rail and derailed to left, and after that, the left wheel of the first axle climbed up the left rail and derailed to left, furthermore, the second axle on the rear bogie also derailed to left.

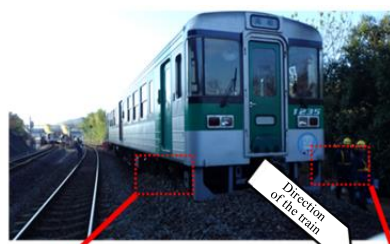
Train after running into the piled gravel buffer stop and stopping

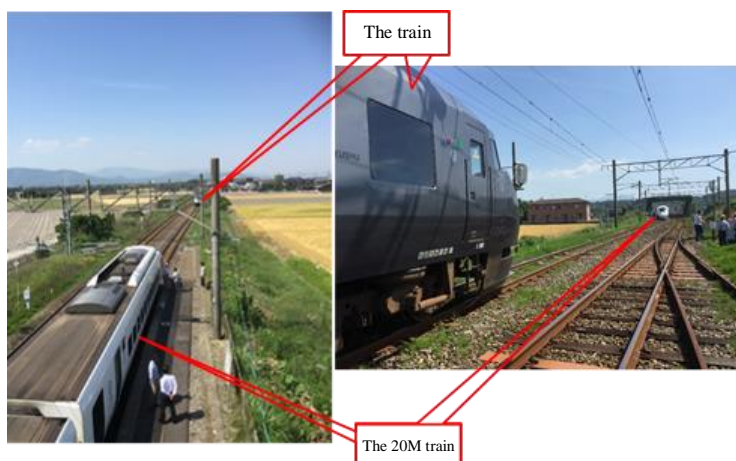
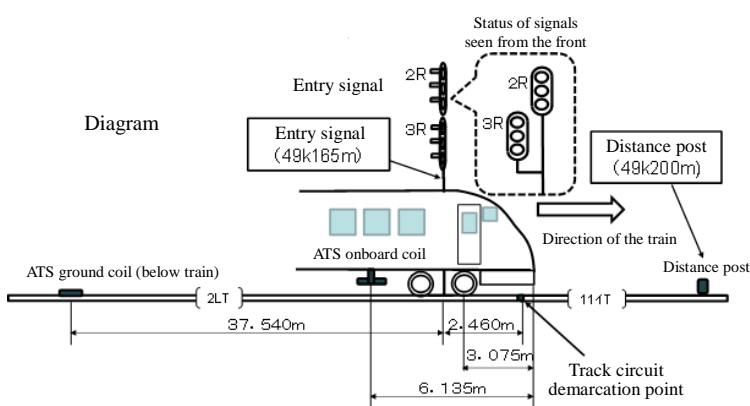
It is probable that, after starting again, the train involved in this incident by entering to the section in which a stop signal was shown. However, because the train had already passed over the ATS ground coil (below the train), the ATS brake was not activated.

It is probable that both the train driver and train dispatcher, did not report or confirm the stopped position determined in past instruction documents and work standards regarding reports on stopped positions. It is also probable that this was because the company had not grasped the working realities of reports and confirmations.

Probable causes (Excerpt): It is probable that the railway serious incident occurred as the outbound limited express train, stopped beyond the down line entry signal of Hizen-Ryuo station indicating proceed signal, restarted operation obeying the instruction by the train dispatcher after the entry signal indicated stop signal, resulted in the state of red signal violation against the entry signal, and entered into the safety margin for overrunning section for the inbound limited express train scheduled to stop in the No.1 line of the station, induced the possibility that the two trains were operating at the same time in the section of the safety margin for overrunning, when the inbound limited express train, operated obeying the instruction of the train dispatcher and signal indication, passed through the entry signal for the up line.

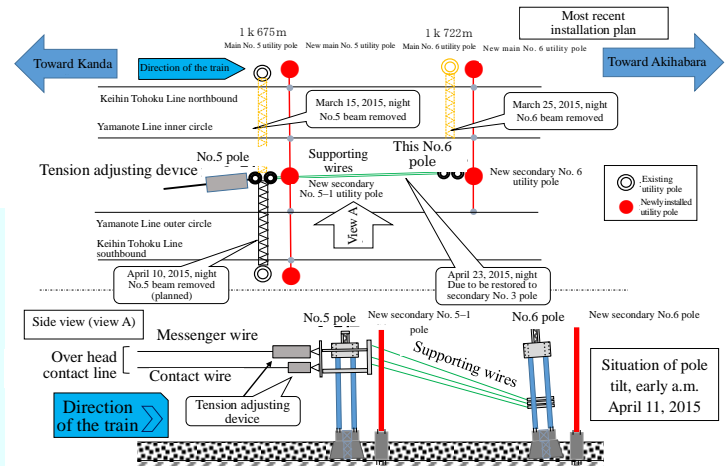
It is probable that the safety factor against tilting decreased to 1 or less, because the beam, overhead contact lines and others attached on the top of the pole were removed in March 2015, and these decrease the vertical force acting on the structure of foundation, although the tilting moment due to the force acting on the supporting wires did not change.

The company staffs, who did not understand the structure of the pole foundations, had mistakenly judged the safety factor to be adequate, based on the assumption that the foundations had a more robust structure such as the anchor bolt foundations used in more than half of the cases between Kanda and Akihabara Stations, and it is probable that this played a part in this incident.

Probable causes (Excerpt): It is probable that the serious incident had occurred as that the pole used for train operation tilted, in the process of the dismantling works of poles accompanied with the integrated overhead contact line construction of the electric circuit facility, and the pole was tilting seriously because the required measures did not implemented, though the information that the pole was tilted was announced to the plural staffs concerned, and fell down on the railway track in the service hours of train operation, and obstructed the structure gauge significantly.
