## Chapter 5 Marine accident and incident investigations

## 5 Statistics of investigations of marine accidents and incidents (As of end of February 2018)

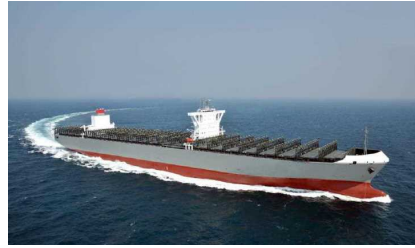
Summary	<p>While the ship was docking with a master, 25 crew members and a pilot onboard at the port of Felixstowe, United Kingdom of Great Britain and Northern Ireland an explosion occurred in the furnace of the auxiliary boiler.</p> <p>The duty oiler died, the second engineer suffered injuries and the burner unit of the auxiliary boiler damaged.</p>

Probable Causes	<p>It is probable that the accident occurred, in the night time, while the ship was docking at the port of Felixstowe, United Kingdom of Great Britain and Northern Ireland, an explosion occurred within the furnace of the auxiliary boiler.</p> <p>It is considered somewhat likely that explosion occurred in the furnace is because under existence of carbon monoxide gases heated by incomplete combustion and flames in the furnace, the second engineer operated the forced draft fan and the secondary air was supplied. The explosion occurred by a rapid chemical reaction changing heated carbon monoxide gas. Or in the situation where marine gas oil existed as a highly concentrated flammable gas in the high temperature furnace, the forced draft fan was operated and secondary air was supplied, then the flammable gas was mixed with air, the concentration was between the upper limit and lower limit concerning the explosion. As a result, the explosion occurred.</p> <p>It is probable that the second engineer operated the forced draft fan for the purge in the furnace.</p> <p>It is probable that the existence of the marine gas oil a highly concentrated flammable gas was as follows. Under slimy wax-like material stuck to strainer etc., which was clogged causing the marine gas oil pressure drop but the marine gas oil pressure did not drop to fuel oil low pressure alarm set point, the marine gas oil to the rotary cup burner flow reduced. The primary air and the secondary air was supplied as same volume as before marine gas oil clogging, the marine gas oil was blown away and the atomizing marine gas oil became unevenly stable. The flame was cooled by the excess air and flame pattern was broken causing the combustion status very bad and remaining unburnt marine gas oil in the furnace and unburnt marine gas oil vaporized.</p> <p>It is probable that the carbon monoxide gases heated by incomplete combustion and flame existed in the furnace because the forced draft fan stopped by the Furnace (Flame-Eye) Abnormal alarm, the secondary air damper was closed, secondary air was not supplied, and combustion continued under insufficient air quantity.</p> <p>It is probable that the strainer was clogged as follows. When the ship used the marine gas oil containing a large amount of paraffin wax and the Cold Filter Plugging Point of it was high, the temperature around the auxiliary boiler oil burning apparatus was below the cold filter plugging point of the marine gas oil and the paraffin wax precipitated in the strainer.</p>

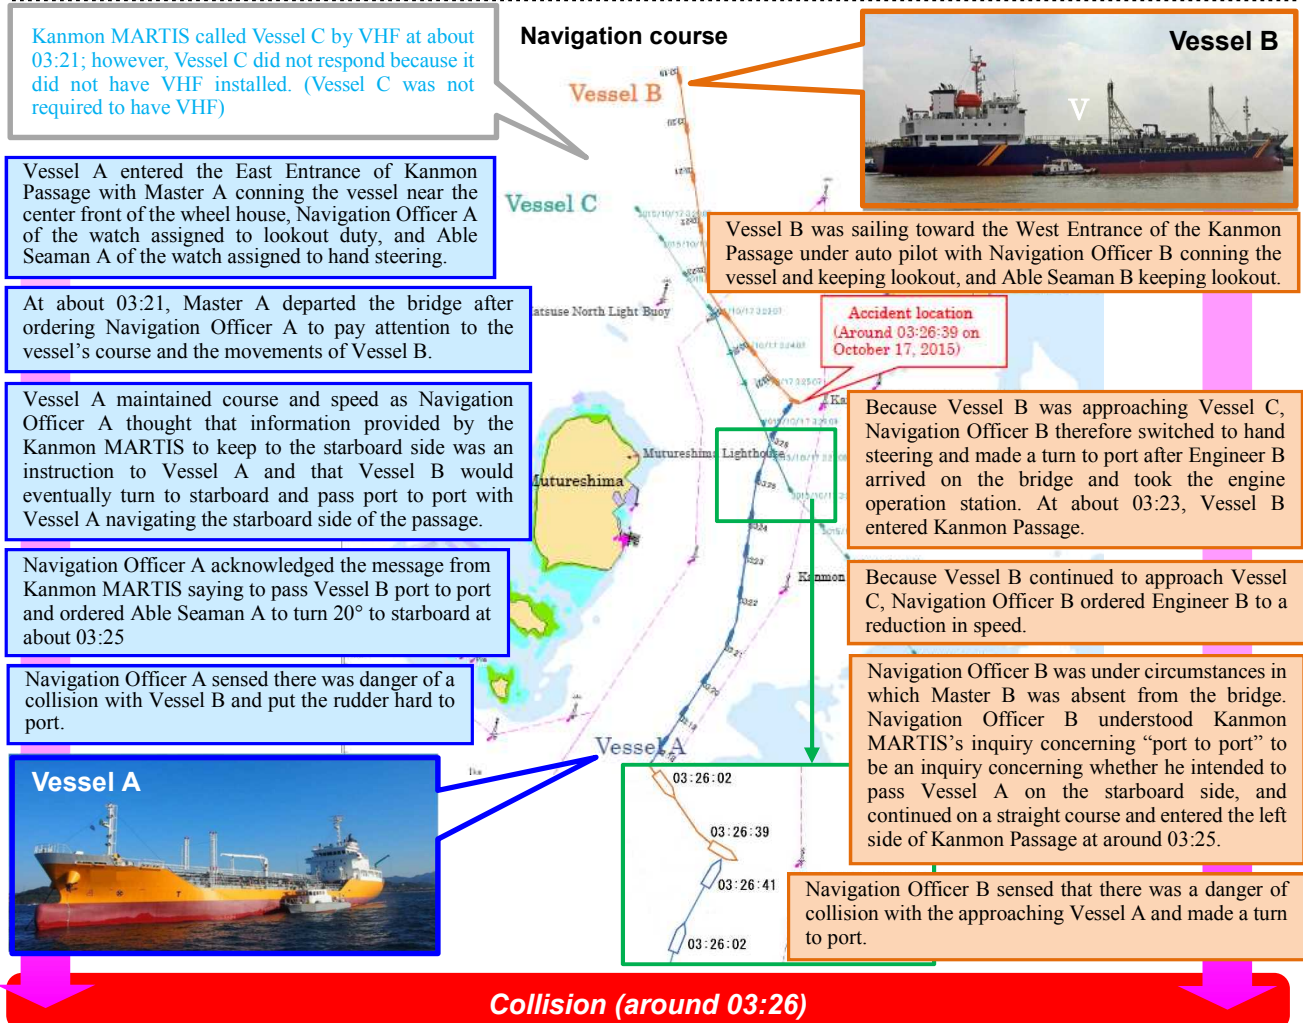
**Summary:** While **chemical tanker SULPHUR GARLAND (Vessel A, 3,498 gross tons)** was proceeding north-northeast along Kanmon Passage of Kanmon Port toward Zhenjiang Port, People’s Republic of China, with a master and a second officer and other 15 crew members onboard, and while **oil tanker WAKOMARU NO. 2 (Vessel B, 2,018 gross tons)** was proceeding south-southeast along the same passage toward Oita Port, Oita Prefecture, with a master and a second officer and other 8 crew members onboard, the two vessels collided at about 03:26 on October 17, 2015, near the West Entrance of Kanmon Passage, east of Mutsureshima Island, Shimonoseki City, Yamaguchi Prefecture. The bow of Vessel A was crushed, and the aft starboard side shell plating of Vessel B was holed and dented, which resulted in an oil spill. There were no fatalities or injuries on either vessel.

**Probable Causes (excerpt):** It is probable that Vessel A and Vessel B collided during nighttime off the eastern coast of Mutsureshima Island because, while Vessel A was proceeding north-northwest through Kanmon Passage toward the West Entrance of the passage and Vessel B was proceeding south-southeast toward the West Entrance of the passage having medium-sized purse seine fishing vessel sailing in the same direction in her starboard bow, Vessel B came close to Vessel C and turned to port to enter the left side of Kanmon Passage while Vessel A maintained course and speed. It is somewhat likely that the reason why Vessel B came close to Vessel C, turned to port and entered the left side of Kanmon Passage was that, after observing Vessel A proceeding north through Kanmon Passage and the medium-sized purse seine fishing vessel proceeding southeast toward the West Entrance of the passage, Navigation Officer B did not maintain proper lookout on Vessel A and Vessel C, and therefore he was unable to anticipate that Vessel B would be in a situation crossing ahead of Vessel A, which was proceeding north through the Kanmon Passage and sailing the port side of Vessel C, and further he made Vessel B’s speed almost same with the speed of Vessel C which was sailing in the starboard ahead which made him confused as Vessel B unable to take starboard turn. It is probable that the reason why Vessel A maintained course and speed was that Navigation Officer A thought that information provided by the Kanmon MARTIS to keep to the starboard side was an instruction, and that he thought that Vessel B would eventually turn to starboard and pass port to port with Vessel A navigating the starboard side of the passage.

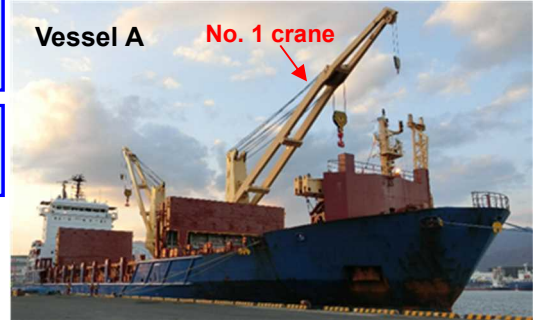
(Arrangement of workers at the time of the accident)

It is probable that Vessel A rolled and inclined approximately 7° to the starboard side at the time of the accident when the underside of the hull fender on Vessel A's starboard midship hull came off the tops of the wharf fenders when the Pipes were hoisted by the No. 1 crane and then stopped under conditions where the underside of the hull fender was caught on the tops of the wharf fenders and Vessel A's starboard inclination was arrested because, among other reasons, the height of tide had fallen compared to that at the time of docking and the vessel's draft had increased.

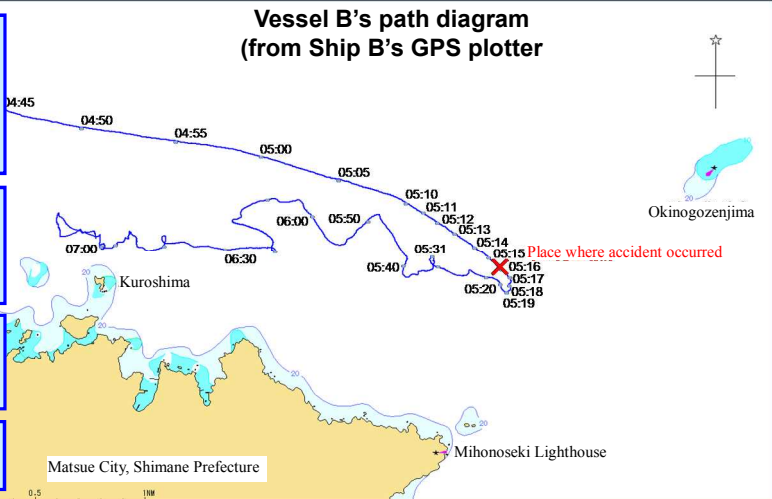
**Capsizing (at around 5:15)**

At around 5:14 to 5:15, Vessel B's radio contact with Vessel A went silent.

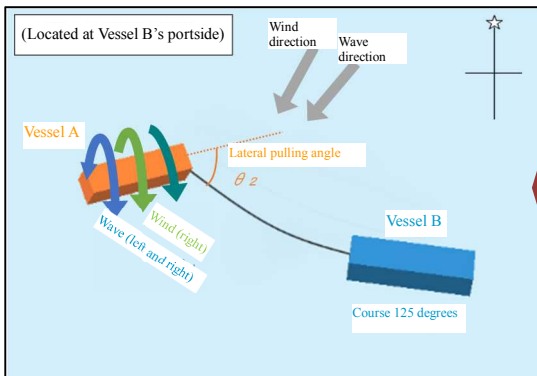
**(Situation of capsizing)**

- It is probable that the stability of Vessel A was reduced due to addition of structural objects, etc. to it and water tanks on its deck and the freeboard of the ship also decreased.
- Vessel A was exposed to the risk of a sudden increase in heeling moment because the towing rope was not long enough. It is somewhat likely that the heeling moment increased due to the.
- It is probable that the angle of the heel of Vessel A became larger than the bulwark submerge angle due to a combination of Vessel A's steady heel caused by wind, rolling motions caused by waves and Vessel A's heeling energy caused by the tension on the towing rope.
- While Vessel A's angle of heel exceeded the bulwark submerge angle and the righting lever became smaller, it is somewhat likely that continuous waves capsized Vessel A with the bulwark acting as resistance to stability.

**Probable Causes (excerpt):** It is somewhat likely that the accident occurred as follows: The main engine of Vessel A stopped at night when the ship's stability was reduced and its freeboard decreased. While being towed southeast by Vessel B north of the Mihonoseki lighthouse, Vessel A became almost unable to regain stability as the angle of the heel exceeded the bulwark submerge angle and capsized by continuous waves.

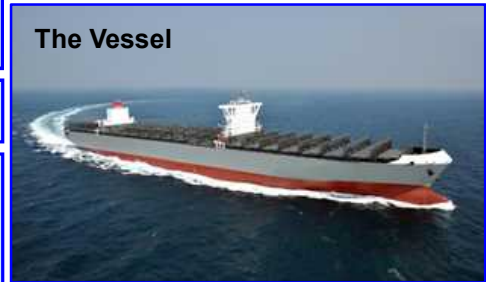
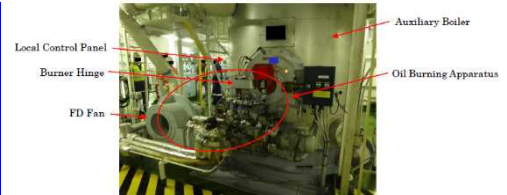
(Auxiliary boiler)

*An explosion occurred in the furnace of the auxiliary boiler (at around 23:04)  
The duty oiler died, the Engineer A suffered injuries*

- It is somewhat likely that under the condition where the primary air and the secondary air was supplied as same volume as before MGO clogging, the MGO pressure dropped and the MGO flow to the rotary cup burner was reduced and then the atomizing of MGO became unstable. The flame was cooled by excessive air and the burning process was disturbed causing the combustion status very bad and unburnt MGO remained in the furnace.

- After automatic combustion of the rotary cup burner was stopped, unburnt MGO remaining in the furnace during automatic combustion was vaporized, became a flammable gas and continued to burn. Then Furnace (Flame-Eye) Abnormal alarm was activated, FD fan stopped, the secondary air damper was closed and combustion air was not supplied. As a result, flame of incomplete combustion and flammable carbon monoxide gas or flammable gas of the MGO became present in the furnace.

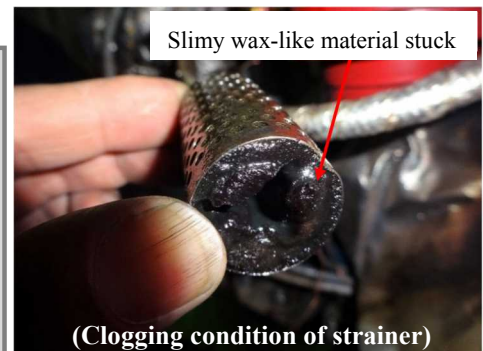
(Clogging condition of strainer)

- It is somewhat likely that under the condition where the primary air and the secondary air was supplied as same volume as before MGO clogging, slimy wax-like material stuck to the strainer of MGO line or the pressure adjusting valve malfunctioned due to the influence of the precipitated paraffin wax, which caused reduced flow of the MGO to the rotary cup burner and unstable atomization of the MGO.
- It is somewhat likely that slimy wax-like material stuck to strainer etc. at the time of using the MGO, which caused the MGO pressure to drop. However, as the MGO pressure did not drop to the set point for fuel oil low pressure alarm, automatic combustion continued. The atomizing of MGO became unstable. The flame was cooled by excessive air and the burning process was disturbed causing the combustion status very bad and unburnt MGO remained in the furnace.

**Probable Causes (excerpt):** It is probable that the accident occurred, in the night time, while the Vessel was docking at the port of Felixstowe, United Kingdom of Great Britain and Northern Ireland, an explosion occurred within the furnace of the auxiliary boiler.

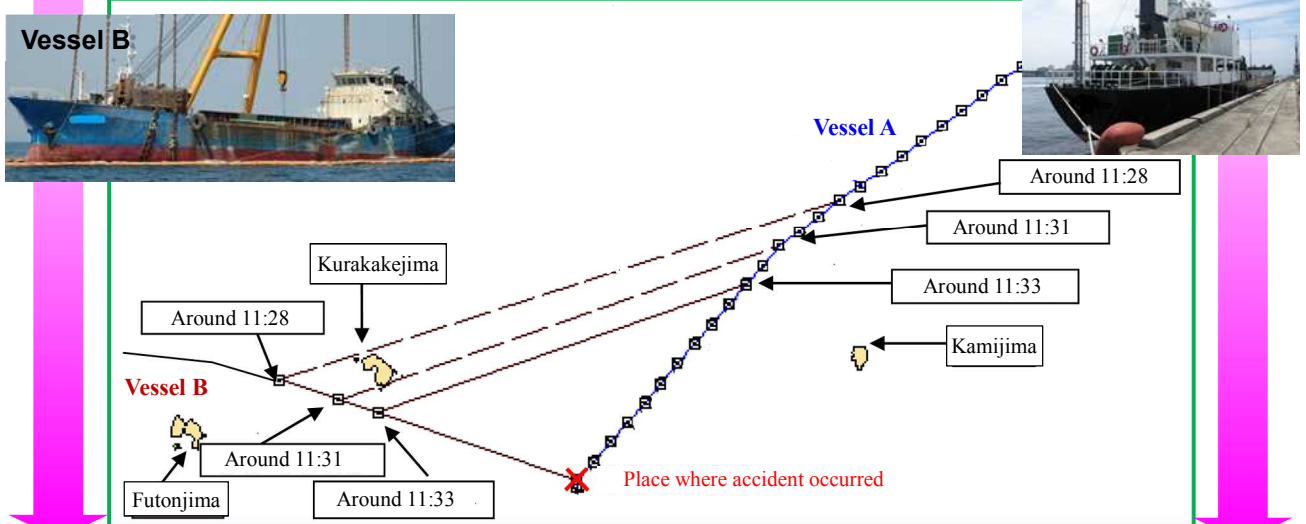
**Collision (at around 11:43)**

Vessel A was sailing in automatic steering mode, with the master on Vessel A serving as the sole bridge watchkeeper. As Vessel B was southwest of Kurakake Island roughly between 11:28 and 11:31, the master could not detect Vessel B either visually or by radar.

Considering that there was no ship ahead as an obstacle to Vessel A's sailing, the master engaged in such work as filling in a document on a chart table in the rear part of the portside bridge and did not maintain a lookout.

**Probable Causes (excerpt):** It is probable that the accident occurred as follows: Vessel A was sailing southwest off the east coast of Kurakake Island while Vessel B was traveling southeast. The master on Vessel A did not notice Vessel B early enough as he engaged in such work as filling in a document and did not maintain a lookout, considering that there was no ship ahead as an obstacle. At the same time, the navigation officer on Vessel B noticed Vessel A on Vessel B's portside bow but thought Vessel A would eventually give way. Although the officer sounded a whistle signal, he did not take actions to avoid the collision in time.
