Feature 2: 10th anniversary of Japan Transport Safety Board — Future Direction of Priority Activities

Direction of Our Focused Commitments with an Eye toward the Next 10 Years

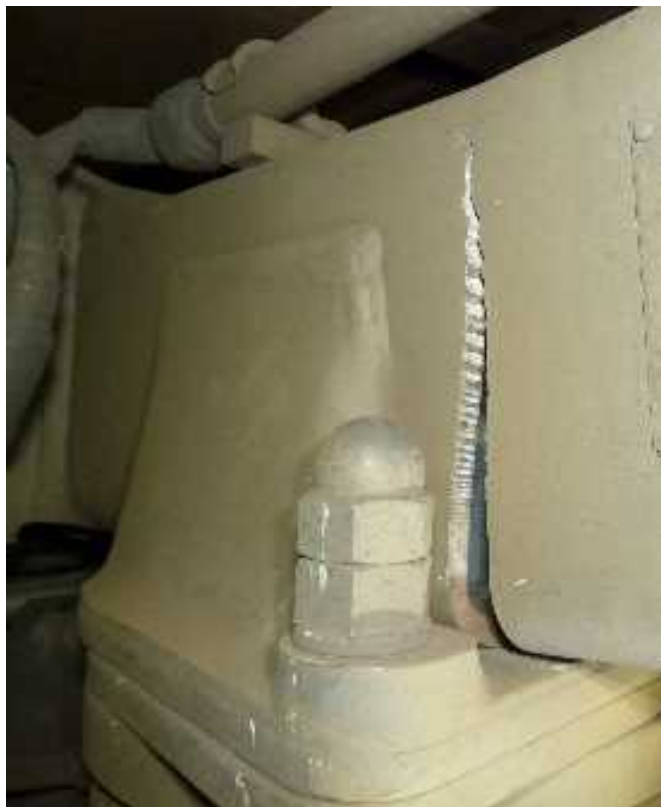
○ Simulation analysis on a crack in a flatcar of a shinkansen (railway mode)

On December 11, 2017, a serious incident occurred in which a crack was found in a flatcar of a shinkansen.
--

To identify what caused the crack in the flatcar in the investigation, we conducted fatigue and breaking tests using a test specimen, a simulation analysis to estimate how the crack developed, and a simulation analysis to estimate the points of the flatcar where a high level of stress is generated. In addition, from a new viewpoint, we analyzed the effect of the deformation and other factors of the flatcar frame based on the air pressure inside the air spring unit recorded in the rail car data recorder to present a technique for estimating the development of cracks.

These analyses revealed that the crack had been caused by improper treatment during the manufacturing of the flatcar frame and that the crack had developed in a period shorter than the duration of the rail car life.

Based on these results, the board requested the Minister of Land, Infrastructure and Transport to ensure that necessary actions are taken in each stage of the manufacturing and design/verification processes of flatcar frames. Specifically, we requested the minister to ensure that manufacturing is thoroughly managed and that when a problem and/or difficulty arises in manufacturing, the effect of the measures against them on the safety is evaluated (see Page 77).

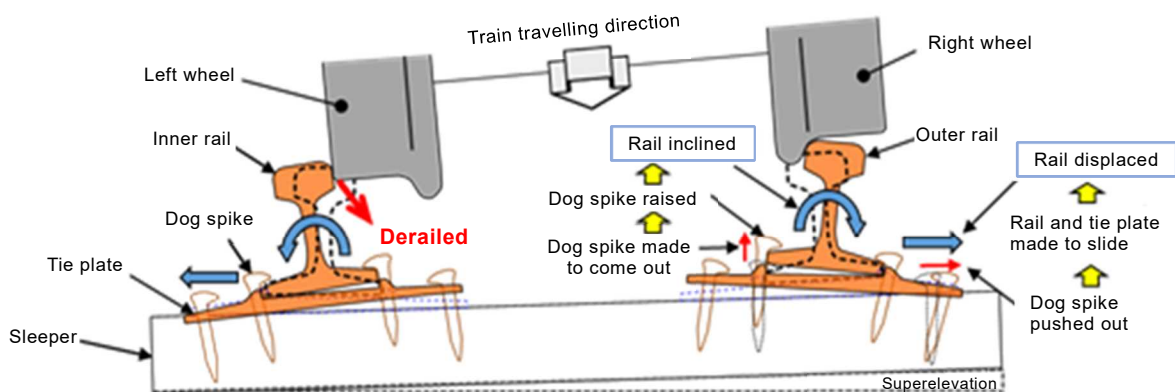
Derailment due to widened track gauge

The railway accidents investigated by the Japan Transport Safety Board include four derailment accidents due to widened track gauges, which occurred between October 2016 and May 2017. These accidents seem to have been caused by the distance between the rails widened by rails inclined when a train passed because of successional problems with wooden sleepers and rail

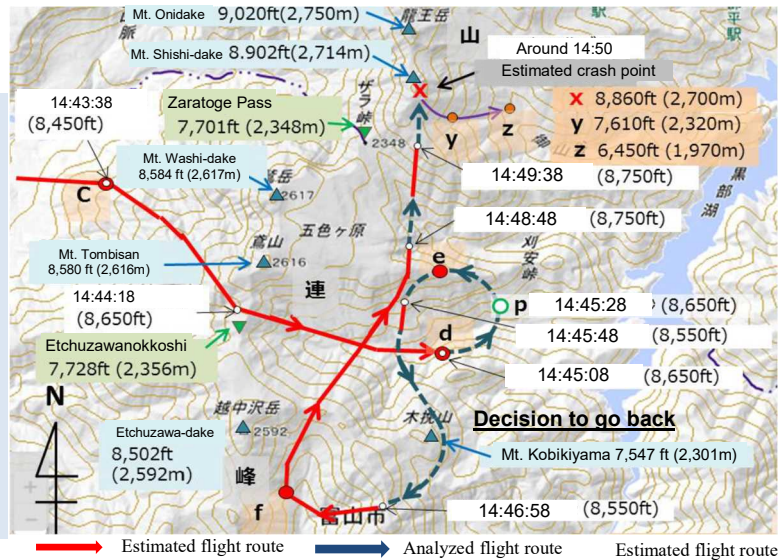
Flight situation of the aircraft after deciding on turning back (Point d in the estimated flight route map)

- It is likely that because the aircraft went into in-cloud flight and the pilots also noticed ice build-up on the aircraft, they tried to go back. (It is somewhat likely that the flight performance deteriorated extremely due to ice build-up and the aircraft became unable to maintain its altitude.)
- It is probable that the aircraft was flying while looking for clouds rifts.
- It is probable that it became difficult for the pilot to grasp its own position and surroundings, causing the Aircraft to crash into the mountain surface near the top of Mt. Shishi-dake

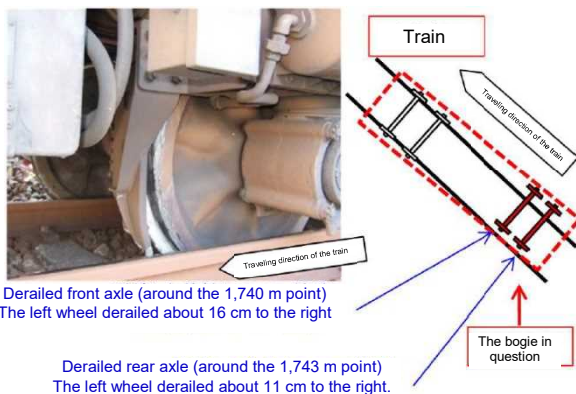
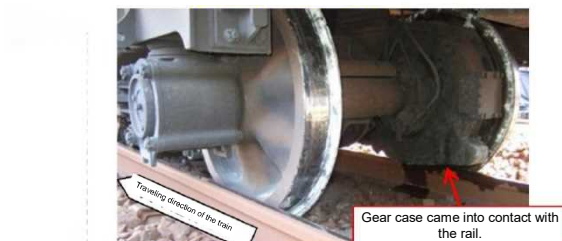
(State of the crack immediately after the derailment [provided by the Company])

Based on the facts that oil-like substance was adhered on the right rail up to the rear axle gear case of the bogie in question and that the gear case was damaged, it is probable that the train was running while the gear case kept in contact with the right rail.

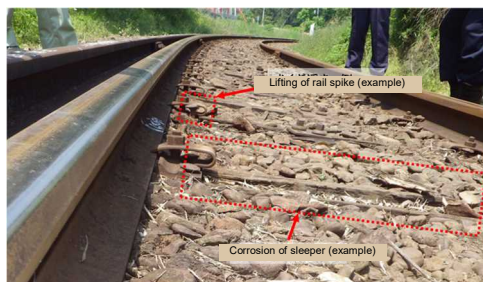
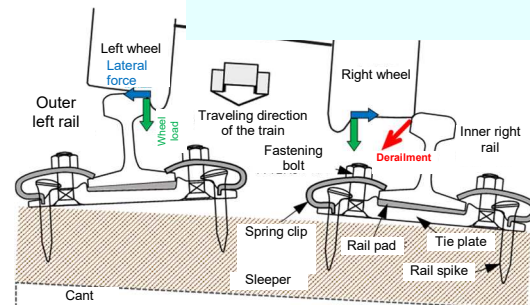
Probable Causes: It is probable that the accident occurred as the right wheel in the 1st axle of the front bogie of the 2nd vehicle fell off to the inside of the gauge and continued running being spread gauge, and then the left wheel flange in the front bogie climbed up to outer left rail and derailed to left, because the gauge was widened while the train, the electric and track inspection cars, was passing in the 160 m radius right curved track.

It is desirable to replace wooden sleepers with sleepers made of concrete or equivalent materials, which have higher durability and maintainability than wooden sleepers (including partial replacement where every several sleepers are replaced).

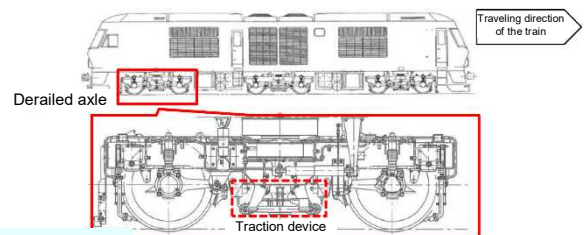
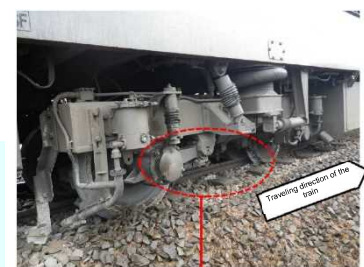
Traction device (damaged)

It is possible that the loosening of the bolts could not be found during the operation check or the regular inspection because no measures, such as matching marks, were provided to facilitate the detection of loosening by visual inspection, and also partly because, although a hammering test was performed, the bolts were placed in such a position that changes in the hitting sound were difficult to catch due to the load acting on the bolts.

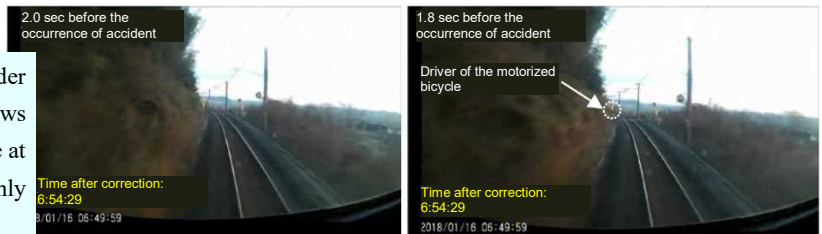
The images captured by the video recorder equipped with the lead vehicle of the train, shows the figure of the driver of the motorized bicycle at around the left-side entrance of the crossing only about 1.8 seconds before the collision.

It was not possible to confirm, from the images of the recorder, that the driver of the motorized bicycle stopped in front of the crossing, or looked at the curved mirror, to check for a train.
