## Chapter 4 Railway accident and serious incident investigations

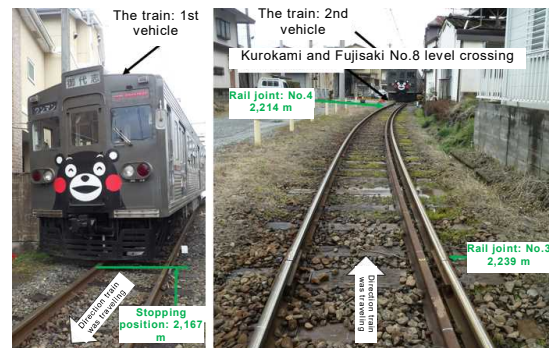
Probable Causes	<p>It is probable that left wheels of the 1st axle in the front bogie and all axles in the rear bogie of the 1st vehicle fell to the inside of the gauge, due to the large gauge widening by the passing train in the 200 m radius right curved track, and ran as spreading the gauge, and then the 1st axle in the front bogie derailed to right and the 2nd axle in the front bogie followed to derail, as all axles in the rear bogie had restored to the track by the guardrail, in the accident.</p> <p>As for the large gauge widening, it is somewhat likely that the gauge was widened dynamically due to the rail tilting etc., caused by the lateral force accompanied with the train running, because the defects of the rail fastening devices had been existed continuously in the curved rack.</p> <p>Here, it is somewhat likely that the following (1) and (2) related to the occurrence of large</p>

<p>gauge widening which caused derailment.</p> <p>(1) The continuous defects of the rail fastening devices as dangerous as to cause derailment and the dangerousness of gauge widening enlarged dynamically could not be found definitely in the periodic inspections etc., and the track maintenance had not been implemented based on the results of the inspection.</p> <p>(2) The margin against derailment to the inside of the gauge had decreased due to the relatively large slack in the curved track.</p>		
	Report	<p><a href="http://www.mlit.go.jp/jtsb/railway/rep-acci/RA2018-1-6.pdf">http://www.mlit.go.jp/jtsb/railway/rep-acci/RA2018-1-6.pdf</a>  <a href="http://www.mlit.go.jp/jtsb/railway/p-pdf/RA2018-1-6-p.pdf">http://www.mlit.go.jp/jtsb/railway/p-pdf/RA2018-1-6-p.pdf</a> (Explanatory material)</p>		
5	Date of Publication	Date and accident type	Railway operator	Line section (location)
	January 25, 2018	March 6, 2017 Level crossing accident	West Japan Railway Company	Senzoku No.1 level crossing, class 4 level crossing without automatic barrier machine nor road warning device, between Kuga station and Suo-Takamori station, Gantoku Line, Iwakuni City, Yamaguchi Prefecture

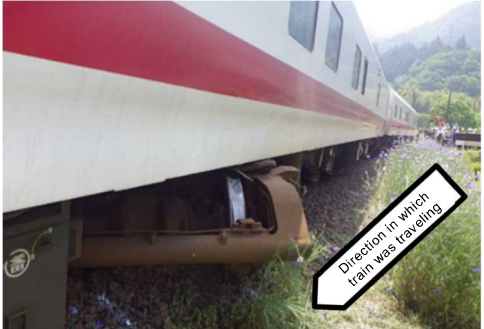
<p>1<sup>st</sup> axle of the front bogie of the 2<sup>nd</sup> vehicle Left wheel</p>

<p><b>Probable Causes</b></p>	<p>It is probable that the accident occurred as the right wheel in the 1st axle of the front bogie of the 2nd vehicle fell off to the inside of the gauge and continued running being spread gauge, and then the left wheel flange in the front bogie climbed up to outer left rail and derailed to left, because the gauge was widened while the train, the electric and track inspection cars, was passing in the 160 m radius right curved track.</p> <p>It is probable that the gauge widening was caused by the rail tilting etc., due to lateral forces accompanied with train running in the curved track where the continuous defective sleepers and rail fastening devices were existed.</p> <p>It is somewhat likely that the existence of significantly large gauge widening to cause derailment was related with that the proper track maintenance had not been implemented because the danger against gauge widening by the continuous defective sleepers and rail fastening devices had not been recognized in the periodic inspection etc., and the proper operation control and the track maintenance had not been implemented even though the remarkably large irregularity of gauge had been detected in the measurement by the track inspection cars just before the accident.</p>

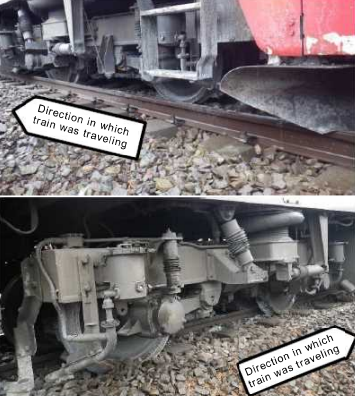
<p>5th axle and 6th axle derailed</p>

<p><b>Probable Causes</b></p> <p>It is probable that the accident occurred as all axles, i.e., the 5th and 6th axles, in the rear bogie in the 1st vehicle, i.e., the locomotive, of the freight train derailed because the traction device had hung down due to the removal of two fitting bolts fastening the center pin and the traction device in the rear bogie during running operation, following the process described in below.</p> <ol style="list-style-type: none"> <li>(1) The left traction link broke when the traction device hit the left guard rail in the Iriechou level crossing.</li> <li>(2) The wheels in all axles, i.e., the 5th and 6th axles, in the rear bogie derailed to right due to the lateral force in right direction acted on the traction device, as the traction device, hanging more after broken, hit the lead rail of the turnout in the premises of Kita-Irie signal station.</li> </ol> <p>It is somewhat likely that the fitting bolts of the traction device fell away because the fitting bolts had come looser due to vibration etc., during train running after finished the important parts inspection, in which the work to connect bogie and vehicle body had finished in the status that the fitting bolts had fastened temporarily, i.e., the fitting bolts had not been fastened with the determined fastening torque.</p>

<p>It is somewhat likely that the work connecting bogie and vehicle body finished as the fitting bolts had not been fastened by the determined fastening torque, because the works to fasten bolts had been implemented without using the torque wrench and the confirmation of the fastened status had not been implemented, as the assigned role for each worker and the procedures of each work for the bolt fastening works, had not been clearly prescribed.</p>		
	Report	<p><a href="http://www.mlit.go.jp/jtsb/railway/rep-acci/RA2018-5-1.pdf">http://www.mlit.go.jp/jtsb/railway/rep-acci/RA2018-5-1.pdf</a>  <a href="http://www.mlit.go.jp/jtsb/railway/p-pdf/RA2018-5-1-p.pdf">http://www.mlit.go.jp/jtsb/railway/p-pdf/RA2018-5-1-p.pdf</a> (Explanatory material)                  See “Feature 2: Summaries of major railway accident and serious incident investigation reports (case studies)”, page 45</p>		
12	Date of Publication	Date and accident type	Railway operator	Line section (location)

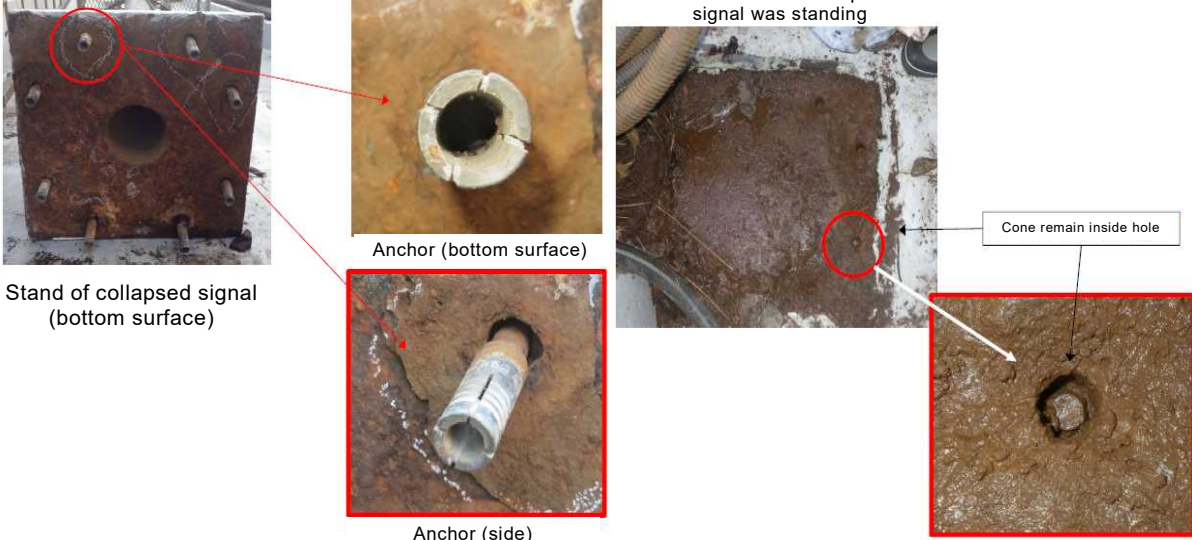
Stand of collapsed signal (bottom surface)

The collapsed signal pole was installed onto an elevated bridge and anchors and bolts were used to secure it to the concrete frame of the elevated bridge. However, all 8 anchors driven into the concrete frame had come loose and the cone (wedge) had remained inside the hole of the frame.

Furthermore, the anchors were made so that their slitted sections would spread out due to the cone when driven into the concrete. However, none of the anchors that had come loose were spread out at the slitted sections.

A detailed investigation is scheduled in the near future for the cause of this serious incident.
