Chapter 3 Aircraft accident and serious incident investigations

8 Summaries of major aircraft accident and serious incident investigation reports (case studies)

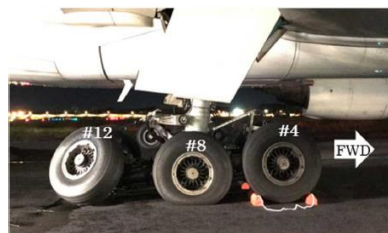
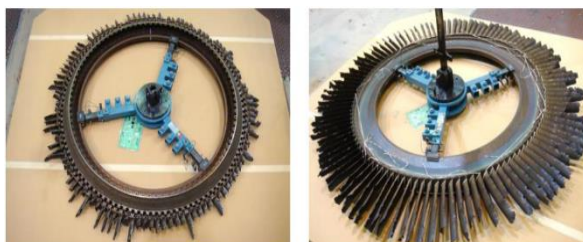
October 31, 2019	September 5, 2017 Tokyo International Airport	Japan Airlines Co., Ltd	JA743J Boeing 777-300 ER (Large aeroplane)
	Summary	<p>On Tuesday, September 5, 2017, a Boeing 777-300 ER, registered JA743J, operated by Japan Airlines Co., Ltd., had noise generating from the No. 1 engine (the left engine) along with indication of occurrence of engine failure illuminated on instruments immediately after take-off from runway 34R at Tokyo International Airport, and consequently, shut down the engine and returned to the airport for landing after obtaining a priority from air traffic control.</p> <p>The inspection conducted after landing revealed that multiple stages of stator vanes and turbine blades in low pressure turbine (LPT) of the engine were damaged and a hole was confirmed to have been generated in turbine rear frame.</p>		
	Probable Causes	<p>It is highly probable that the serious incident was caused by collisions of some of fragments with turbine rear frame (TRF), which led to generating the hole due to damage to multiple stages of stator vanes and turbine blades of low pressure turbine (LPT) of No. 1 (left side) engine immediately after take-off.</p> <p>It is highly probable that damage to multiple stages of stator vanes and turbine blades of low pressure turbine was contributed by the fracture of one of LPT fifth stage stator vanes.</p> <p>It is highly probable that the fracture of one of LPT fifth stage stator vanes was contributed by the crack generated by stress concentration caused by arch-binding, which progressed to the fracture by repetitive stress associated with engine operation.</p>

Damaged condition of LPT fifth stage disk and blades (left) and sixth stage disk and blades (right)

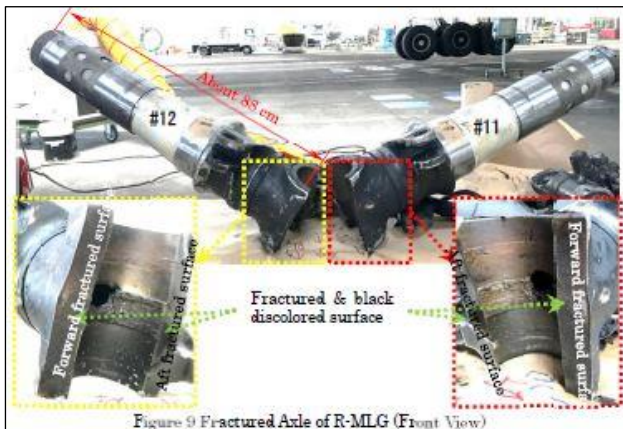
Situation of main damages to aircraft (The R-MLG AFT Axle was fractured)

- The entire fractured surface of the front side of the pivot discolored black due to the corrosion.
- It was confirmed that a partially black-discolored portion due to corrosion and a grey new metal surface were confirmed on the fractured surface of the aft side of the pivot.

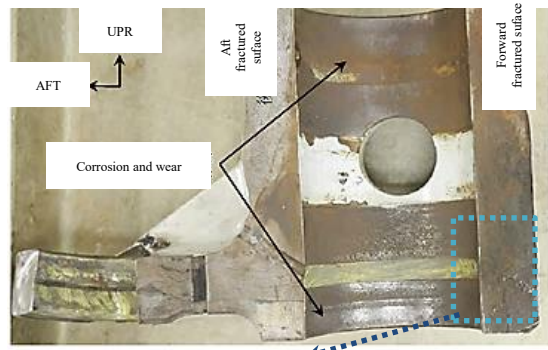
The forward fractured surface had an initiating region of corrosion on the lower side of the pivot bore, then was generating SCC and finally was fractured due to repetitively imposed loads.

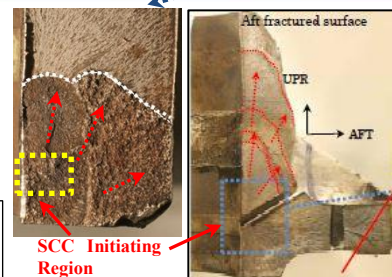
The aft fractured surface was caused by SCC initiated by the corrosion generated on the lubrication passage, which then led to progressing cracking due to repetitively imposed loads.

Probable causes: It is certain that the aircraft had the right main landing gear aft axle fractured when landing in the serious incident, and subsequently, it was forced to halt on taxiway and could not continue taxiing. It is highly probable that the fractured axle was attributed to the SCC originated from the corrosion generating on the pivot bore and ongoing operations of the aircraft thereafter with cracking occurred. It is highly probable that the corrosion generated on the pivot bore was contributed by water penetration caused by the torn fillet seal due to rotation of the bushings and corrosion inhibitor that was not applied.

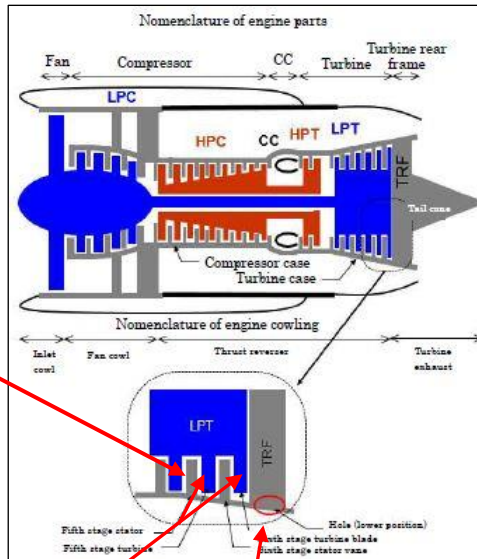
- Fifth and sixth stage turbine blades which were downstream from LPT fifth stage stator vanes were damaged all along the circumference.

- A hole in size of about 6 cm x about 1 cm, concave deformation (dent) and crack were confirmed on the lower section of TRF attached to the aft flange of the LPT case.
