Japan Transport Safety Board
Annual Report 2022
【March 2022】

ANNUAL REPORT 2022

Japan Transport Safety Board

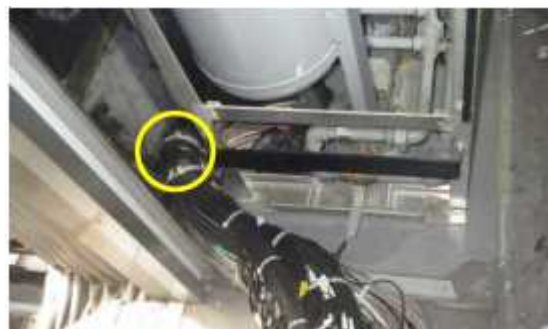
Wired status viewed from aisle side, broken in back side of the circled bundle of cables

It is probable that the electric wire to convey the running direction in the Device Room of the train was broken, so the running direction did not change in the control device at the turn-back station. Therefore, the train ran in wrong direction, resulting in collision with the car stop.

As a background to this accident, it is likely that the latent causes for such dangerous incident were existed because the confirmation and the arrangement on the understandings for the designing organization, etc., and the extraction of items to be paid attention before designing between related parties the safety factors were not implemented sufficiently, in the designing and manufacturing process of the vehicle. In addition, it is probable that the existence of latent causes of the dangerous events was not noticed due to the insufficient verification of the safety during the design examination, etc.

Based on the result, Japan Transport Safety Board has recommended establishing of the following stages regarding to the designing and manufacturing process to the Minister of Land, Infrastructure, Transport and Tourism: "confirm and arrange the designing organization, etc.", "extract safety factors", "verify the safety", for preparing the designing organization to implement the system integration, etc., and the thorough instruction provision to the railway and tramway operators and the manufacturers of the railway vehicles, etc., and has also provided opinions to the Minister of Land, Infrastructure, Transport and Tourism on considering the institutionalization of the details of the recommendations.

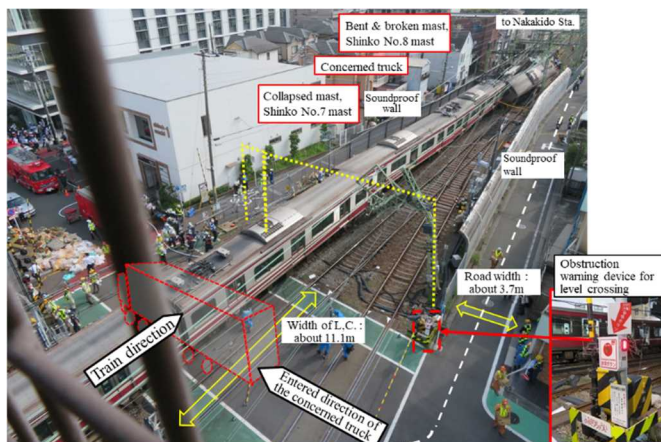
Status of around the accident site

The JTSB concludes that the probable cause of this accident was certain that the truck entered the Level crossing and hindered the route of the train, and the train could not stop before the Level crossing although the obstruction warning signal of the Level crossing had been indicating the stop signal, then collided with the Truck.

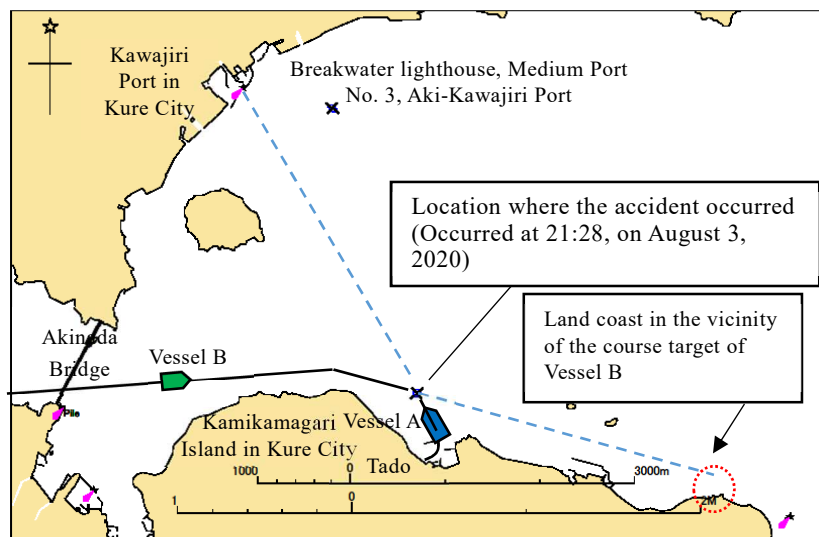
Schematic diagram of accident occurrence progress

At night, the captain of the pleasure boat kept proceeding on the same course and at the same speed, focusing on setting the course to the breakwater lighthouse, Medium Port No. 3, Aki-Kawajiri Port. The captain of the fishing vessel was assuming that there was no vessel in the starboard direction and kept proceeding with the same course and at the same speed with a blind spot in the starboard bow direction. Therefore, it is probable that they collided without noticing that they were mutually approaching.

The investigation carried out the detailed interviews about the blind spot in the bow direction caused by the awning in place at the time of the accident and the objects that the crew members were focusing on, and the verifications of the captain's visual recognition of the radar screen from the maneuvering position, and so on. Further detailed interviews were conducted on the blind spot created by the net hauler in the fishing vessel's bow direction, the action conducted by the crew members in order to eliminate the blind spot, and so on.

As preventive measures against recurrence based on the investigation result, the Japan Transport Safety Board offered opinions as follows: (1) during navigation captains shall keep their eyes on the surroundings by the methods such as using a radar, without assuming that there are no other vessels around and without focusing on a specific direction only, (2) keep watching, covering any blind spots in the bow direction by standing up or moving horizontally and (3) persons who get on board small vessels shall always wear a life jacket on exposed decks.

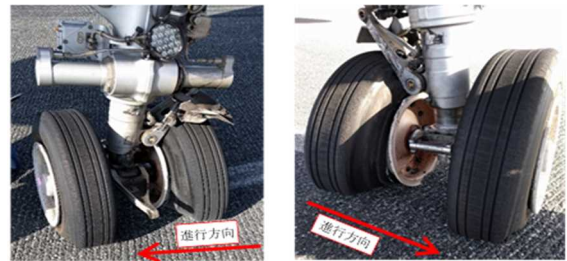
Damages to the nose landing gear of the Peach Aviation Limited's aircraft

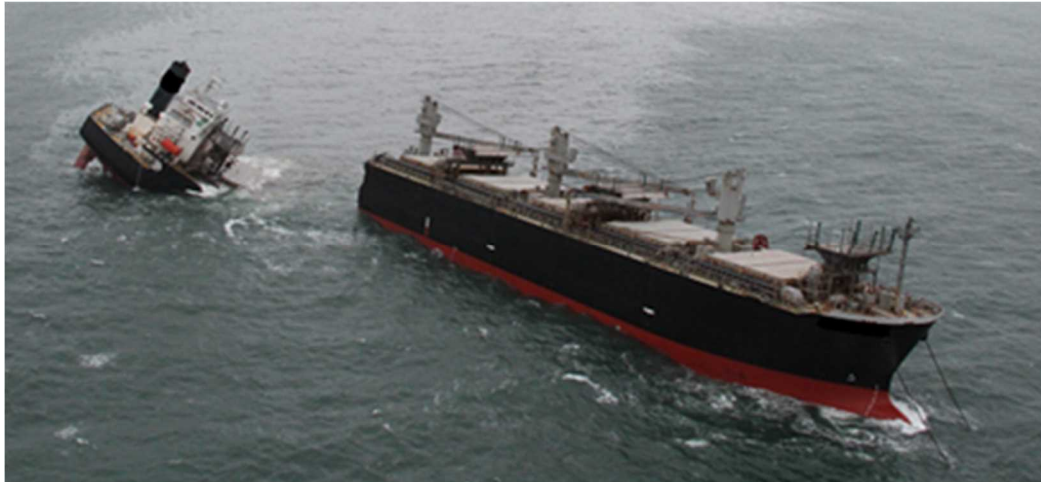
A picture of the cargo ship's hull broken in two taken on August 12. The picture was provided by the 2nd Regional Coast Guard Headquarters.
