## Chapter 3 Aircraft accident and serious incident investigations

### Aircraft accident investigation reports published in 2023

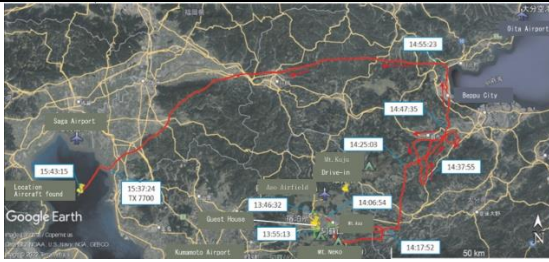
4	Date of publication	Date and location	Operator	Aircraft registration number and aircraft type	
	March 30, 2023	April 18, 2022 Approximately 10 km west of Miike Port in Omuta City, Fukuoka Prefecture, in the Ariake Sea	Privately owned	JA3803 Fuji Heavy Industries FA-200-160 (Small aeroplane)	
	Summary	<p>For a flight training, the aircraft ditched into the Ariake Sea about 10 km west of Miike Port in Omuta City, Fukuoka Prefecture, and subsequently submerged under the sea. There were three persons on board the captain as a flight instructor, a student pilot, and a passenger. They were rescued drifting in the sea, the captain and the passenger suffered fatal injuries.</p>

Probable Causes	<p>The probable cause of this accident was that during the flight training, the captain continued flight after he lost the position of the aircraft, the aircraft run out of the fuel over the Ariake Sea, and ditched in the sea, resulting in drowning of the captain and the passenger.</p> <p>The captain lost the position of the aircraft possibly because he did not have sufficient terrain feature familiarization and did not carry flight charts. In addition, the reason why the captain continued flying without taking appropriate emergency responses could not be determined.</p>			
	Safety Actions	<p>Various factors likely contributed to the occurrence of the accident. However, the similar accidents can be more likely prevented by ensuring compliance with existing rules for safe operation for preparation of flight such as familiarization to terrain, onboard fuel, flight charts, and emergency response procedures, and filing a flight plan. (See “3. ANALYSIS” on the Investigation Report.)</p>

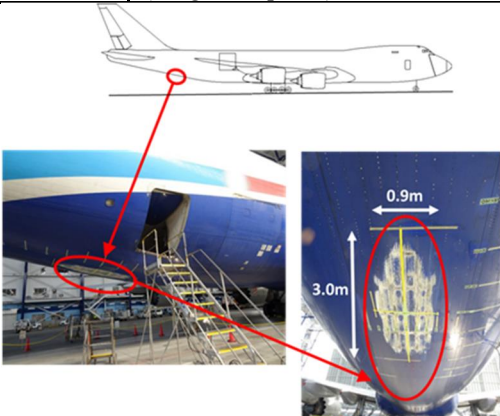
August 31, 2023	February 1, 2021 At Runway 16R of Narita International Airport	Nippon Cargo Airlines Co., Ltd.	JA13KZ Boeing 747-8F (Large aeroplane)	
Summary	<p>The aircraft experienced a bounce and became unstable attitude when landing at Runway 16R of Narita International Airport. Therefore, the aircraft executed a go-around, but the lower aft fuselage contacted with the runway, which resulted in damage to the airframe.</p> <p>There were two persons on board, consisting of the pilot in charge (PIC), one crewmember, but no one was injured.</p>

Probable Causes	<p>The probable cause of this accident was that when the aircraft made a go-around while becoming unstable attitude after touching down and bouncing, the pitch angle became excessively large with an inadequate aircraft speed, which more likely resulted in the lower aft fuselage contacting with the runway.</p> <p>The aircraft bounced after the touchdown is because it was likely insufficient to deal with the crosswind.</p> <p>The pitch angle became excessively large with an inadequate aircraft speed is probably because the PIC reflexively moved the reverse thrust levers after the touchdown, therefore, in the situation where it took time for the aircraft speed to increase due to the go-around operation, while being anxious about the runway-remaining length and others and trying to get off the ground as quickly as possible, the PIC performed the nose-up operation without checking the aircraft speed.</p>

Safety Actions	<p>Regarding the procedures for stabilized approach and go-around, it is probably necessary for the Company to have the flight crew members comply with the rules in the AOM<sup>*1</sup>. In addition, it is required for the Company to enhance the Company's CRM/TEM education/training by studying this accident and reflecting it in the contents of CRM/TEM education/training so that the flight crew members would be able to demonstrate the CRM skills appropriately and practice the TEM.</p> <p>*1 "AOM" is a set of regulations concerning the aircraft performance, aircraft operations, and operation procedures for crew, which is provided for each type of aircraft and issued by airlines after review based on manuals issued by aircraft manufacturers. The AOM specifies operating limitation, normal operations, emergency response procedures / procedures in case of malfunction, various systems and the system operations, performance, special operations, weight and balance and others.</p>

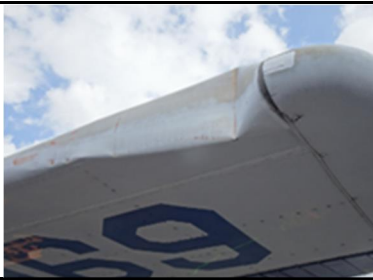
Summary	<p>The Aircraft landed at Yao Airport, and it contacted with an equipment storage box attached to the pole of the apron floodlighting installed in the vicinity of the apron while taxiing toward the spot, resulting in damage to the left wing leading edge. There were two persons on board the aircraft, but no one was injured.</p>

Probable Causes	<p>The probable cause of this accident was that the left wing leading edge highly probable came in contact with the equipment storage box attached to the pole of the apron floodlighting and sustained damage because the aircraft mistakenly entered the GSE Service Road*1.</p> <p>It is most likely that the reason why the Aircraft mistakenly entered the GSE Service Road is because the fellow pilot, who was piloting the aircraft, missed the entrance to the Lead-in Lines for Spot H while the time limit for the spot use time was looming, continued taxiing without stopping the aircraft and confirming a new travel route, in addition, did not know that the GSE Service Road was the exclusive one for vehicles and not the zone for aircraft to travel.</p> <p>*1 “GSE Service Road” refers to the route provided for airport Ground Support Equipment (GSE) to travel.</p>

Safety Actions	<p>(1) It is required for a person in charge of pilotage of an aircraft to taxi after sufficiently confirming the travel route to the Spot, the Spot location, and the aircraft maneuvering areas.</p> <p>(2) In case of taking a wrong travel route, it is required for a person in charge of pilotage of an aircraft to share the situation of its own aircraft with the ATC facilities and others and taxi after sufficiently confirming the travel route to the spot to park.</p>		
	Report	<p><a href="https://www.mlit.go.jp/jtsb/aircraft/rep-acci/AA2023-5-2-JA3969.pdf">https://www.mlit.go.jp/jtsb/aircraft/rep-acci/AA2023-5-2-JA3969.pdf</a> (Japanese)</p> <p><a href="https://www.mlit.go.jp/jtsb/eng-air_report/JA3969.pdf">https://www.mlit.go.jp/jtsb/eng-air_report/JA3969.pdf</a> (English)</p>

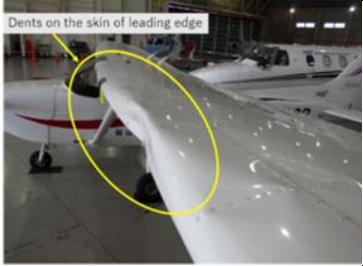
August 31, 2023	December 10, 2022 At an altitude of about 150 ft (45 m) about 0.5 nm (900 m) west of Kohnan Aerodrome, Okayama City, Okayama Prefecture	Okayama Air Service Co., Ltd.	JA123R Cessna 172R (Small aeroplane)
	Summary	<p>The Aircraft sustained damage due to bird strike when making a landing approach to the Aerodrome.</p> <p>There were four people on board, consisting of the captain and other three passengers. No one was injured.</p>

Probable Causes	<p>The probable cause of this accident was that the Aircraft most likely sustained damage due to bird strike when making a landing approach. However, as the bloodstains attached to the Aircraft was not collected, the species of bird that struck the Aircraft was unable to be determined.</p>		
	Safety Actions	<p>In order to proceed more effective measures for Bird Strike prevention according to the birdlife, it shall be recommended to appropriately handle the carcass and bloodstains of the birds collided with aircraft, such as collecting them as samples and identifying the species of the birds. (See “3. ANALYSIS” on the Investigation Report.)</p>

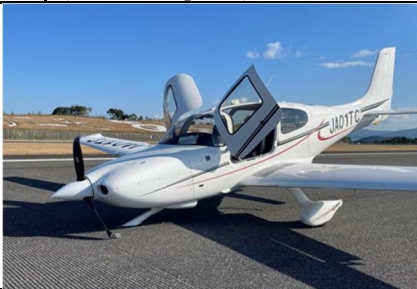
August 31, 2023	December 26, 2022 On the runway at Amakusa Airfield, Kumamoto Prefecture	Japan General Aviation Service	JA01TC Cirrus SR20 (Small aeroplane)
	Summary	The aircraft tried to execute a go-around when approaching Runway 31 at Amakusa Airfield in Kumamoto Prefecture for touch-and-go training, but touched down on the runway on the nose landing gear first, resulting in damage to the airframe.

Probable Causes	<p>The probable cause of this accident was most likely that because the nose went down when the aircraft tried to execute a go-around, the lower structure of the right central fuselage (Longeron) was damaged when the broken landing gear hit the lower fuselage after the aircraft touched down on its nose landing gear first on the runway.</p> <p>Regarding the fact that the aircraft's nose went down, Trainee A probably pushed the control yoke forward when trying to execute a go-around, and it is possible that Trainee A in the right pilot seat moved the control yoke handled by the right hand forward instead of the power lever.</p>

Safety Actions	<p>(1) It is probable necessary for the Company to provide an environment conducive to flight training after sorting out the differences in flight operations between the right and left pilot seats including that when trainees conduct flight operations in the right pilot seat, their left and right hands operate different devices, and how different looks have the instrument displays between the right and left pilot seats, and preparing well in advance.</p> <p>(2) It is necessary for the Company to verify the points to be noted when a trainee takes flight training in the right pilot seat, clarify the procedures for the trainee to control the airplane sitting in the right pilot seat as well as reeducate about the takeover by the instructor during the flight training.</p>		
	Report	<a href="https://www.mlit.go.jp/jtsb/aircraft/rep-acci/AA2023-5-4-JA01TC.pdf">https://www.mlit.go.jp/jtsb/aircraft/rep-acci/AA2023-5-4-JA01TC.pdf</a> (Japanese) <a href="https://www.mlit.go.jp/jtsb/eng-air_report/JA01TC.pdf">https://www.mlit.go.jp/jtsb/eng-air_report/JA01TC.pdf</a> (English)

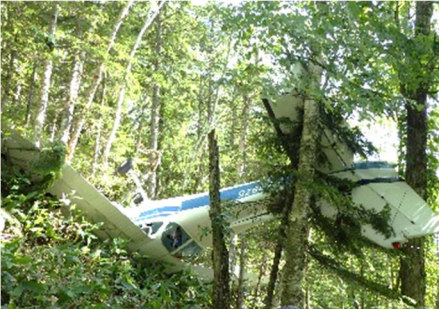
14	Date of publication	Date and location	Operator	Aircraft registration number and aircraft type
	September 28, 2023	July 19, 2020 Minamifurano-cho, Sorachi-gun, Hokkaido	Privately owned	JA3825 Cessna 172R RAM (Small aeroplane)
	Summary	The aircraft was conduct flight training, but crashed into the mountain slope in Minamifurano-cho, Sorachi-gun, Hokkaido. The two persons onboard the aircraft suffered serious injuries. The Aircraft was destroyed but no fire broke out.

Probable Causes	<p>This accident is presumed to have occurred because the aircraft unintentionally approached the mountain and crashed on the mountainside without enough time to avoid it while conducting flight training at a low altitude in a mountainous area.</p> <p>The lack of time to avoid the mountain due to insufficient altitude during flight training is presumed to be due to a lack of awareness of safe flight.</p>

Safety Actions	To prevent the recurrence of similar accidents, selecting safe training locations based on the training content and ensuring sufficient altitude during training flights are necessary. (See “3. ANALYSIS” on the Investigation Report.)

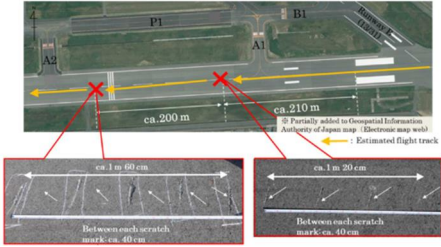
2	Date of publication	Date and location	Operator	Aircraft registration number and aircraft type
	February 16, 2023	March 6, 2022 Yao Airport, Yao City, Osaka Prefecture	Privately owned	JA007Z SOCATA TBM700 (Small aeroplane)
	Summary	<p>The aircraft repeated bouncing*1 on Runway A at Yao Airport when landing, then executed a go-around, and landed on the runway. The inspection conducted after the aircraft's landing found the damage of the propeller blade tip and scratch marks on the runway.</p> <p>The only person on board the aircraft was the captain, who did not sustain any injuries.</p>

Probable Causes	<p>The probable cause of this serious incident was that after the aircraft touched down and bounced with a greater than normal impact while the descent rate could not be reduced in the strong wind blowing from the northwest, it was unable to establish a proper attitude and touched down again with a nose-low attitude.</p> <p>It is probable that the aircraft touched down again with a nose-low attitude because the change in the Aircraft's attitude after the touchdown was not properly recognized.</p>		
	Safety Actions	<p>It is important for pilots to execute a go-around without hesitation, if a bounce occurs after the touchdown with a greater than normal impact while the descent rate cannot be reduced.</p>		
	Report	<p><a href="https://www.mlit.go.jp/jtsb/aircraft/rep-inci/AI2023-2-2-JA007Z.pdf">https://www.mlit.go.jp/jtsb/aircraft/rep-inci/AI2023-2-2-JA007Z.pdf</a> (Japanese)</p> <p><a href="https://www.mlit.go.jp/jtsb/eng-air_report/JA007Z.pdf">https://www.mlit.go.jp/jtsb/eng-air_report/JA007Z.pdf</a> (English)</p>

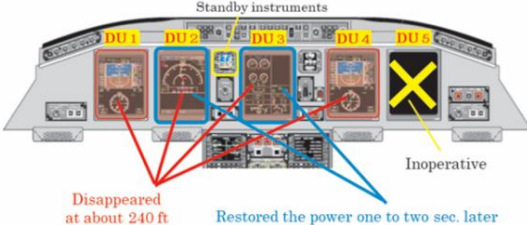
4	Date of publication	Date and location	Operator	Aircraft registration number and aircraft type	
	March 30, 2023	December 23, 2019 Approximately 2.3 km south of New Chitose Airport, at an altitude of about 240 ft	Privately owned (entrusted flight operation to Sino Jet)	B-3203 Embraer ERJ 190-100ECJ	
	Summary	<p>The aircraft was on the final approach to New Chitose Airport, the destination aerodrome, with 24 persons on board, consisting of the captain, four other crewmembers and 19 passengers, but at a pressure altitude of approximately 240 ft (AGL: about 165ft), the indication on all the display units powered by multiple systems temporarily disappeared in the cockpit. The aircraft landed without any change.</p>

Probable Causes	<p>The probable cause of this serious incident was that when the Aircraft was on the final approach, the IDG*12 was tripped off from the power supply system due to the false detection of an Overfrequency condition by the general control unit (GCU) 2, and then the IDG1 was also tripped off from the power supply system due to the false detection of an Undervoltage condition by the GCU1, which most likely resulted in the power loss of the both two main power supply systems of the aircraft.</p> <p>Regarding the fact that the both two IDGs were tripped off due to the false detections of the Overfrequency and Undervoltage, the two GCUs involved in the event did not have the Service Bulletins (to correct the faults) incorporated, which probably contributed to it.</p> <p>*1 “IDG”, which stands for Integrated Drive Generator, is an electrical generator installed in each of the left and right engine gear boxes, which provides stable 3-phase AC power at 400Hz, 115/200VAC, and 30/40KVA.</p>

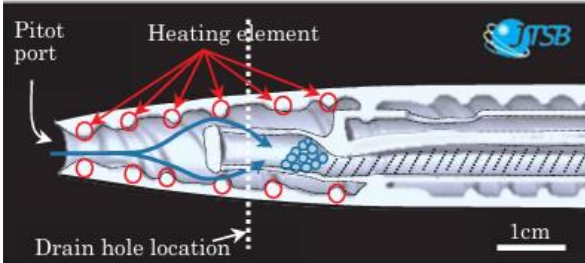
Probable Causes	<p>It is most likely that the probable cause of this serious incident was that the right and left sides of the pitot system became blocked while the aircraft was flying at FL 360, the failure airspeed indication temporarily occurred on both sides of the Pilot in Charge and the First Officer.</p> <p>Regarding the pitot system being blocked, it is probable that the aircraft flew in an area where ice crystals existed.</p>

Safety Actions	<p>This serious incident occurred during the night, and in spite that visually recognizable information such as topography and others was unable to be obtained, the flight crewmembers continued to fly with their calm response and made a safe landing. It was difficult for weather prediction and airborne weather radar to detect the airspace presented ice crystals, and it is possible that ice crystals are suddenly encountered during flight. As there is a past event where wrong responses by flight crewmembers led to a serious accident, even if similar it is necessary to be prepared so as to address appropriately should a similar situation arise.</p>

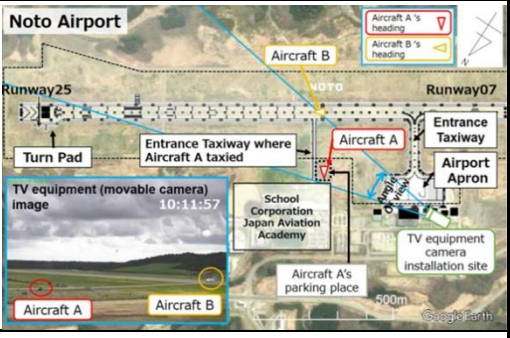
Summary	<p>At Noto Airport, Aircraft A took off from the runway where Aircraft B was taxiing toward the apron.</p>

Probable Causes	<p>The probable cause of this serious incident is that it is certain that even though Aircraft B had not yet vacated the runway it had landed on, Aircraft A took off from the runway.</p> <p>It is probable that Aircraft A took off because the captain of Aircraft A had assumed that there would be no other aircraft on the runway, and the captain did not fully conduct visual safety check for the runway with a desire to keep the time schedule for the repeatedly continuing sightseeing flights.</p> <p>The captain of Aircraft A had assumed that there would be no aircraft on the runway is most likely because with the increasing workload, Noto Radio, who had forgotten the existence of the Aircraft B having landed on the runway, provided Aircraft A with the information that "RUNWAY IS CLEAR" without fully confirming there was no traffic on the runway.</p>

Safety Actions	<p>Flight crew members have to surely keep watch for the runway by themselves at the time of take-off and landing, and it is necessary to follow the procedures to implement this thoroughly. Besides, in the case where several aircraft use the same aerodrome, in order to have common recognition among them regarding the air traffic condition, it is desirable for flight crew members of each aircraft to make efforts to grasp other aircraft movements by monitoring not only the information provided by AFIS but also the radio communication with other aircraft as much as possible.</p> <p>Furthermore, in the case of the flight operation for sightseeing flight and others that would be repeated continuously in a short time, it is important to plan with plenty of time.</p> <p>In the case where those engaged in AFIS provide the information "RUNWAY IS CLEAR", it is important to implement thoroughly the procedures to ensure that there is no relevant aircraft on the runway. (See "3. ANALYSIS" on the Investigation Report.)</p>

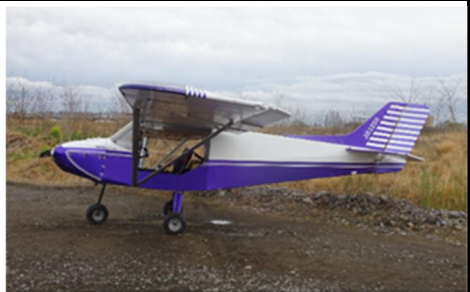
16	Date of publication	Date and location	Operator	Aircraft registration number and aircraft type
	December 21, 2023	March 12, 2023 Tamamura Town, Sawa-gun, Gunma Prefecture	Privately owned	JR1250 Rans S-6 Coyote II-R582L (Ultralight plane with two seats)
	Summary	<p>During a leisure flight near Tamamura Town, Sawa-gun, Gunma Prefecture, the aircraft experienced a decrease in engine output and made an emergency landing on a riverbank.</p> <p>The aircraft had one pilot on board, but no one was injured, and there is no damage for the aircraft.</p>

Probable Causes	<p>The probable cause of this serious incident is most likely because the fuel supply to the engine decreased during the flight, leading to a continuous loss of engine output.</p> <p>It is highly probable that the reduction in fuel supply to the engine during the flight is caused by debris adhering to the fuel filter, obstructing the fuel flow, and an incomplete closure of the check valve inside the fuel pump, resulting in insufficient fuel pressure.</p> <p>According to the manufacturer's manual, the failure to recognize debris adherence to the</p>

fuel filter and reduced fuel pump performance before the continuous loss of engine output during flight is considered to have resulted from inadequate inspection and maintenance.		
	Safety Actions	Ultralight plane users must conduct proper inspections and maintenance following the manufacturer's manual. Additionally, maintenance records should be kept whenever inspections and maintenance are performed. (See "3. ANALYSIS" on the Investigation Report.)		
	Report	<a href="https://www.mlit.go.jp/jtsb/aircraft/rep-inc/Al2023-8-3-JR1250.pdf">https://www.mlit.go.jp/jtsb/aircraft/rep-inc/Al2023-8-3-JR1250.pdf</a> (Japanese)

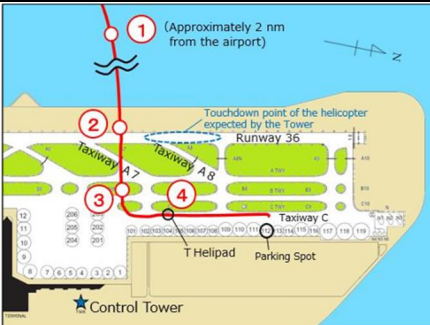
17	Date of publication	Date and location	Operator	Aircraft registration number and aircraft type
	December 21, 2023	May 22, 2023 Chubu Centrair International Airport	AERO ASAHI CORPORATION	JA6718 Aerospatiale AS355F2 (Rotorcraft)
	Summary	When landing at Chubu Centrair International Airport, the helicopter landed at the take-off/landing field for helicopters (helipad) on a taxiway that was different from the runway assigned by the air traffic controller.

Probable Causes	The probable cause of this serious incident was that when the helicopter was cleared to land on Runway 36 by the Tower, the captain most likely mistakenly believed that it was cleared to land at T Helipad and it landed at the helipad.		
	Safety Actions	It is important for pilots to acquire sufficient knowledge related to ATC phraseology and correctly recognize the transmission contents from air traffic controllers. (See "3. ANALYSIS" on the Investigation Report.)		
	Report	<a href="https://www.mlit.go.jp/jtsb/aircraft/rep-inc/Al2023-8-4-JA6718.pdf">https://www.mlit.go.jp/jtsb/aircraft/rep-inc/Al2023-8-4-JA6718.pdf</a> (Japanese)		<a href="https://www.mlit.go.jp/jtsb/eng-air_report/JA6718.pdf">https://www.mlit.go.jp/jtsb/eng-air_report/JA6718.pdf</a> (English)
