Chapter 4 Railway accident and serious incident investigations

Railway accident investigation reports published in 2023

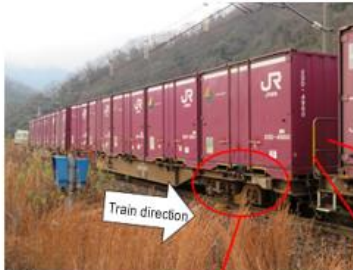
<p>The train had one crew member in the lead locomotive and one in the auxiliary locomotive, but there were no injuries.</p> <p>*1. “Brake pipe pressure” refers to the air pressure in the brake pipe that controls the brake force. It is usually maintained at a constant pressure of 490 kPa, reducing the pressure applied to the brakes and increasing the pressure that releases them.</p>
	<p>Probable causes</p>	<p>It is probable that this accident occurred when the train passed through a right curve with a radius of 300 meters. Near the accident site, the weight on the outer rail side of the first axle of the front bogie of a Koki 106-type freight car decreased. Additionally, the weight on the inner rail side increased the lateral pressure on the outer rail side, causing the outer rail side wheel to climb onto the rail and derail.</p> <p>It is probable that the reduction in the weight on the outer rail side was due to multiple loaded containers that significantly exceeded the left-right load imbalance rate of 10% for managing a single 12-foot container, resulting in an expanded imbalance of wheel load.</p> <p>The occurrence of the left-right load imbalance is more likely due to:</p> <ol style="list-style-type: none"> (1) There was a lack of shared information about load imbalance among related companies, such as freight forwarders, shippers, and loading companies (2) The system was insufficient for checking load imbalance after loading and sealing containers. (3) The absence of a system to investigate causes and implement measures to prevent recurrence when load imbalance was detected led to these factors’ accumulation.

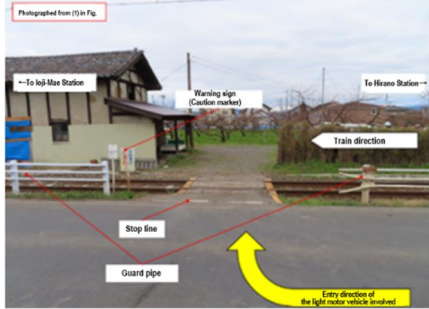
4	Date of publication	Date and accident type	Railway operator	Line section (location)
	March 30, 2023	April 5, 2022 Level crossing accident	Fukushima Transportation, Inc.	Between Hirano Station and Iojimae Station on the Iizaka Line (Fukushima Prefecture) 6k961m crossing (Class 4 level crossing without crossing gate nor road warning device)
	Summary	<p>While the train ran approximately 50 km/h between Hirano Station and Iojimae Station, the driver recognized a light vehicle entering the crossing (Class 4 level crossing) from the left. The driver immediately sounded the horn and applied the emergency brake, but the train collided with the light vehicle.</p> <p>The driver of the light vehicle involved in this accident was killed, and the passenger was seriously injured.</p>

Probable causes	<p>It is certain that this accident occurred because the light vehicle entered the 6k961m crossing (Class 4 level crossing without gates or road warning devices) while the train was approaching, resulting in a collision.</p> <p>It is probable that the light vehicle driver did not notice the approaching train, but the details could not be clarified as the driver was deceased.</p>

Safety actions	<p>Class 4 level crossings, which lack crossing gates and road warning devices, should be abolished or equipped with proper safety equipment.</p> <p>Railway operators and stakeholders such as orchard owners need to proceed with discussions to reach an agreement on abolishing or equipping this crossing with safety equipment and implementing safety measures.</p> <p>Until these measures are implemented, it is desirable to restrict passage through the crossing only when necessary.</p> <p>Furthermore, since the company has many other Class 4 level crossings, it is recommended that railway operators, landowners, municipalities, and residents conduct discussions to abolish or equip these crossings with safety equipment.</p>		
	Report	https://www.mlit.go.jp/jtsb/railway/rep-acci/RA2023-3-2.pdf (Japanese)

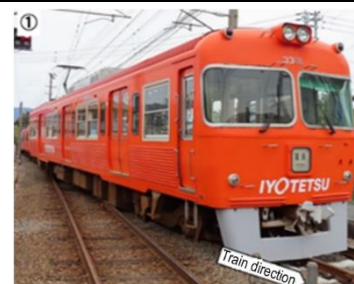
Probable causes	<p>It is probable that this accident occurred because the switch rod*4 of the spring switch machine*3 was broken, causing both tongue rails to adhere to the stock rails on the respective sides. When the driver confirmed the caution signal of the home signal, the train entered the</p>

<p>switch facing^{*5} it, causing the flanges of both front bogie wheels to be caught between the tongue rails. As a result, the first axle of the front bogie entered the down track, while the second axle entered the up track, leading to the derailment.</p> <p>It is highly probable that the switch rod was broken because fatigue cracks developed from the boundary between the welded and unwelded sections at the weld ends on two upper corners of the fracture surface, extending to the center, eventually leading to a complete break without plastic deformation on the lower side of the fracture surface.</p> <p>It is probable that the fatigue cracks in the switch rod were caused by the front end of the right tongue rail lifting and hitting a U-shaped protrusion welded to the iron plate of the switch rod every time a train passed over the switch in the trailing direction^{*6}, striking the upper surface of the right switch rod against the bottom of the right stock rail.</p> <p>The company had conducted penetration inspections^{*7} on all switch rods during regular inspections, but because the paint on the switch rods was not removed during these inspections, the penetrant did not sufficiently penetrate the cracks, and the indicators of the cracks did not appear, making it likely that the cracks were not detected.</p> <p>Regarding the home signal displaying a caution signal, normally, it should display a stop signal unless the switch's tongue rails on both sides are set to the default position^{*8}. However, due to the broken switch rod, both tongue rails adhered to the stock rails. The switch involved in the incident lacked a circuit controller to detect the right tongue rail's adherence to the right stock rail. As a result, it is highly probable that it failed to detect this, only detecting the left tongue rail's adherence, leading the home signal to display a caution signal.</p> <p>*3. "Spring switch machine" uses the rebound force of a spring and is typically set to the default position, which is the mainline direction. However, if a train approaches from the reverse direction (against the mainline direction, in this case, the down track), the train's wheels push the tongue rail to the reverse position. After the train passes, the spring force returns the tongue rail to the default position.</p> <p>*4. "Switch rod" is a component that transmits the switching force from the switch machine to the tongue rail via a switch adjuster.</p> <p>*5. The term "facing" refers to approaching the switch from the diverging side, which in this case means from Yokogawara Station toward Matsuyama City Station.</p> <p>*6. The term "trailing" refers to approaching the switch from the converging side, which in this case means from Matsuyama City Station toward Yokogawara Station.</p> <p>*7. "Penetration inspection," a color check, is a widely used surface inspection method in the industrial field. This non-destructive testing method involves applying a penetrant to detect surface-breaking flaws, followed by a developer to draw the penetrant out of the flaw for observation.</p> <p>*8. The term "default position" refers to the direction in which the switch is normally set, which is the up track.</p>

Safety actions	<p>The switch rod is a critical component connecting both tongue rails. If it breaks, the tongue rails can no longer move in unison, creating a dangerous situation that can cause a train derailment. Therefore, it is crucial to prevent fatigue cracks in the switch rod and, if they occur, detect them early and perform appropriate maintenance before they lead to a complete break.</p> <p>It is advisable to inspect the upper surface of the switch rod during regular inspections to prevent fatigue cracks. If contact marks with the bottom of the stock rail, such as a peeled black oxide scale, are observed, the cause of the contact must be analyzed, and appropriate measures implemented.</p> <p>Additionally, to reliably detect fatigue cracks in the switch rod, it is essential to carefully observe the surface for cracks during regular inspections and conduct penetration inspections. During penetration inspections, proper pre-treatment, such as removing paint from the switch rod to ensure the penetrant seeps into any cracks, is necessary.</p>

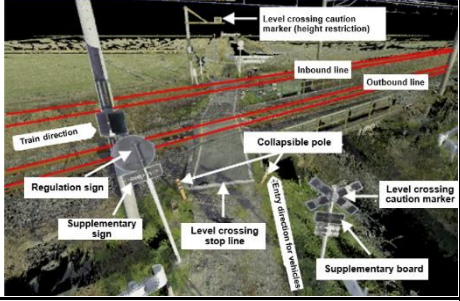
June 29, 2023	October 31, 2022 Level crossing accident	Kyushu Railway Company	Between Saga Station and Igaya Station on the Nagasaki Line (Saga Prefecture) Ipponyanagi Crossing (Class 4 level crossing without crossing gate nor road warning device)
	<p>Summary</p> <p>While traveling between Saga Station and Igaya Station, the train driver recognized a car entering Ipponyanagi Crossing (Class 4 level crossing) from the right side and applied the emergency brake, sounding the horn, but the train collided with the car.</p> <p>As a result of this accident, the driver of the car was killed.</p>

<p>Probable causes</p> <p>It is highly probable that this accident occurred because the car entered Ipponyanagi Crossing, Class 4 level crossing without crossing gate nor road warning device, just before the train, traveling at approximately 85 km/h, reached the crossing. The collision could not be avoided despite the train driver applying the emergency brake.</p> <p>It is probable that the car entered the crossing while the train was approaching because the driver did not notice the approaching train. It is possible that this was due to the driver not performing safety checks or being inaccurate.</p> <p>It is possible that the safety check was ultimately inaccurate, preventing the driver from noticing the approaching train. Several factors might have contributed to the difficulty in seeing the train if the driver of the vehicle had performed a safety check near the right-side entrance of the crossing: The crossing angle caused the train to approach from behind the vehicle, the train's direction nearly coincided with the sun's position, and if the safety check was brief, the vehicle's structure might have obstructed the view.</p> <p>However, the detailed reasons could not be clarified as the driver of the vehicle was deceased.</p>

<p>Safety actions</p> <p>Class 4 level crossings without crossing gates nor road warning devices should be abolished or equipped with proper safety equipment.</p> <p>To prevent the recurrence of crossing accidents, it is crucial for crossing users to obey traffic laws, but fundamental measures are also important. After the accidents at Ipponyanagi Crossing in April 2021 and this incident, the company and Saga City proposed abolishing the crossing for residents. It held discussions, but no agreement had been reached as of January 2023. The company and the city should continue discussions using the Local Level Crossing Improvement Council and strive for early agreement and cooperation from residents.</p> <p>As an urgent and provisional measure, the company and the city should collaborate with the police and other authorities to conduct awareness campaigns for drivers to obey traffic laws and, where traffic regulation enforcement is difficult, to encourage avoiding the crossing. The company should continue measures such as laying weed control sheets, spraying herbicides, and mowing grass to ensure crossing users can easily notice approaching trains.</p> <p>On the other hand, crossing users should carefully perform safety checks and accurately grasp the situation.</p>

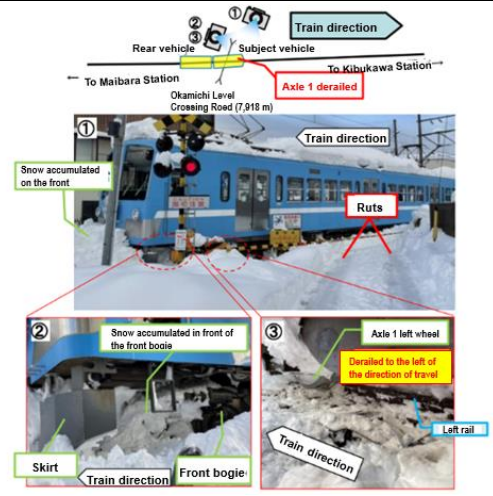
October 26, 2023	December 27, 2021 Train derailment	OHMI Railway Co., Ltd.	In the premises of Hikoneguchi Station, Main Line (Shiga Prefecture)
	Summary	<p>Due to heavy snowfall, train operations were suspended between Hikone Station and Yokaichi Station. However, as the snow had stopped, this train departed from Hikone Station as a test run train before resuming operations.</p> <p>When the train was traveling at about 10 km/h through Okamichi Crossing, the driver heard an abnormal noise and applied the emergency brake to stop the train.</p> <p>After the train stopped, the staff got off and checked, finding that the first axle of the front bogie of the lead car had derailed to the left.</p> <p>One driver, four staff members responsible for clearing snow from the switches south of Takamiya Station, three drivers working at Yokaichi Station and other locations, and two station staff members were on board, but no one was injured.</p>

Probable causes	<p>It is possible that this accident occurred when the front bogie of the lead car swiveled to the left, reducing the wheel load on the front bogie, and the first axle of the front bogie rode up on the compacted snow on the rails and flange way*1 of the crossing, leading to derailment.</p> <p>It is possible that the reduction in the wheel load on the front bogie of the lead car was caused by the accumulation of snow entering from both the lower and upper parts of the skirt, increasing the upward load on the front bogie of the lead car as the train pushed through a large amount of snow on the tracks.</p> <p>The front bogie of the lead car likely swiveled to the left due to the snow accumulating in front of the lead car and the front bogie pushing the front parts of the car body and bogie.</p> <p>A large amount of snow on the tracks is likely due to the snow that fell before the train's passage not melting due to low temperatures and heavy snowfall, in addition to the snow that remained on the tracks from the last train passage the previous day.</p> <p>It is possible that the compacted snow on the crossing was caused by vehicles repeatedly compacting the snow as they passed over the crossing between the last train passage the previous day and the train's passage under low temperatures and heavy snowfall. Additionally, the snow on the tracks and the compacted snow on the rails and flangeway of the crossing were not cleared before the train passed.</p> <p>It is probable that the decision to operate the train without a snowplow*2-equipped vehicle and without conducting snow removal have been based on the assumption by the Chief Safety Management Officer that the snow accumulation on the tracks and the compacted snow conditions at the crossing were similar to those on January 24, 2017, when the train had previously run without issues. However, it is highly probable that the snow accumulation and compacted snow conditions differed at the time of the accident. It is probable that the final decision on the necessity of snow removal and whether to operate the train was made based on</p>

<p>past experiences rather than the actual conditions at the time of the accident. Additionally, the company’s internal regulations did not provide objective criteria or conditions for determining the necessity of snow removal, the use of snowplow-equipped vehicles, or the operation of trains under varying snow conditions. The company also did not check the compacted snow conditions at the crossings. This lack of objective standards and insufficient information gathering likely contributed to inadequate decision-making regarding snow removal and train operation.</p> <p>*1. The “flangeway” refers to the space provided for the wheel flanges to pass through. *2. The “snowplow” is a snow removal device attached to the lead car to clear snow from the tracks within the vehicle’s clearance.</p>		
	Safety actions	<p>Accurate information collection regarding snowfall, snow accumulation, and compacted snow conditions is necessary to clearly define objective criteria and conditions for determining the need for snow removal on the tracks and crossings, snowplow-equipped vehicles, and the feasibility of train operations.</p>

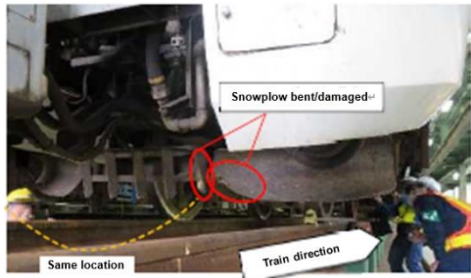
Probable causes	<p>It is probable that this accident occurred because the train driver did not notice that a wheel chock was attached to the second axle of the rear bogie of the seventh car when the train departed. As a result, the wheel rode up on the wheel chock and derailed shortly afterward. The derailed wheel then rode over concrete blocks laid on the staff passage within the station premises, re-railing itself.</p> <p>The train departed without the driver noticing the wheel chock attached to the second axle of the rear bogie of the seventh car because the yard driver had attached the wheel chock after the temporary coupling operation before departure. However, it is probable that the train and yard drivers did not communicate the wheel-chock attachment status. It is likely that a contributing factor to this lack of communication was the unclear confirmation procedures between the vehicle operation duty officer and the crew operation duty officer when planning and executing vehicle or crew operation changes or temporary yard work.</p>

Safety actions	<p>It is probable that this accident occurred because the wheel chock handling and the implementation of the departure inspection were unclear when temporary work was performed, which led to the train departing with the wheel chock still attached. Therefore, it is necessary to establish a system that clarifies the items to be mutually confirmed by the relevant parties (the vehicle operation duty officer and the crew operation duty officer) to prevent omissions or discrepancies in the work content when planning and executing changes in vehicle or crew operations or temporary yard work.</p> <p>Additionally, the company should implement necessary measures to prevent similar incidents in the future, considering that the wheel chock usage tag*² did not function effectively during</p>

<p>this accident.</p> <p>*2. The “wheel chock usage tag” is a tag placed on the master controller handle of the operating cab to indicate that a wheel chock is in use.</p>		
	Report	https://www.mlit.go.jp/jtsb/railway/rep-acci/RA2023-9-2.pdf (Japanese)

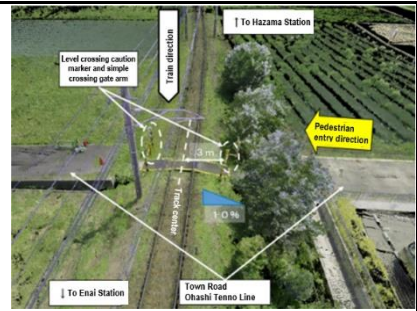
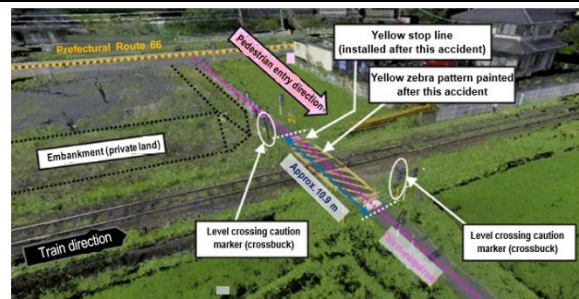
December 21, 2023	April 10, 2023 Level crossing accident	WILLER TRAINS, Inc.	Between Shisho Station and Nishimaizuru Station on the Miyazu Line (Kyoto Prefecture) Shimoyuri Crossing (Class 4 level crossing without crossing gate nor road warning device) (managed by Kitakinki Tango Railway Co., Ltd.)
	Summary	<p>While the driver of the train was traveling at approximately 70 km/h between Shisho Station and Nishimaizuru Station, they noticed a pedestrian in a handle-operated electric wheelchair*¹ entering Shimoyuri Crossing (Class 4 level crossing) from the left side (front, back, left, and right are based on the train's direction of travel). The driver applied the emergency brake and sounded the horn, but the train collided with the pedestrian.</p> <p>As a result of this accident, the pedestrian was killed.</p> <p>*1. The “handle-operated electric wheelchair” refers to an electric wheelchair that can change direction using a handle and includes similar structures. Handle-operated electric wheelchairs are also known as “electric carts” or “senior cars” and are recognized as vehicles used by older people.</p>

Probable causes	<p>It is highly probable that this accident occurred because the pedestrian in the handle-operated electric wheelchair (senior car) entered Shimoyuri Crossing, Class 4 level crossing without crossing gate nor road warning device, from the left side. At the same time, the train approached, leading to a collision.</p> <p>The pedestrian entered the crossing while the train was approaching, and it is possible that the pedestrian did not notice the approaching train when entering the crossing. Possible reasons</p>

include the pedestrian not stopping temporarily near the crossing warning sign and not performing safety checks. However, the detailed reasons could not be clarified as the pedestrian was deceased.
Safety actions	<p>Abolishing Class 4 level crossings without crossing gates nor road warning devices to enhance safety is desirable. If abolition is impossible, they should be upgraded with safety equipment to become Class 1 level crossings. Given that a fatal accident occurred at this crossing in 2004 and there is an alternative route through Class 1 level crossing, the railway operator and road administrator should abolish this crossing for safety improvement. If abolition is not feasible, the crossing should be upgraded to Class 1 level crossing. Therefore, the railway operator and road administrator need to work on gaining the understanding and cooperation of crossing users and residents, establish a policy early, and implement concrete safety measures.</p> <p>Until concrete safety measures are implemented, the railway operator and road administrator should encourage the users to use the alternative Class 1 level crossing actively and promote safety measures such as installing warning signs and stop lines. Furthermore, considering this accident may have occurred because the pedestrian did not stop and perform a safety check, the railway operator and road administrator should raise awareness among crossing users to ensure that safety checks are performed when crossing.</p>

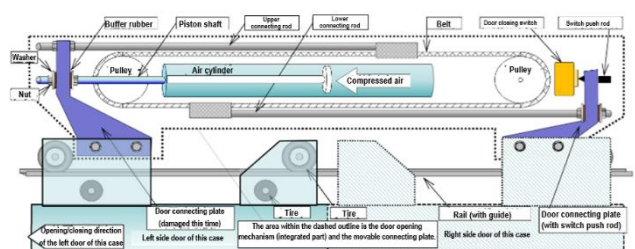
1	Date of publication	Date and incident type	Railway operator	Line section (location)
	December 21, 2023	July 24, 2022 Dangerous trouble in vehicle	Enoshima Electric Railway Co., Ltd.	In the premises of Shonan-kaigan-koen Station on the Enoshima Electric Railway Line (Kanagawa Prefecture)
	Summary	<p>The conductor of this train was informed by a passenger that a door was open just before arriving at Kugenuma Station. Upon checking inside the train, the conductor confirmed that one of the two-panel passenger doors (each panel sliding in opposite directions) at the front right side of the rear car (based on the train’s direction of travel) was open. The conductor reported this to the train driver after stopping.</p> <p>The train driver reported the situation to the operations control center, restricted passenger access to the affected car, and continued the commercial operation of the train in the order of Fujisawa Station, Kamakura Station, and finally, Gokurakuji Station, where the train was taken to the depot.</p> <p>The train had approximately 50 passengers and two crew members (one driver and one conductor) on board, but there were no injuries from falling, etc.</p> <p>Subsequent investigation revealed that the door was also open at Shonan-kaigan-koen Station just before the incident was discovered. However, the door status indicator light*1 was off, and the train departed with the door open.</p> <p>*1. The “door status indicator light” is a light that informs crew members of the door’s open/close status. One is installed on outside of left and right of each car, and it lights up on the side where any door is open.</p>

Probable causes	<p>It is certain that this serious incident occurred because the door coupling plate on one side of the two-panel passenger door broke, causing the door to remain open while the train was running.</p> <p>It is certain that the train ran with one door open because the door coupling plate on the other door, functioning normally, pressed the door-close switch, detecting the door as closed.</p> <p>It is probable that the breakage of the door coupling plate was caused by fatigue failure due</p>

<p>to repeated stress on the welded area near the stress concentration from the opening and closing of the two-panel door.</p> <p>Additionally, the damage to the door coupling plate was not discovered until it broke, more likely due to the insufficient inspection of the door coupling plate during regular inspections, such as not opening the inspection cover above the passenger door for inspection.</p> <p>Furthermore, regarding the fact that the open door was not noticed until a passenger reported it while the train was running, it is more likely related to the continuation of operations without taking appropriate measures, despite multiple unexplained door operation abnormalities being confirmed at several stations before this serious incident occurred.</p>
	Safety actions	<p>The company needs to ensure thorough inspections of the door coupling plates on the same type of vehicles, considering the possibility of fatigue failure due to the opening and closing of passenger doors. Additionally, as observed in this incident, the company should review and update the operational handling standards to account for failures on one side of the two-panel door.</p>
