ANNUAL REPORT 2024

JAPAN TRANSPORT SAFETY BOARD

March, 2024

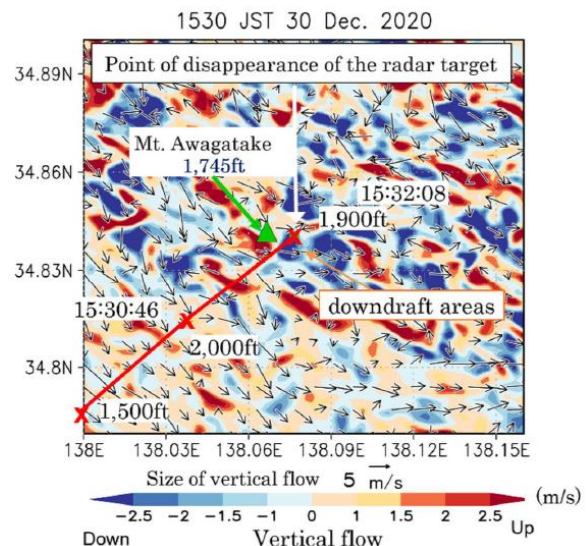
Fig. 1: Vertical flow at 600 m altitude (color) and horizontal wind deviation from the

As a result, the JTSB concluded that while flying at an altitude of approximately 2,000 ft at maximum cruising speed, the aircraft encountered a localized downdraft near the point where the radar target disappeared (Fig. 1). During the low-G flight condition (a state of reduced gravitational forces), the aircraft's attitude was not properly controlled, resulting in mast bumping, where the main rotor blade attachment contacted part of the main rotor drive shaft. This most likely led to a loss of control and a subsequent crash.

Based on the results of this investigation, one measure considered necessary to prevent recurrence is to inform pilots of semi-rigid rotor helicopters^{*2} about precautions to prevent mast bumping, which can lead to loss of control, and to ensure that they obtain necessary weather information before departure. If adverse weather conditions are expected, pilots should either cancel or conduct the flight with a safe flight plan (see Chapter 3, page 44).
