Crash during hoisting down rescuers in the ravine downstream of waterfall plunge pool for rescue operation

Summary: On Sunday July 25, 2010, a Eurocopter AS365N, owned by Saitama Prefectural Government took off from a temporary helipad in Otaki, Chichibu City, Saitama Prefecture at 10:48 local time (UTC+9 hours) for a rescue operation and crashed, while hoisting down two rescuers (Air Rescuer A and Firefighter A) to a ravine upstream of Takigawa, around 11:03. Of seven persons on board, two hoisted-down rescuers survived, however, five persons (a pilot in command, a pilot, two rescuers from Saitama Disaster Prevention Aviation Unit and a firefighter from Fire Brigade Headquarters) sustained fatal injuries. The aircraft was destroyed, however, no fire broke out.

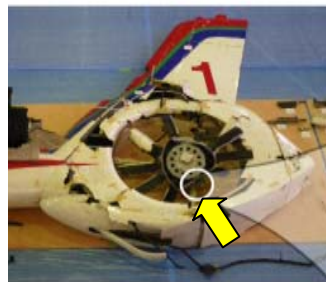
Fenestron

Tree branches were sucked into the Fenestron, and the aircraft lost its yaw control due to the damaged tail rotor, started to spin to the left, and its main rotors contacted with trees located left aft side of the aircraft.

Tree fragments viewed in the direction of the arrow

It is very likely that the aircraft crashed when it hovered to the left to adjust the position without appropriate looking out, the Fenestron’s tree contact developed into a loss of yaw control followed by main rotor tree strike.

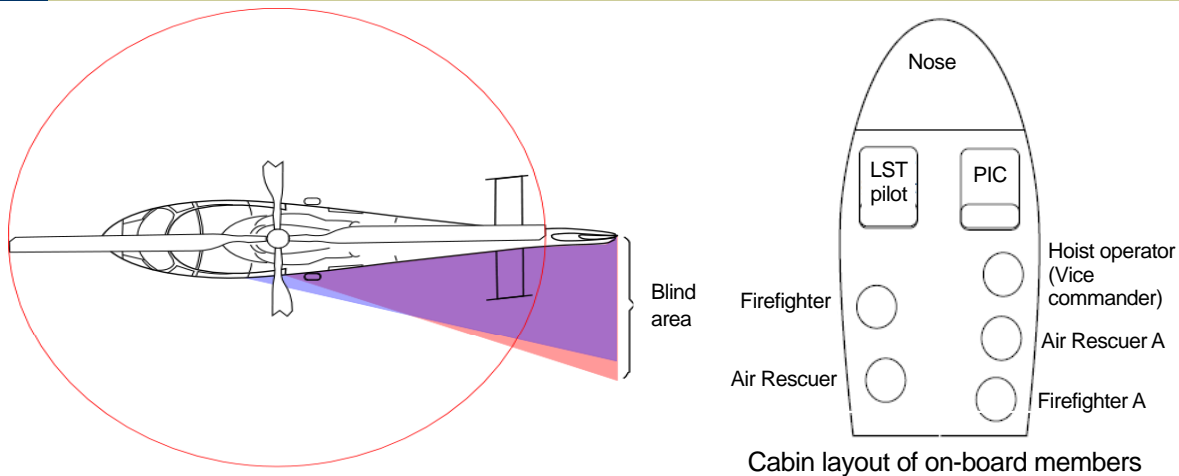
Blind Area in Aft Left Section of Aircraft

The Aviation Unit maintains that they did looking out per duty assignment as described in the above figure when a helicopter hovers in a small confined area. However, usually the left cabin slide door is closed during hoist operation therefore blind area exists near the Fenestron as depicted in the above figure, unable to see from the aircraft interior.

It is not certain whether the PIC confirmed the left side of the aircraft or gave instructions to watch that section before moving to the left for the position adjustment, it is very likely that the looking out to the left aft was inappropriate.

Although the voice procedures (call-out procedures for rescue mission) did not include looking out, the JTSB considers it desirable to include the looking out in the voice procedure so that aircraft occupants do looking out properly per duty assignment.

It is most likely that inappropriate looking out to the left aft lead to the aircraft's tree contact and consequently developed into accident. The JTSB believes that the necessary training should be repeated to train aircraft occupants to do proper looking out responding to the rescue site circumstances.
