Case 2

Collision caused by an assumption, without keeping a proper lookout while sailing, that it would be possible to cross ahead of the other vessel

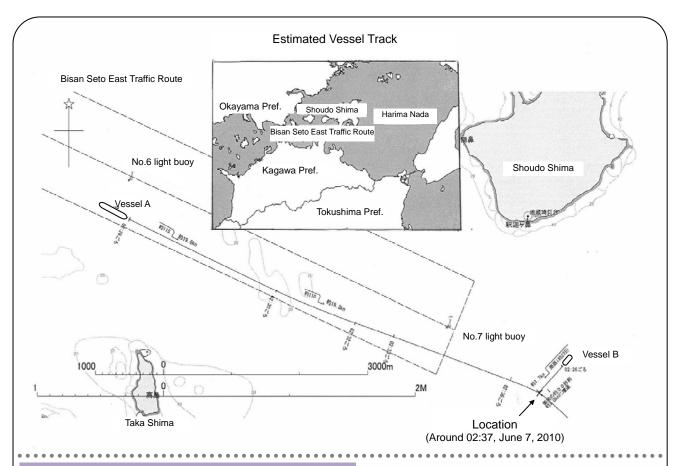
Probable Causes: It is probable that the accident occurred involving a collision of two vessels, Vessel A and vessel B, because Officer A was sailing without keeping a proper lookout and Skipper B was also not keeping a lookout while Vessel A was proceeding eastward and Vessel B was proceeding southwestward at night in waters south of Jizo Saki, Shoudo Shima, Kagawa Pref.

It is probable that the reason Officer A was not keeping a proper lookout was that due to the condition of the lights on Vessel B and the low speed she was sailing at, he assumed that Vessel B was a fishing vessel engaged in net towing, and that Vessel A would be able to pass ahead of her leaving a gap of approximately 0.2M.

It is probable that the reason Skipper B was not keeping a lookout was that he assumed that the net washing work would be completed before Vessel A approached, and that he was concentrating on that work on the aft deck.

- ➤When crossing paths with other vessels, continue to keep a proper lookout in order to judge the risk of collision properly.
- >If the other vessel does not take action to avoid a collision, immediately give a warning signal.
- ➤If one's own vessel shall become the stand-on vessel, take such action as will best aid to avoid collision.
- >If one's own vessel shall become the give-way vessel, take early and substantial action in order to keep sufficient distance from the other vessel.
