Case 4

Collision between an inbound vessel and an outbound vessel whose courses intersected at Kurushima Kaikyo Traffic Route west entrance during southward current

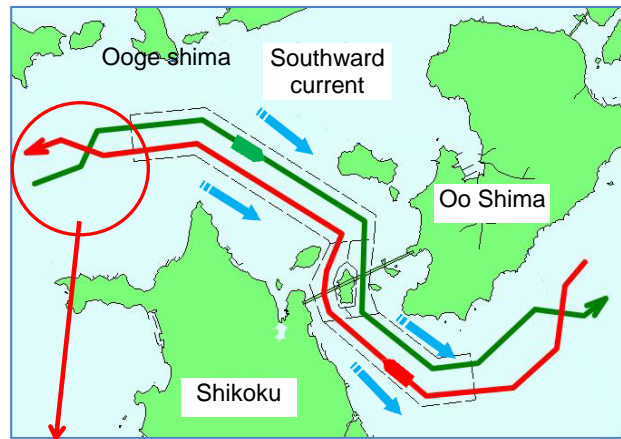
Keep-to-the-left rule

When the tidal current of the Kurushima Kaikyo Traffic Route is **flowing southward**, vessels navigating that route must follow a **“Keep-to-the-left rule”**, which differs from the “Keep-to-the-right rule”, the general rule for marine traffic. In that case, vessels should pay more attention because they need to change to the “Keep-to-the-left rule” and the **courses of vessels sailing in opposite directions intersect each other near the west entrance of the route**.
