JTSTB (Japan Transport Safety Board)

Digest of Marine Accident Analyses

For prevention of “Collision Accidents in Congested Areas”

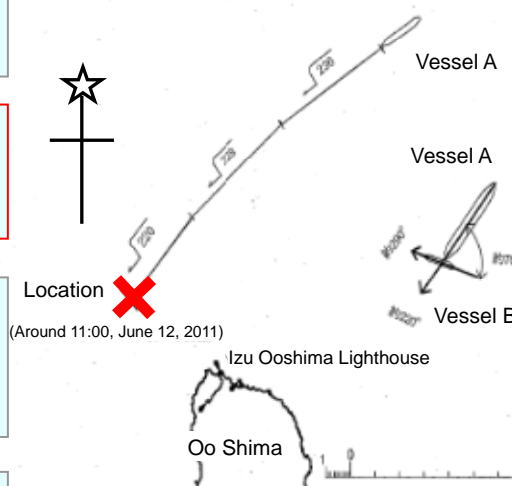
Estimated Vessel Track

Probable Causes: It is probable that the accident occurred involving a collision of two vessels, Vessel A and vessel B, because both Master A and Skipper B were not keeping a lookout under hazy conditions off the northwestern coast of Oo Shima, with Vessel A proceeding southwestward and Vessel B drifting.

It is probable that the reason why both Master A and Skipper B were not keeping a lookout was that under hazy conditions, they both were looking out only visually without using the radar and did not see any other vessels, mistakenly assuming that there were no other vessels in the area.

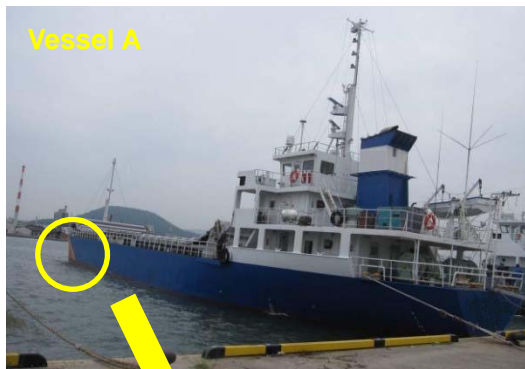
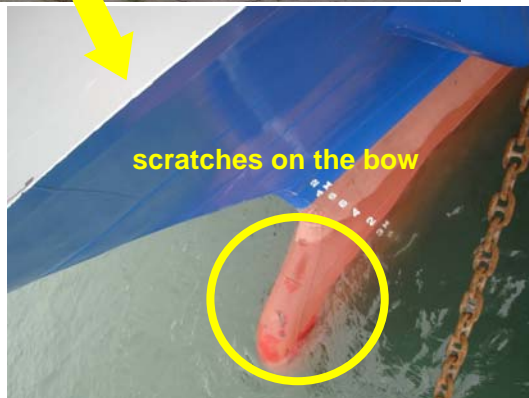
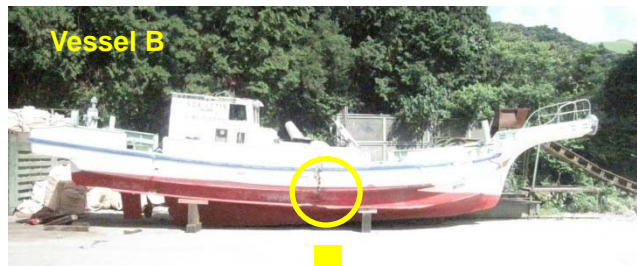
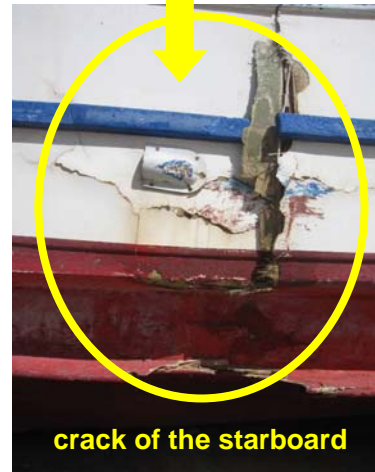
State of the damage (Vessel A and Vessel B)

One of the passengers on the Vessel B was injured and her starboard was cracked. The Vessel A sustained scratches on the bow.

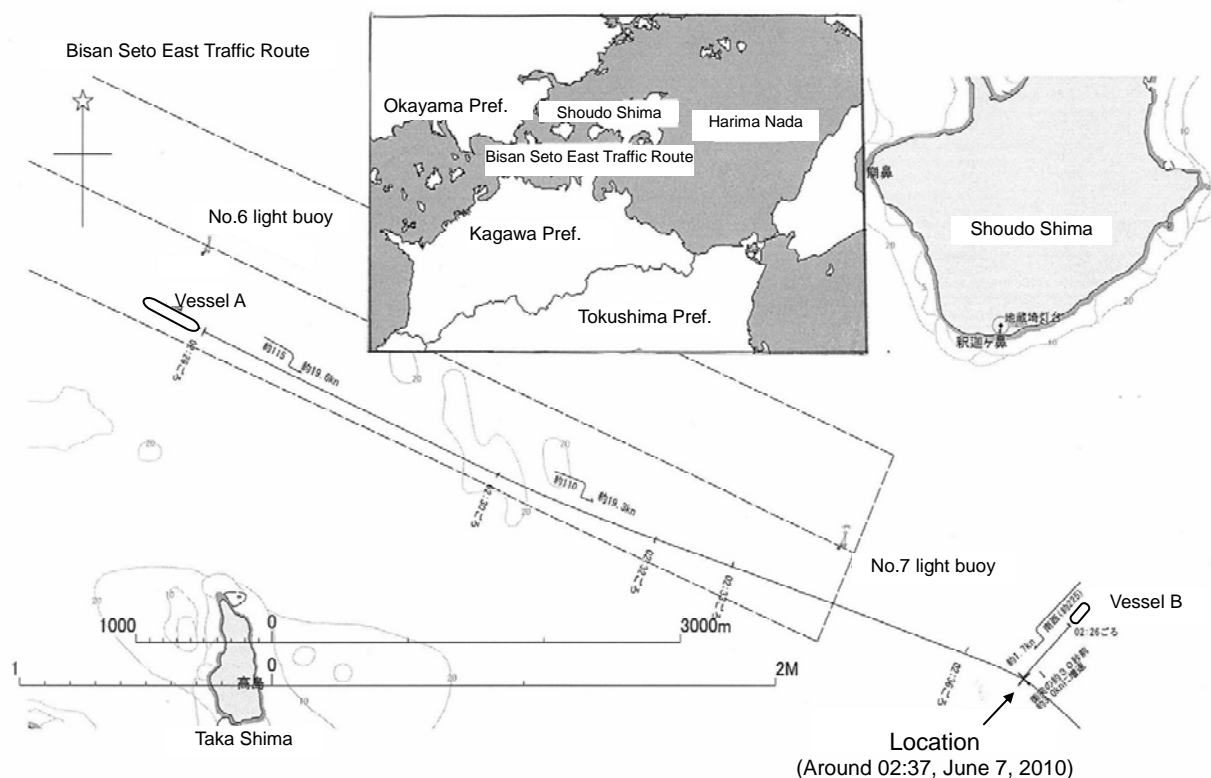
Estimated Vessel Track

Probable Causes: It is probable that the accident occurred involving a collision of two vessels, Vessel A and vessel B, because Officer A was sailing without keeping a proper lookout and Skipper B was also not keeping a lookout while Vessel A was proceeding eastward and Vessel B was proceeding southwestward at night in waters south of Jizo Saki, Shoudo Shima, Kagawa Pref.

It is probable that the reason Officer A was not keeping a proper lookout was that due to the condition of the lights on Vessel B and the low speed she was sailing at, he assumed that Vessel B was a fishing vessel engaged in net towing, and that Vessel A would be able to pass ahead of her leaving a gap of approximately 0.2M.

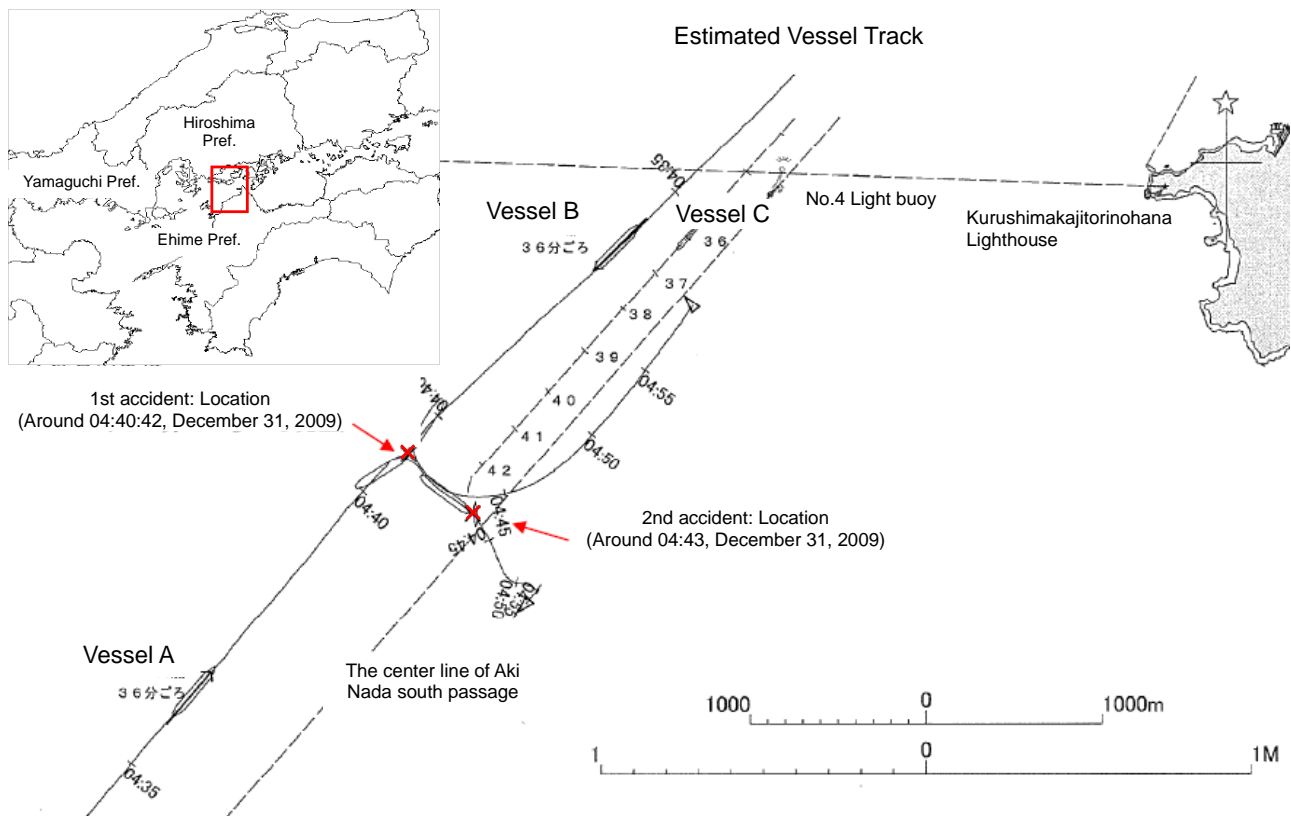
The port bow of the Vessel A was breached and port stern was dented. The bow of the Vessel B was cracked and dented and the starboard stern was dented. But no fatality or injury was caused on both vessels.

Summary (2nd accident): The Vessel A was proceeding southeastward after colliding with the Vessel B around the location of the 1st accident and the Vessel C, manned with the Master C and 3 crew members, was proceeding southwestward behind the port side of the Vessel B. The two vessels collided with each other at around 04:43.

The Vessel A sustained damage in the bow, and the Vessel C sustained the dent damage in her starboard mid-section. But no fatality or injury was caused on both vessels.

Probable Causes (1st): It is probable that the 1st accident occurred involving a collision of two vessels, Vessel A and vessel B, because both Vessel A and Vessel B were not keeping a lookout while Vessel A was proceeding northeastward on the left side of the center line of the Aki Nada south passage and Vessel B was proceeding southwestward on the right side of the center line of the Aki Nada south passage at night-time off the southwestern coast of Kajitorinohana.

Probable Causes (2nd): It is probable that the 2nd accident occurred involving collision of Vessel A and vessel C, because Vessel A sailed toward the path ahead of Vessel C while Vessel A was proceeding southeastward turning to starboard due to her residual momentum after the collision with Vessel B and Vessel C was proceeding southwestward,.

- > Vessels sailing along the recommended route should sail on the right side of the center line of the route.
- > Keep a proper lookout by sight and using radar and other available means.

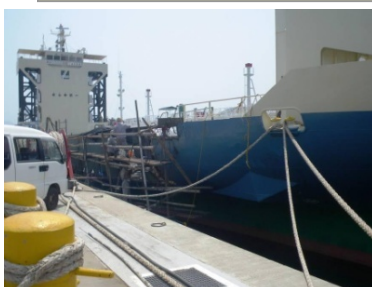
Damage to Vessel A

Vessel A sustained dents and other damage to her starboard bow, and the bow of the Vessel B was cracked and breached, but no fatalities or injuries were caused on both vessels.
