3. Case Studies of accidents

Case 1

Injuries suffered by passengers and cabin attendants from the shaking of the aircraft encountering turbulence during its descent in convective clouds

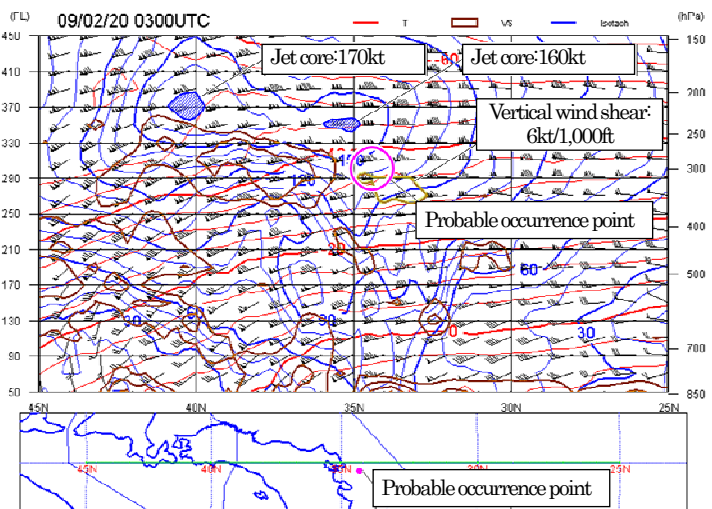
Hourly Analysis Chart

Because warm and damp winds were blowing from the south into the low pressure near the Tokai region, generating unstable atmospheric condition. As a result, it is considered highly probable that clumpy convective clouds were developing there.

It is highly probable that clumpy convective clouds developed from the waters off the Tokai region to the Kanto region.

A vertical wind shear of 6kt/1,000 ft was observed amid jet stream near Latitude 35° N at an altitude of 26,000 to 30,000 ft. Therefore, it is considered highly probable that turbulent air was generated in the airspace near the place where the accident occurred.

1200JST 20 FEB 2009(Longitude 140°E) Some information was overlaid onto the JMA document.

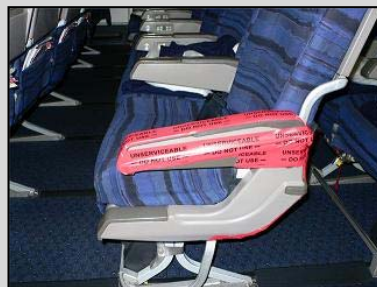
Armrest

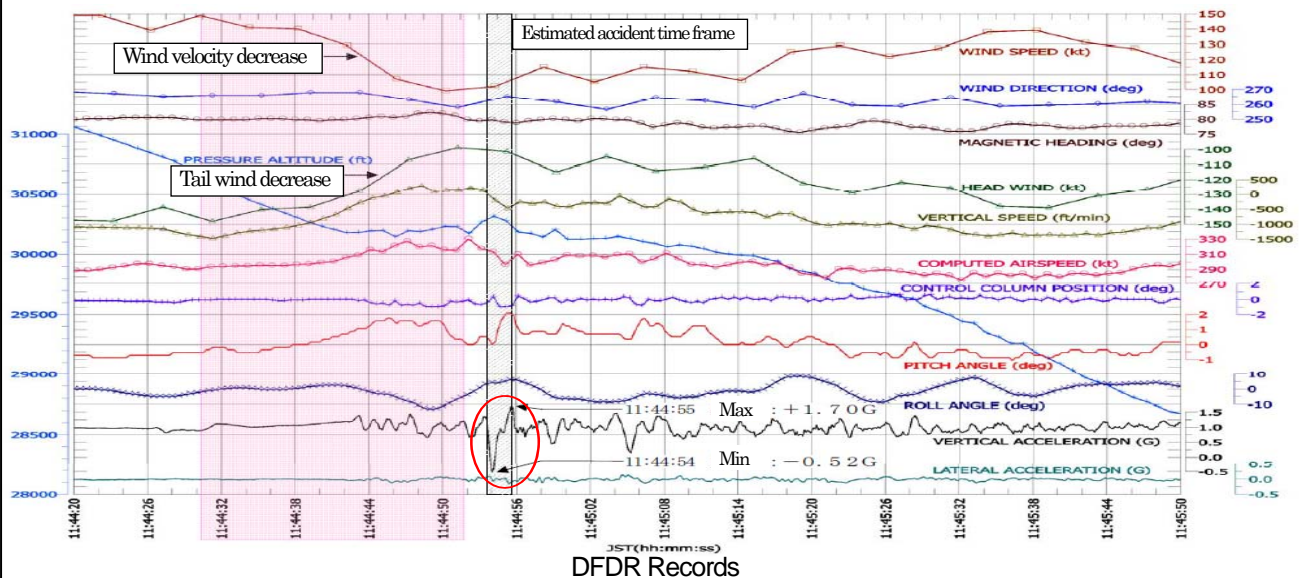
According to the DFDR record concerning the vertical acceleration which indicates vertical bumpiness of flight, it is considered highly probable that the Aircraft encountered turbulence around 11:44:26 and the bumpiness began bigger from around 11:44:43 with the Aircraft's attitude change and then, reaching its culmination at 11:44:53 to 11:44:55 at an altitude of about 30,300 ft.

The wind velocity was 130 to 140kt in the vicinity of the airspace where the accident occurred. But the wind velocity that the Aircraft actually flew varied by about 50kt from about 150 kt to about 100kt. Therefore, it is considered highly probable that the Aircraft was influenced by the sudden large wind velocity change near the airspace where the accident occurred.
