Case 2

Serious injuries suffered by one FA and slight injuries suffered by four passengers from the shaking of the aircraft caused by locally-occurring clear-air turbulence

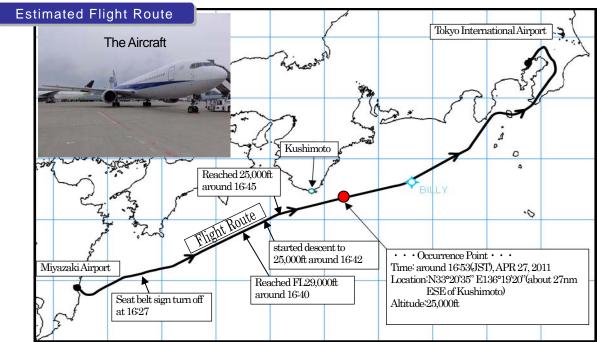
Summary: On Wednesday April 27, 2011, a Boeing 767-300, operated by Company A, at 16:16 Japan Standard Time (JST: UTC+9hr, unless otherwise stated, all times are indicated in JST on a 24-hour clock), took off from Miyazaki Airport for Tokyo International Airport as a scheduled flight. While flying at 25,000 ft, 27 nm east-southeast of Kushimoto, around 16:53, the aircraft encountered turbulence and one cabin attendant was seriously injured in front of the left aft lavatory. Four other people consisting of passengers and cabin attendants were slightly injured. There were 119 people on board: a Pilot in Command (PIC), seven crew members and 111 passengers. The aircraft was not damaged.
