Case 3

Injuries suffered by FAs from the shaking of the aircraft encountering turbulence after entering cumulonimbus clouds that suddenly developed

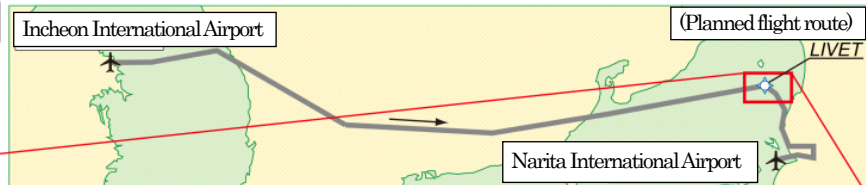
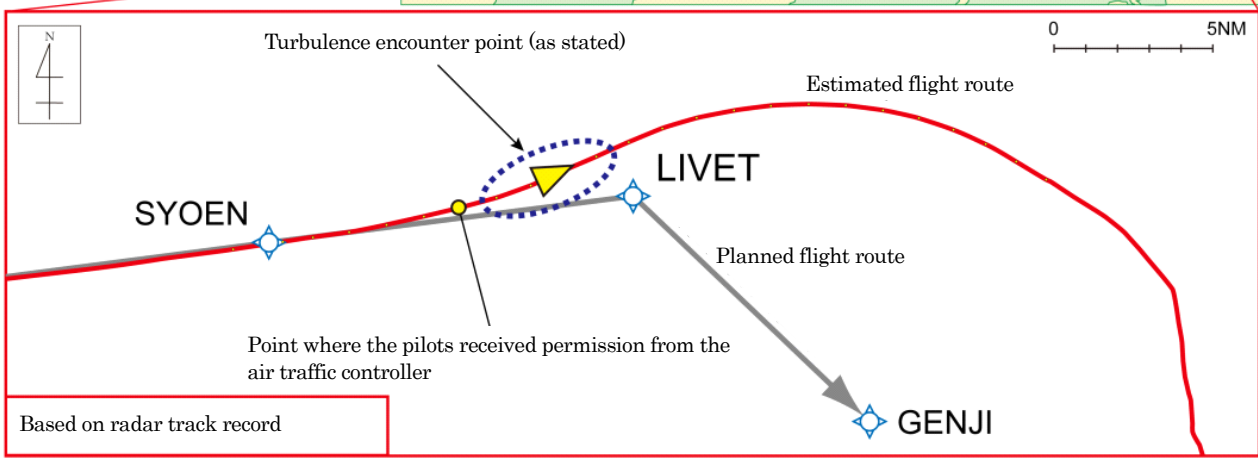
Estimated Flight Route

The PIC and the first officer (FO) found a small cumulonimbus to the right of the course very close to LIVET (waypoint) as the aircraft was descending before LIVET. The aircraft's weather radar displayed only green weak weather returns. It became apparent they needed to go further left to avoid it; therefore, they started to make a deviation flight to the left after receiving permission from the air traffic controller.

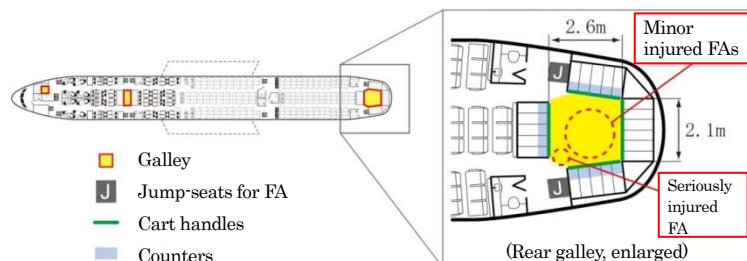
In the rear galley where the four injured FAs were working

- Handholds designed specifically for the shaking of the aircraft were not equipped.
- Fixed objects such as the counters and the cart handles stored in the lower part of the galley on four sides were available to hang on as substitute for handholds.
(All of the carts had been stored when the accident occurred)
- Making the FAs and the fixed objects, which were substitute for handholds, slightly far apart.

It is probable that the four FAs working in the rear galley were thrown into the air because they had not been informed by the PIC of the turbulence in advance and were unable to hang onto fixed objects around them when the rear of the airframe sank suddenly.

It is probable that the FA was seriously injured because she was unable to hang onto the fixed objects around her when the aircraft was shaken suddenly.

➤After the occurrence of this accident, Company A strengthened the contents of Flight Attendant Operations Manual (UNEXPECTED TURBULENCE).

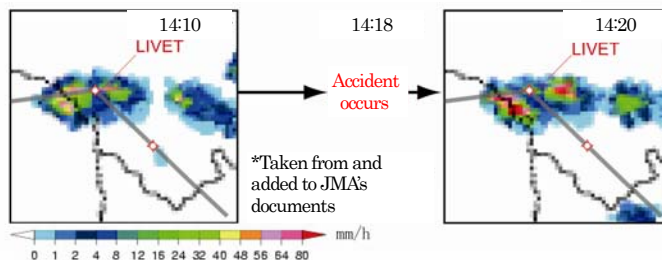
Weather Radar Imagery (Strength: indicates precipitation intensity)

According to the Weather Radar Imagery at 14:10: before the accident occurred, and 14:20: shortly after the accident occurred, **the echo strength increased during this period as its top height reached 26,000 ft and over.**

avoided had developed quickly immediately before the time of the accident.
