# JTSTB Digests

JTSTB (Japan Transport Safety Board)

(Issued in January, 2015)

## Digest of Aircraft Accident Analyses For Prevention of Accidents due to the Shaking of the Aircraft

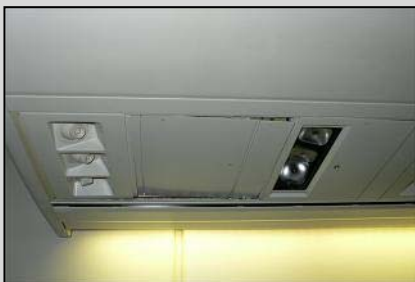
In the mid cabin section, some unseated passengers fell on the floor after bumping their heads against the ceiling, and one of them was unable to move.

Cabin ceiling

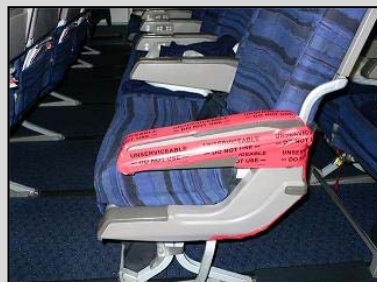
Armrest

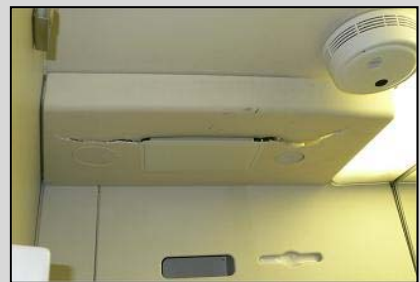
Lavatory ceiling

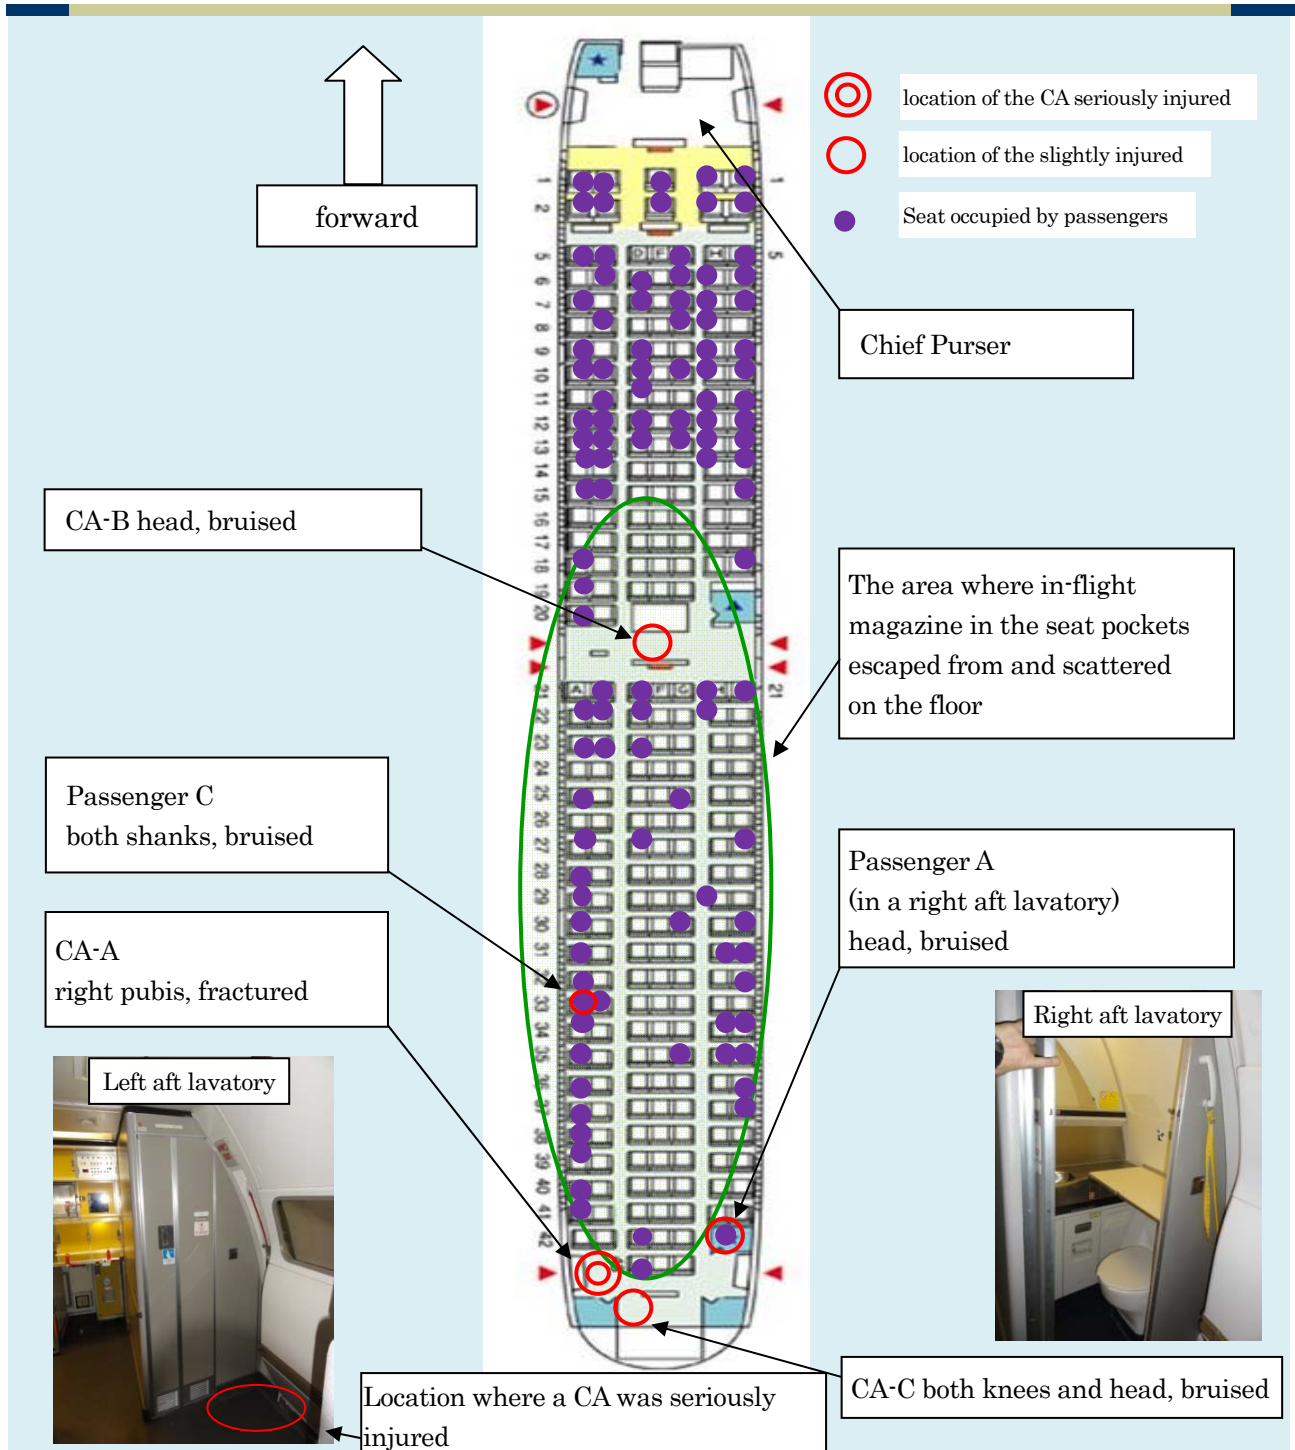
## Locations of injured persons

Before the strong shaking she felt rolling and she anticipated another shaking in the aft lavatory, but her anticipation was betrayed by the pitching by which she was thrown upward to have her head hit against the ceiling, and was dropped on the floor.

The combination of the aircraft motion around the center of gravity caused by the increase in the pitch angle and the sharp descent of the aircraft by 80 ft gave the aft section of the aircraft a sudden lowering.

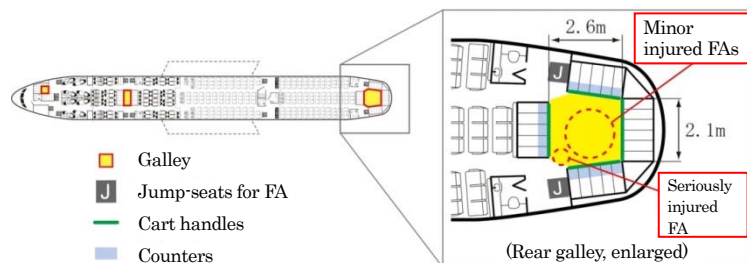
#### In the rear galley where the four injured FAs were working

The aircraft encountered a moderate turbulence when it entered some clouds while going around. Serious and slight injuries were suffered by four FAs working in the rear galley of the aircraft as a result of the severe shaking of the aircraft.

- Handholds designed specifically for the shaking of the aircraft were not equipped.
- Fixed objects such as the counters and the cart handles stored in the lower part of the galley on four sides were available to hang on as substitute for handholds.  
(All of the carts had been stored when the accident occurred)
- Making the FAs and the fixed objects, which were substitute for handholds, slightly far apart.
