Case 2 Due to fuel exhaustion and insufficient flight planning (Fuel exhaustion)

When returning from a familiarization flight, the Small Aircraft made a forced landing due to fuel exhaustion and was damaged. (Captain: Age 26, Total flight time: 357 hours; Another pilot on board: Age 46, Total flight time: 1,070 hours)

Summary: On Monday May 12, 2014, a privately owned Extra EA300/L, took off from Fukushima Sky Park Temporary Airfield for a familiarization flight. While returning to the Airfield after finishing the familiarization flight, the Aircraft failed to increase the engine power and made a forced landing on a bamboo grass field in Nakanochinai, Iizaka-cho at around 10:16.

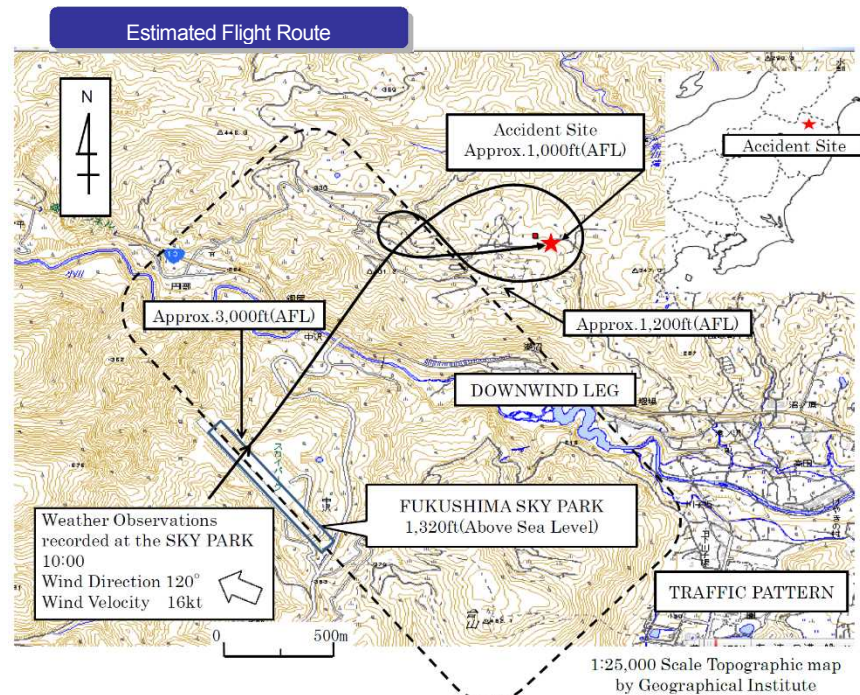
The captain got slightly injured and another pilot on board got seriously injured.

The Aircraft was destroyed but there was no outbreak of fire.
