JTSTB Digests

JTSTB (Japan Transport Safety Board)

(Issued in February 2017)

Digest of Aircraft Accident Analyses For prevention of Accidents Involving Private Small Aircraft and Gliders

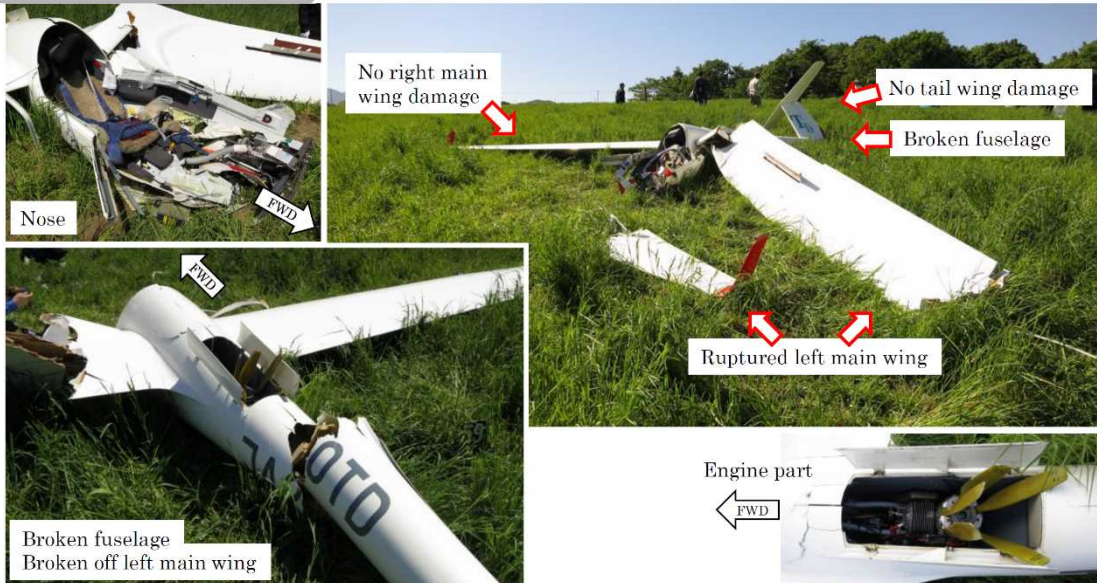
Detailed Damage Description

There were taller trees surrounding the tree with broken branches. Based on the thickness of broken branches, the distance between the tree and the impact marks, and other facts, it is probable that the Glider greatly lost the height during the left turning, which made the left main wing collide with the tree.

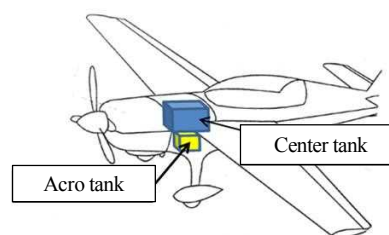
Fuel Tank

Since the flight time elapsed more than 30 minutes after takeoff and very little remaining fuel was detected from the acro tank, it is also highly probable that the fuel quantity indicator had read “zero” when the aircraft entered the downwind leg.

The remaining fuel in level flight cannot be used safely when indicator reads “zero”, it is highly probable that the fuel was almost exhausted at that time, thus the aircraft couldn't get the sufficient engine power to return back to the Sky Park.

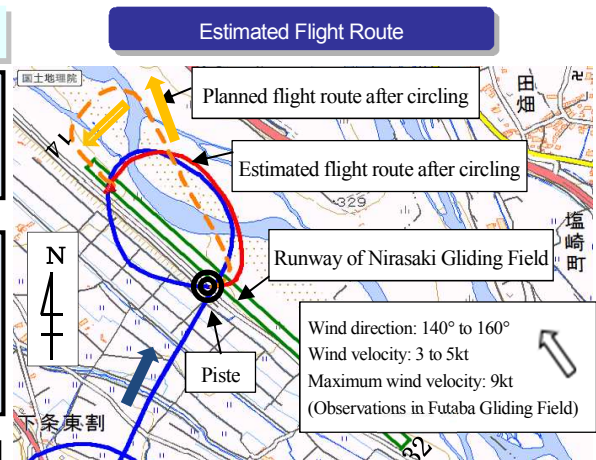
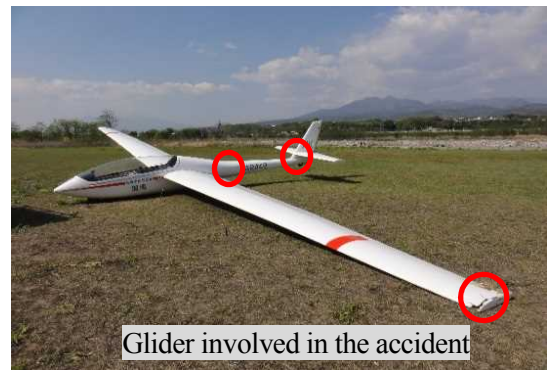
The Glider continued to turn to the left, it could not directly face the Runway and the left main wing tip was brought in contact with the ground in front of the Runway. After bouncing once, the Glider slightly veered the nose to the right, crossed the Runway while skidding sideways, and stopped with the nose directed to the west.

- Extent of damage: Substantially damaged
- Fuselage: Severe distortion, Paint peeling and others
 - Left main wing: Wing Tip breakage, Cracks and others
 - Tail wheel: Recessed into the fuselage

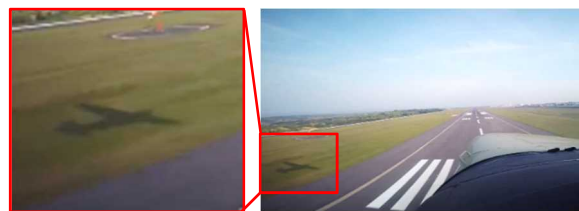
Video Picture

Picture of the Aircraft landing on the Airport was recorded by the video camera carried on the Aircraft. The shadow of the Aircraft immediately before landing was recorded on the picture. The shadow shows that the landing gear was not extended.

Probable causes: In this accident, it is highly probable that the Aircraft belly landed and the lower part of the Aircraft was damaged because the captain did not extend the landing gear in landing.
