(3) Emergency evacuation was conducted, Fuel leaking from the fuel tank caught fire and the aircraft was engulfed in flames

Summary: On August 20, 2007, a Boeing 737-800, operated by Airline C, landed at Naha Airport. Immediately after the aircraft stopped at Spot 41, fuel that was leaking from the fuel tank on the right wing caught fire. The aircraft was engulfed in flames and destroyed by the fire, leaving only part of the airframe intact.

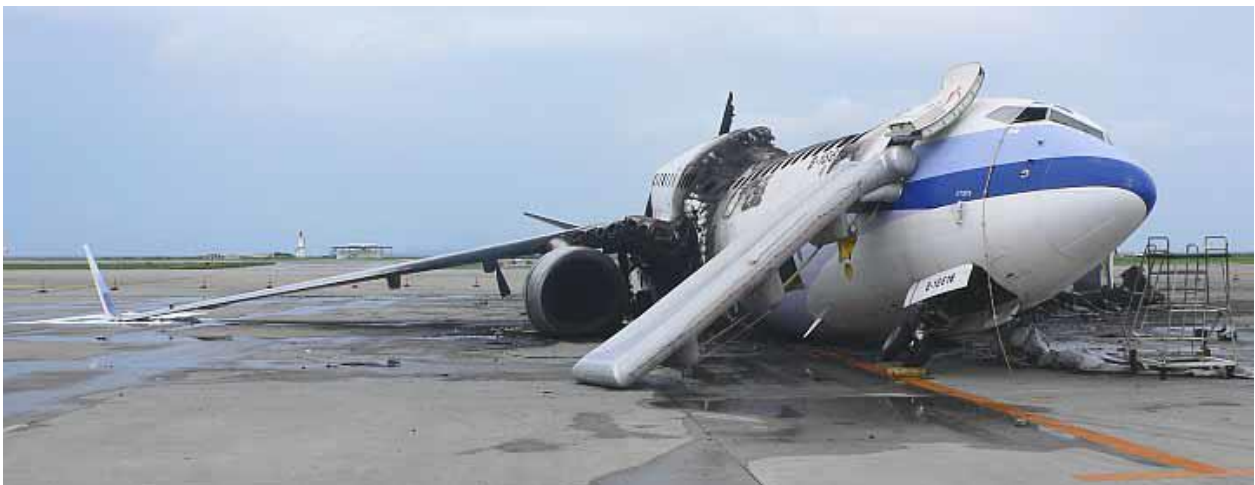
A fire broke out somewhere in an area aft of the No.2 (right) engine and it spread to the right wing leading edge and the apron surface below the No.2 engine.

The first explosion occurred on the right wing.
