JTTSB (Japan Transport Safety Board) DIGESTS

Digest of Aircraft Accident Analyses

Injuries suffered in Use of Evacuation Slides during an Emergency Evacuation

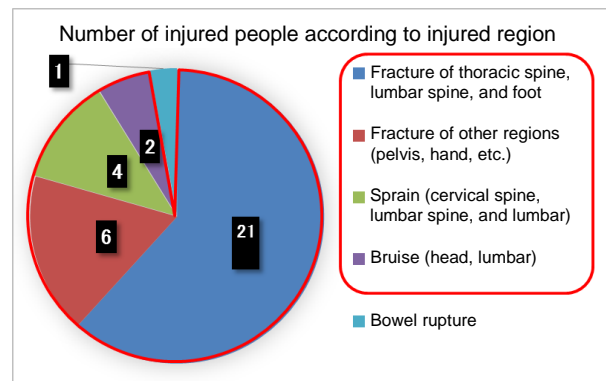
Fig. 3

In this chapter, the injury region of 34 seriously-injured persons, excluding slightly-injured persons, were analyzed and 27 injured person suffered a fracture of the thoracic spine, lumbar spine, pelvis, etc., and they account for nearly 80% of the total. (Fig. 3)

An analysis of the cases where serious injuries occurred during evacuation using evacuation slides revealed that, in each case observed the serious injured suffered in use of evacuation slides, the slides were deployed at a ground with a hard surface, such as a runway, taxiway, and aircraft

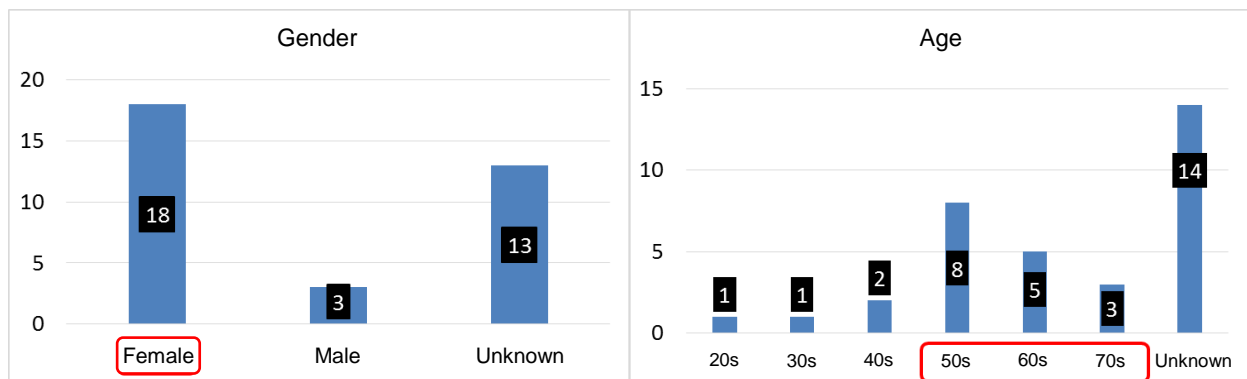
Fig. 4

The gender and age structures of the passengers vary. However, as far as the seriously injured are concerned, the tendency is more females in terms of the male-to-female ratio and people over 50 years old by the age. (Fig. 4, Fig. 5)

There are some medical study reports cited in the investigation report for the accident occurred in an All Nippon Airways aircraft in 1993 (Case (1)) (http://www.mlit.go.jp/jtsb/eng-air_report/JA8096.pdf), one report says that the spines of older people are weaker than those of younger people. And another report says that females suffer rapid reduction in bone mass after menopause, in contrast, males have less of a tendency for bone deterioration due to aging.

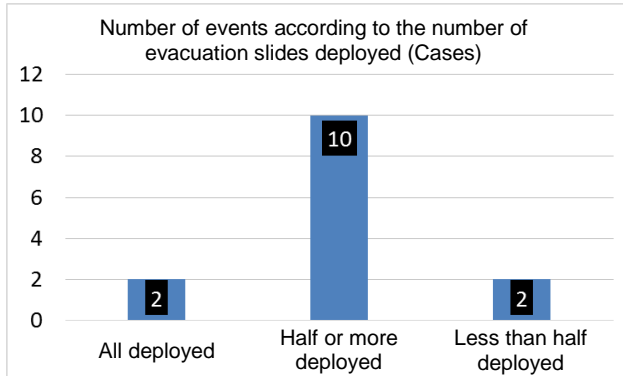
Fig. 6

The number of deployed evacuation slides is also an important factor for smooth evacuation. During an emergency evacuation, some emergency exits are judged as dangerous to use due to a fire, and thus not all slides can be used. (Fig. 6, Fig. 7)

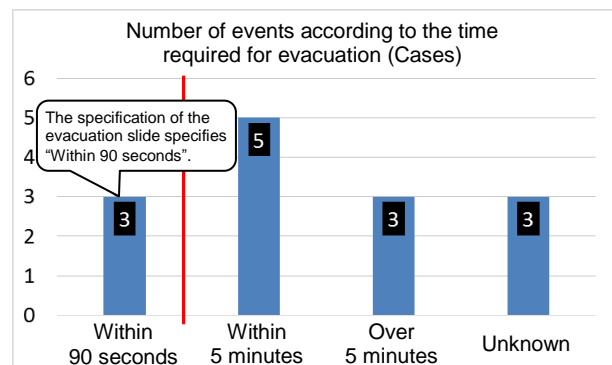
Fig. 8

Finally, as for the capability of evacuation slides, the design criteria for aircrafts stipulate that it must have been demonstrated that, by using the slide, all of the specified number of passengers can evacuate within 90 seconds under the specified conditions.

However, in an actual emergency evacuation, the required evacuation time depends on such factors as the weather at that time, the time zone, the number of evacuation slides deployed and the degree of emergency. (Fig. 8).

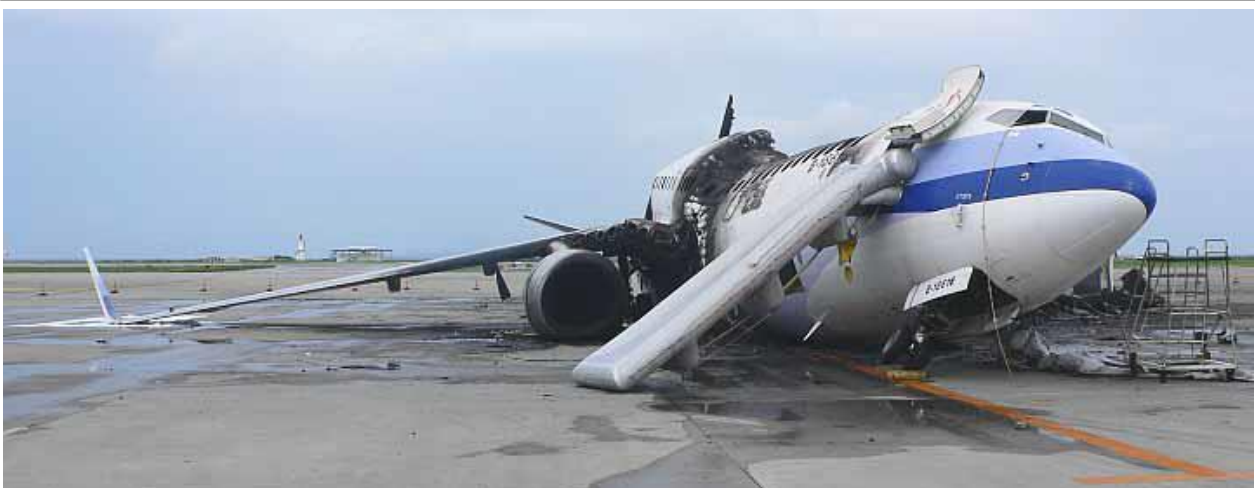
Summary: On August 20, 2007, a Boeing 737-800, operated by Airline C, landed at Naha Airport. Immediately after the aircraft stopped at Spot 41, fuel that was leaking from the fuel tank on the right wing caught fire. The aircraft was engulfed in flames and destroyed by the fire, leaving only part of the airframe intact.

A fire broke out somewhere in an area aft of the No.2 (right) engine and it spread to the right wing leading edge and the apron surface below the No.2 engine.

- There were no dead or wounded.
- The time required for the evacuation was 2 minutes and 28 seconds. (from 10:33:52 to 10:36:20)
- The number of evacuation slides used was 4 out of 6.
- In a questionnaire survey conducted for the passengers, about 25% of the respondents said that they saw assistants at the bottom end of the evacuation slides.
- About 60% of the respondents brought their baggage with them when they evacuated. None of them said that they were restrained by carrying their baggage as they evacuated.

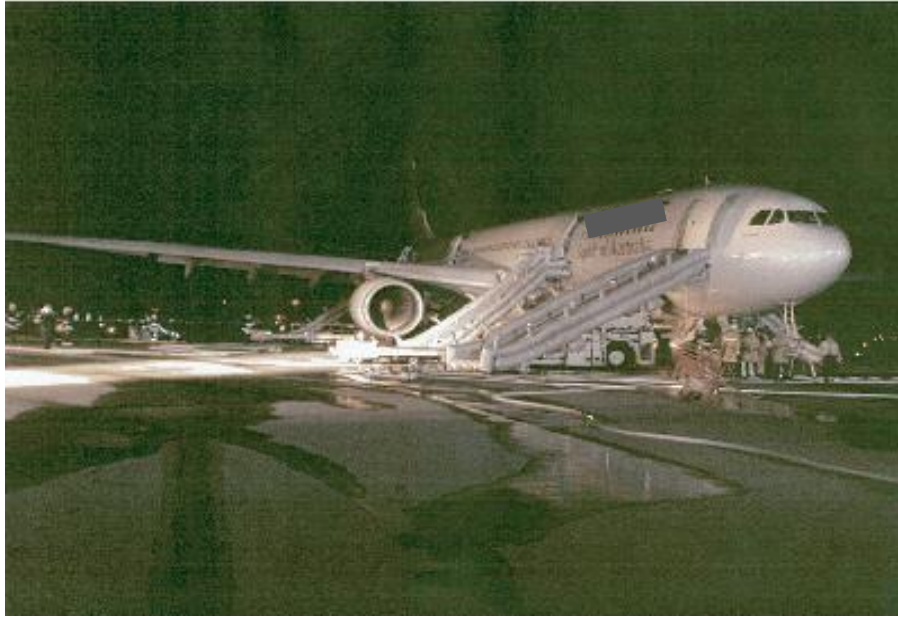
- Female unknown age fractured her pelvis.
On the lower portion of an evacuation slide, the passenger, who was until then held by her parent from behind, slid out of her parent's arms and struck her lower back against the ground.

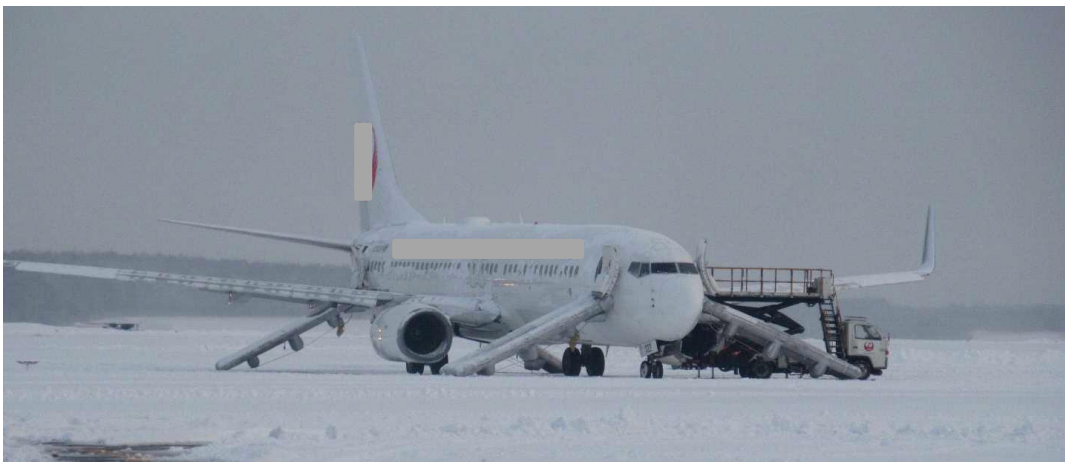
Although two helpers were at the bottom of the evacuation slide, their attention was on an infant following the passenger, so they did not pull the passenger up when the passenger fell down and forward, which caused them to land on their back.

- Revision of the safety video
- Adding the contents to the periodic rescue training carried out by cabin attendants
- Implementation of education concerning the emergency evacuation for the group staff of the company
