3. Examples of the accident investigation

Case 1, Gauge widening

Train derailed by the rail tilting, etc., due to the continuous defects of the rail fastening devices

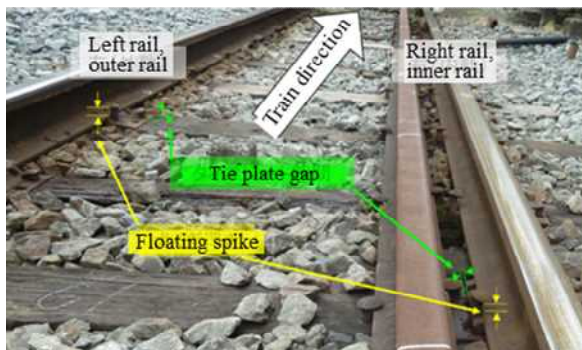
Insufficient comprehension on the danger of dynamic gauge widening by the continuous defects of rail fastening devices.

Slack in relatively large curve.

Dynamic gauge widened large due to rail tilting, etc., by the lateral force while train was running.

Decreased margin against derailment to inside gauge.

At about 21:26 Outer rail side wheel fell to inside gauge and the train derailed.

Probable causes : It is probable that the train, while passing through the 200 m radius right curve, left wheels on the front and the rear bogies fell to inside gauge due to largely widened gauge, the front bogie derailed to right although the rear bogie restored by the guard rail, in the first vehicle.

As for that the gauge had widened largely, it is likely that the gauge had widened dynamically due to the rail tilting, etc., caused by the lateral force when train was running, because the defects of rail fastening devices had been continued in the curved track, and related by that the margin against derailment to inside gauge had been decreased due to relatively large slack in the curved track.

- (1) Certain implementation of the track maintenance
 - Check the corrosion of sleepers and the loosened spikes, etc.
 - Implement re-hammering or additional hammering of spikes, replacement of sleepers or the installation of the gauge tie, *i.e.*, metal to hold the gauge, etc.

- Establish the system that can implement the above two items certainly.
 - Maintain in high priority when defects of sleepers, etc., continued or existed in steep curve with large slack.

- Pay attention to the inner rail side same as for the outer rail side in the management of sleepers and rail fastening devices in the curved section.

- (2) Change of material of sleepers
 - Replace to the concrete sleepers, etc., which is superior in the durability and easiness of maintenance compared to the wooden sleepers.

- (3) Study to shorten slack
 - In order to increase margin against derailment to inside gauge, study in line with the improvement of the track, and shorten in the possible range.

- (1) Change of material of sleepers in around the accident site, etc.
 - Changed to the concrete sleepers and replaced the ballast as the measure to improve the drainage.
- (2) Additional hammering of spikes
 - The number of spikes fastening the outer rail was increased from one to two, in the place of wooden sleepers in the curves of the radius less than 250 m.
- (3) Thoroughgoing of the inspection of sleepers
 - Educated the staffs to pay thoroughly attention to the status of drainage in the inspection of sleepers, etc.

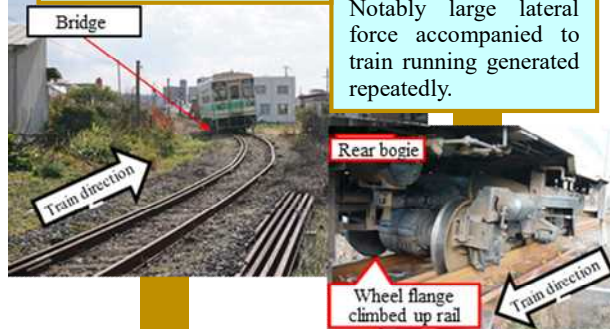
Comprehension on the danger of dynamic gauge widening by the continuous defects of sleepers and rail fastening devices were insufficient.

Insufficient track maintenance.

Continuous corrosion and cracks generated in the sleepers in the curve.

Rail fastening force by spikes decreased continuously.

Gauge dynamically widened largely due to rail tilting, etc., by lateral force by train running.

Slack in relatively large curve.

Decrease margin against derailment to inside gauge.

Large irregularity of alignment in rail joint due to long-term angular rotation.

Notably large lateral force accompanied to train running generated repeatedly.

Fastened number of guard rail to sleepers lacked.

Fastening force of guard rail decreased.

Derailment could not be prevented.

At about 11:00 **Inner rail side wheel fell to inside gauge and the train derailed**

Probable causes : It is probable that left wheels in the first and the second axles in the rear bogie derailed to inside gauge, right side of the left rail, *i.e.*, inner rail, because the gauge had widened largely while the train was passing the 160 m radius left curve, in this accident.

There was the possibility that the gauge widened dynamically by the rail tilting, etc., due to lateral force accompanied to the train running, because the rail fastening force by the spikes had been decreased by the effects of the continuous collision and cracks generated in the sleepers in the curve.

It is likely that the rail fastening force had decreased by corrosions and cracks generated in the sleepers continuously, related by that the company had not been comprehended the danger to cause derailment accident by the dynamically widened gauge due to the continuous defects of sleepers and rail fastening devices, in the inspection for track materials, etc., and the track maintenance responded these situations had not been implemented promptly.

- (1) Review the maintenance standard values
 - Establish the handling when exceeded the maintenance standard value, and to take measures certainly according to it.
 - The maintenance standard value of the gauge shall be increased or decreased corresponding to the slack.
- (2) Proper installation of guard rail, etc.
 - The guard angle shall be installed properly by using tie plate for the section where installed the guard rail, etc.
 - Or study the replacement to the guard angle considering the easiness of the maintenance.
- (3) Inspection of guard rail, etc., and measures when noticed the traces
 - Add the existence of contacted trace with wheel in guard rail, etc., as requiring care item in the periodic inspection, etc.
 - When the trace was found, confirm the existence of abnormality and take measures if there is abnormality.

- (1) Replacement of sleepers and realignment of track
 - Replaced 100 wooden sleepers and spikes to new ones in the section included the accident site, enforced track by supplied ballasts and tamping, realignment of track.

- (2) Review of the slack
 - Changed the slack in the accident curve from 25 to 20 mm, and managed the irregularities based on the new slack.
- (3) Enforced the management system of the track

- (4) Replacement to the guard angle
 - Replaced the guard rail already installed in the accident curve to the guard angle.
- (5) Used the concrete sleepers

- Replaced to concrete sleeper every one of two wooden sleepers, in the curves scheduled to be maintained next to the accident curve.

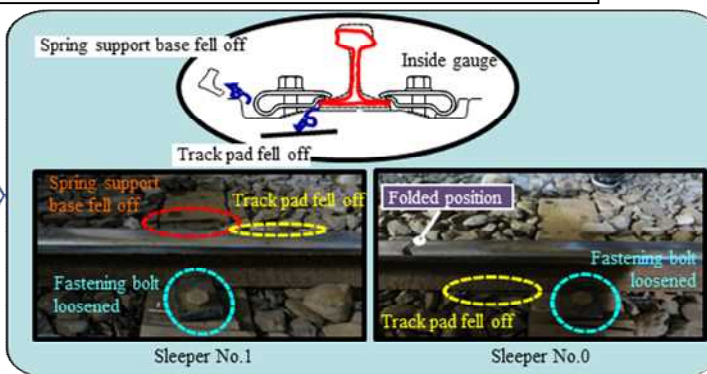
The status that cross-section of rail had been decreased remarkably by corrosion could not noticed.

Missed to find crack in the rail.

Missed to find continuous looseness of rail fastening bolt and removed track pads, in the track where relatively large irregularity of cross level had been existed.

Lateral force in outer rail generated in the curve increased by the existence of relatively large irregularity of alignment.

Rail, outer rail, was folded and damaged.

Derailment coefficient increased due to decrease of outer rail side wheel load and increase of lateral force.

At about 19:25 Outer rail side wheel ran over the rail and the train derailed.

Probable causes : It is likely that left wheel in the third axle in the rear bogie of the train ran over the rail and derailed, because the wheel load decreased significantly and the derailment coefficient had increased while the train was running in the circular curved section in the tunnel, based on the followings.

- (1) The outer rail side lateral force which is generated steadily in the curved track, increased further due to the existence of relatively large irregularity of alignment.
- (2) The loosed fastening bolts of the rail fastening devices and the falling off track pads had been existed continuously, in the track where relatively large irregularity of cross level to promote to decrease wheel load had been existed.
- (3) The left rail, the outer rail, had been folded and damaged when the rear bogie of the train passed.

- (1) On the measures for the folded and damaged rail
 - On the places of leaking water from tunnel, manage properly as to concentrate to confirm the corroded status of rail, including the replacement of rails according to the necessity. It is effective to suppress leak of water from tunnel, and to introduce rust proof treatment which apply antiseptic to rails.
 - Conduct systematic replacement of rails when the corrosion of rails had been deteriorated.
 - Replace rail as soon as possible when deterioration of corrosion of rail was in danger. When replacement was difficult, watch carefully the change of the rail by on-foot patrol and reinforce the rail according to the necessity.
- (2) Implementation of the careful track inspection.
 - Implement careful inspection so as not to overlook continuous looseness of the rail fastening devices and the falling off track pads.

- (1) Replacement of the decrepit rails in the tunnel section.
 - Total 25 rails in five tunnels were judged to be replaced in the status inspection including the rail bottom, and completed to replace all designated rails.

- (2) Certain implementation of track inspection in the tunnel section.
 - Adopted bolt cap with white one line and paint of fitting mark with a marker, in order to find looseness of bolts visually and easily.

- (3) Measures against folded and damaged rails in the tunnel sections.
 - Newly installed the point to measure the corroded status of rails in the place of water leakage in tunnel section, and implemented the status check of rails by the on-foot patrol, etc.

- (4) Measures against the folded and damaged rails in the open section.
 - Reinforced the rails which the flaw was found on the rail head, according to the necessity.

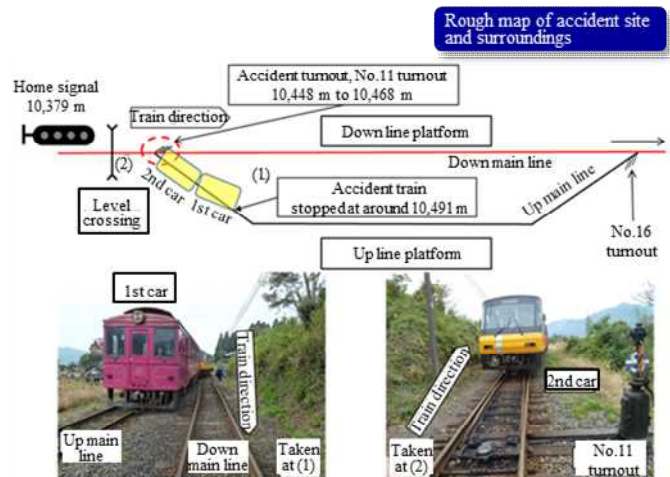
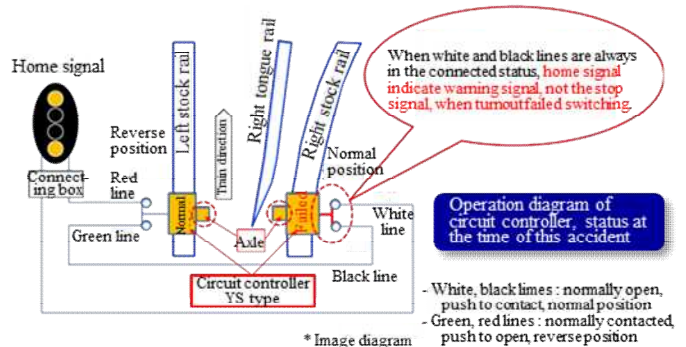
**(1) Defect of switching of the turnout**

It is likely that the switching load exceeded the switching force of the spring switch, due to the increase of the coefficient of friction between the tongue rail and the floor board, caused by **the lack of lubrication to the floor board in the point part of the turnout.**

(2) Signal indication of the home signal

It is highly probable that the home signal did not indicate the stop signal but indicated the speed restriction signal even though the turnout had been in the status of the defect of switching, because **the insufficient contact of the tongue rail could not be detected caused by that the contact point of the micro switch in the circuit control device to detect the defect of switching of the turnout did not switched and in the status as being conducted.**

Probable causes : It is probable that right wheel flange of the first axle of the front bogie of the first vehicle went into the space between right stock rail and right tongue rail, and derailed to right, and the rear bogie of the first vehicle and all bogies of the second vehicle had entered to the up main line side different from the designated direction of travel, because right tongue rail of the turnout did not contact to the normal position side and in the status of the defect of switching, when the train entered the straight line side of the turnout obeying to the indication of the speed restriction signal of the home signal, in this accident.

Required Safety Action : To comprehend the status that the home signal did not indicate the stop signal but indicated the speed restriction signal even though the circuit control device was in the status as could not detect the defect of contact in the home position side, was the dangerous status with the possibility of derailment, and implement the followings.

- (1) Implement the maintenance and the management of changes by years of the circuit control device, certainly.
- (2) Make reliability higher as not to spoil safety even in case of troubles.

Furthermore, it is desirable to implement lubrication to the floor board in the point part of the turnout, considering the status of rains, etc., in high frequency.

- (1) Replaced the spring switch of the accident turnout by the new product.
- (2) Decided the limited speed when passed the accident turnout and No.16 turnout in the premises of B station as 15 km/h or slower, and let the train crews know well, and newly installed the speed limit sign.

- (3) Improved the security level of the circuit control device by making dual system in the home position side of the accident turnout and the No.16 turnout, because the exact signal control could not be implemented. Furthermore, replaced the circuit control device by new one.

- (4) Implemented the switching test of the accident turnout once a month, in order to reinforce the confirmation of safety.
- (5) Increased the number of the lubrication for the floor board in the point part of the accident turnout, certainly in the inspection described in the above (4) and when the effects by rainfalls are considered.

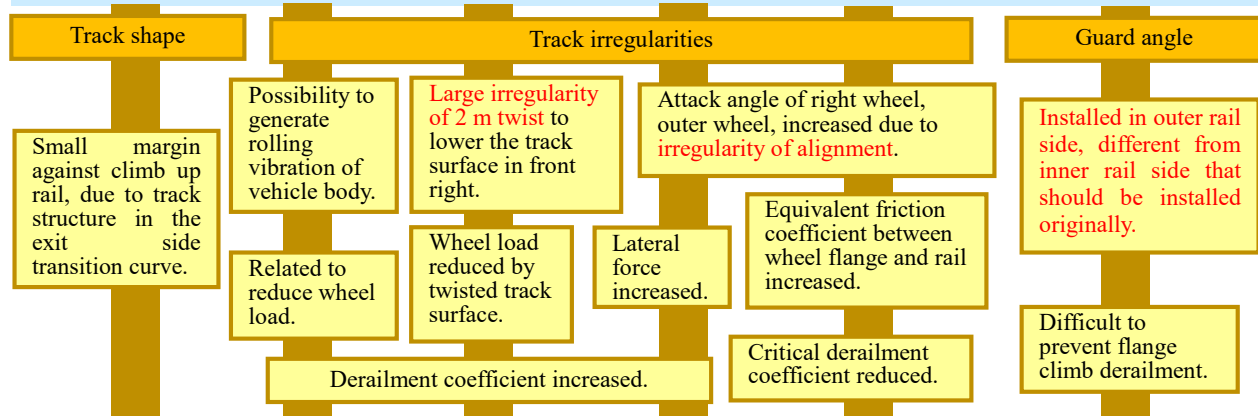
At about 11:58 **Outer rail side wheel climbed up rail and the train derailed in exit side transition curve**

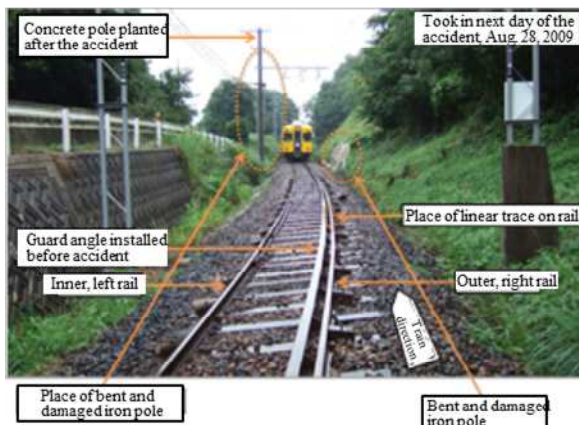
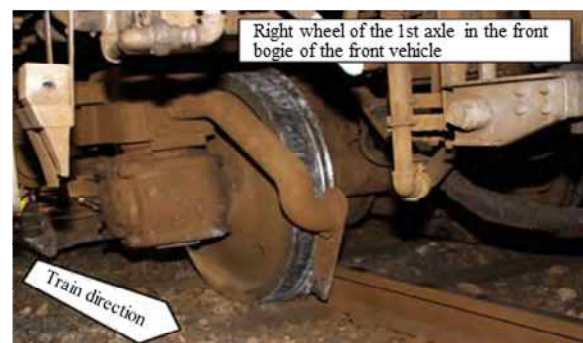
Probable causes : It is probable that right wheel in the first axle in the front bogie of the front vehicle climbed up right rail, outer rail, and derailed to right, because the lateral force had increased and the wheel load had decreased for the right wheel, outer rail side wheel, due to the existence of the irregularity of alignment in the direction to shorten radius of curvature and the irregularity of 2 m twist in the direction to lower front right of the track surface, in the exit side transition curve connected to the 200 m radius curve. In addition, it is highly probable that the derailment could not be prevented because the guard angles had been installed in outer rail side, different from the inner rail side where it should originally be installed.

- (1) Guard angle in this accident site
 - It is highly probable that this derailment accident could not be prevented because the guard angles had been installed in the place different from the place where it shall be installed originally.
 - It is necessary to implement the safety measures of the company by using sufficiently the railway accident investigation reports and the security information, etc., and comprehending the purpose of the measures to prevent the recurrence which should be taken after the accident from the examples of the other accidents.
- (2) Method of track management
 - Comprehend the track irregularities from the results of the track inspection, review to enable the proper management of the track irregularities, and should maintain the track in good condition.

- (1) Installed the guard rail in inner rail side of the accident curve, in addition, installed the guard angles in inner rail side of the curve in eight curved section, with the radius of 200 m or shorter, where the guard angles or the guard rails had been installed only in the outer rail side.
- (2) The company reviewed the track management so as to estimate the track irregularities based on the measured values of the track measurement in the periodic inspection and manage the track irregularities based on the maintenance standard values.
