3. Case Studies of Serious Accidents (3 Cases)

Serious Accident : Case 1

During discharge of copper sulfide concentrate, oxygen-deficient air was inhaled, leading to anoxia

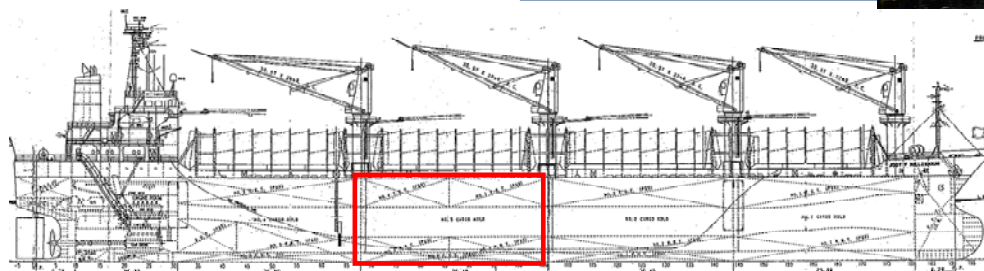
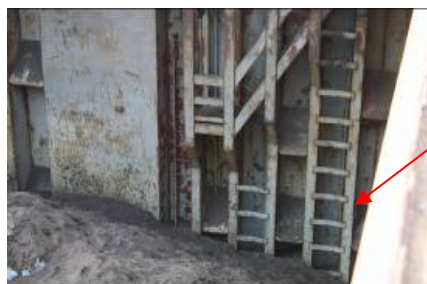
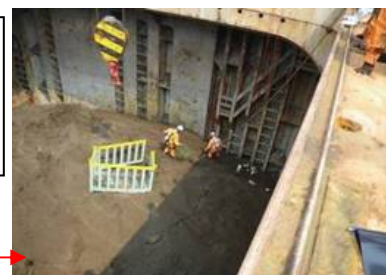
cargo hold No. 3
 Above: general arrangement”(excerpt)
 Left: approach to cargo hold
 Right: rescue operation

While the ship was berthed at the wharf of port of Saganoseki, and Driver B entered cargo hold No. 3 and was descending toward the bottom, he inhaled oxygen-deficient air (*4), developed anoxia and died.

The Foreman, Operator C and Operator F entered cargo hold No. 3 in order to rescue Driver B. The foreman inhaled oxygen-deficient air, developed anoxia and died.
