JTSTB (Japan Transport Safety Board) DIGESTS

Vol. 37 (Issued in October 2021)

Digest of Marine Accident Analyses For prevention of Collision Accidents of Small Vessels —Let's Use AIS—

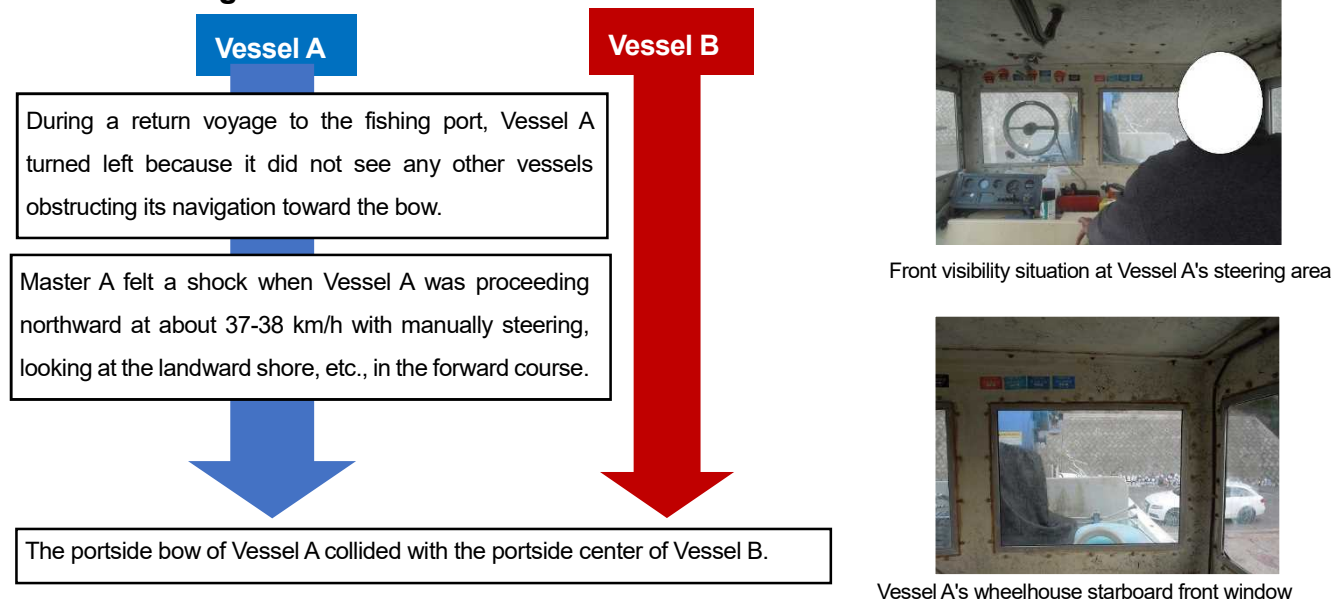
- When Master A stood in front of the helm wheel on the starboard side of Vessel A's wheelhouse, which is the usually maneuvering location, and looked at the forward course, **a wide area in front of the portside was blinded by the crane prop portside.**
- Master A did not accurately understand the blind spot created by the crane prop, and recognized after the accident that **even if he stood at the maneuvering area and kept watch on the forward course as usual, a blind spot would be created in the range of approximately 20 to 30 degrees toward the portside bow.**

Probable Causes : It is probable in this accident that, while Vessel A was proceeding north, Master A **thought that there were no vessels in the forward course that would interfere with navigation**, and continued to **navigate with a blind spot** toward the portside bow, and was unaware that the Vessel was approaching Vessel B, which caused the collision between the portside bow of Vessel A and the portside center of Vessel B.

- After this accident, Master A decided to **assign two persons to watch over Vessel A in order to eliminate a blind spot** caused by the crane in the forward way watch.
- The operator should be on watch **with an accurate understanding of the blind spots** created by the structures on deck.
- When a blind spot caused toward the bow of the vessel, the operator should **keep a lookout to compensate for the blind spot** caused by constantly swinging the bow to the left or right, or by moving from the maneuvering location whenever possible, rather than keeping a lookout from a single location.

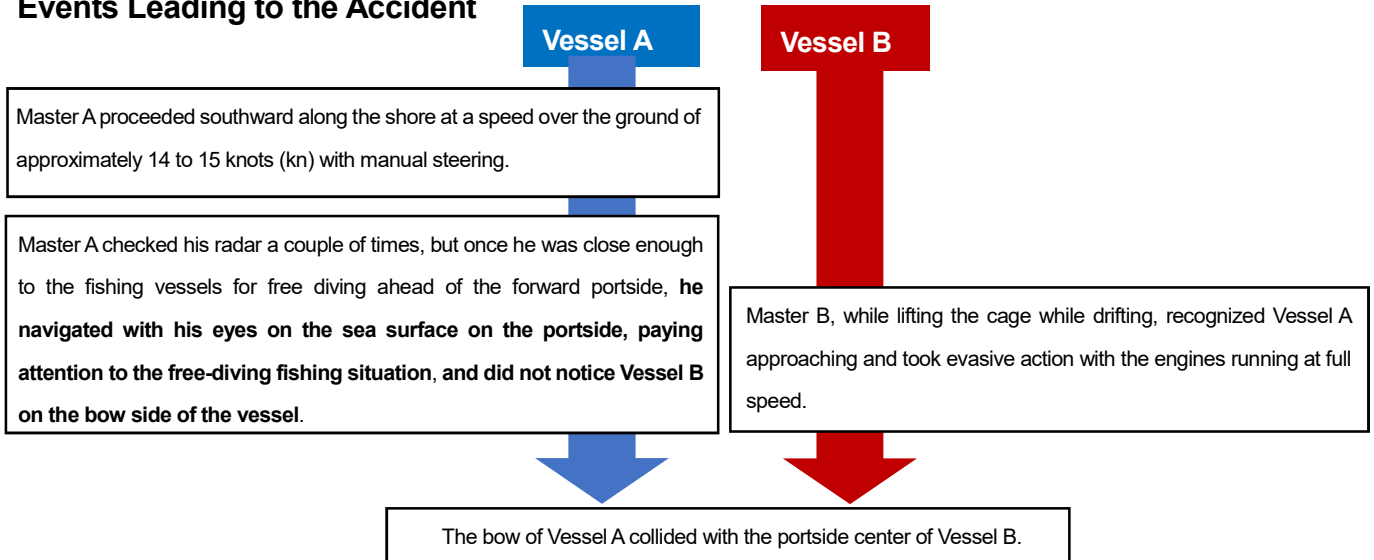
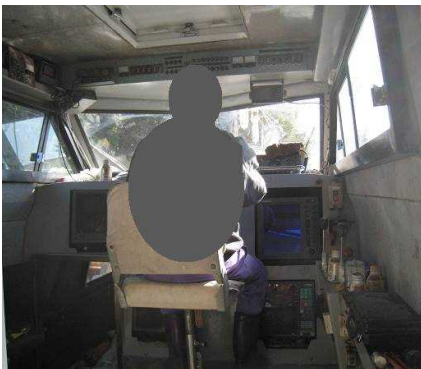
Maneuvering situation of Master A
(reproduced)

Probable Causes : It is probable that, Vessel A was collided with Vessel B because while the vessel A proceeding south, Master A **continued to navigate** visually **observing the situation of free-diving fishing** near the portside, and **did not notice Vessel B on the side of bow**, It is probable that while Vessel B was lifting its baskets while drifting, Master B saw Vessel A approaching and took evasive action with full ahead, but Vessel B collided with Vessel A despite this action.

• Keep a proper watch on the surroundings at all times, because **paying too much attention to a particular object may cause you to miss other vessels or objects in the surroundings.**

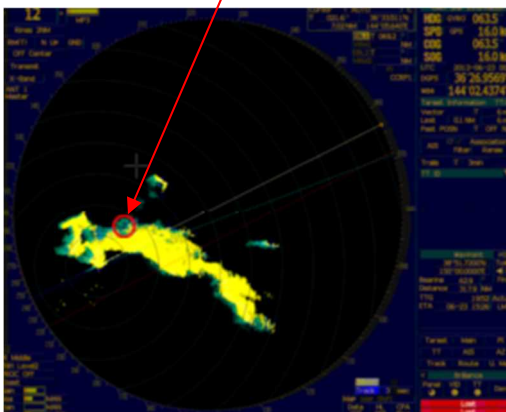
Radar image of Vessel A

(Images of other vessels are not recognized)

- Third Officer A did not notice Vessel B due to **the lack of images of Vessel B on the radar screen affected by the rainfall.**
- Ordinary Seaman B was on visual watch in the lookout room with a blind spot caused by the wall, and did not notice Vessel A because **Vessel A was approaching from approximately 83° on the starboard bow, which was a blind spot caused by the wall.**
- Ordinary Seaman B could see the radar screen, but had no authority to adjust the radar.
- Both vessels **were not conducting acoustic signaling** in the restricted visibility conditions.

- When a restricted visibility condition occurs, the management company of vessel A should **increase the number of bridge duty personnel** and familiarize the crew of the operating vessels with **the acoustic signals to be made** during the restricted visibility condition.
- In the event of a restricted visibility condition, the owner of Vessel B should **report to the master and reinforce the personnel on bridge duty**, as well as **establish a system for acoustic signaling** in the restricted visibility conditions on the operating vessel. It is also desirable to **equip** the operating vessel **with an AIS.**
