Case 2: Weather (Wind)

Date and Time of Occurrence: Around 13:04, July 27, 2014

Type : Beaver RX550-R503L (rudder surface controlled ultralight plane)

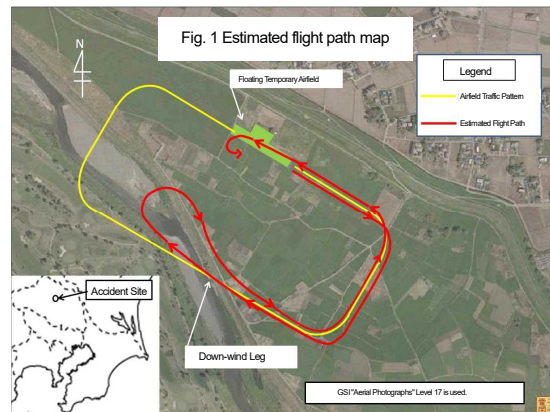
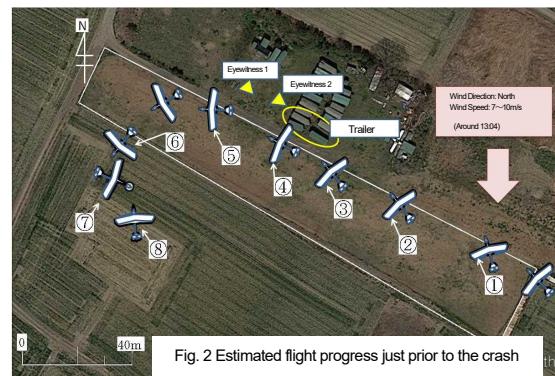
See Figure 2 for (1) to (8)

Aircraft deflected to the right.

The nose suddenly deflected to the right (1).
Weathervane effect due to strong right crosswind

Nose-up attitude near stall speed

Flying with the right wing tip grazing the trailer (4)

The aircraft tilts sharply to the left.(5)

Left wing tip (6) and the nose (7) grounded.

Crash(8)

Step on left rudder → unable to correct properly
Considering go-around, but because the angle of approach was appropriate and altitude was decreasing, the approach was continued.

Step on left rudder → Nose direction not easily corrected (2)

Danger of colliding with a trailer
Decided to go-around

Increase engine power and pull back on the control stick (3)

Step heavily on left rudder to avoid collision

- When rudder is stepped heavily near the stall speed, the aircraft enters a spin in the direction of the rudder step.
- Since propeller rotation direction is clockwise when viewed from behind, nose tends to turn to the left due to increased engine power.

- In a slow nose-up condition near stall speed, the pilot stepped heavily on the left rudder. It is probable that this was due to the pilot's attempt to avoid a collision with the trailer.
- The aircraft went close to the trailer, probably due to the pilot's inability to properly steer the aircraft, which was deflected to the right by a strong right crosswind.
- It is probable that the fact that the trailer was placed in an area which should have been free played a role in the go-around maneuver.
- Since large corrective maneuvers just before ground contact are dangerous, the pilot should have considered go-around when the nose deflected to the right.

During landing go-around, the pilot increased the engine power at a low nose-up speed near the stall speed. In this situation, the pilot stepped heavily on the left rudder, which probably caused the aircraft to lose altitude and tilt sharply to the left and to have crashed.
