JTSB (Japan Transport Safety Board) DIGESTS

No.41 (Issued in February 2023)

## Digests of marine accident analysis

# Safe navigation of recreational fishing vessels For prevention of accidents involving vertebral fractures of anglers

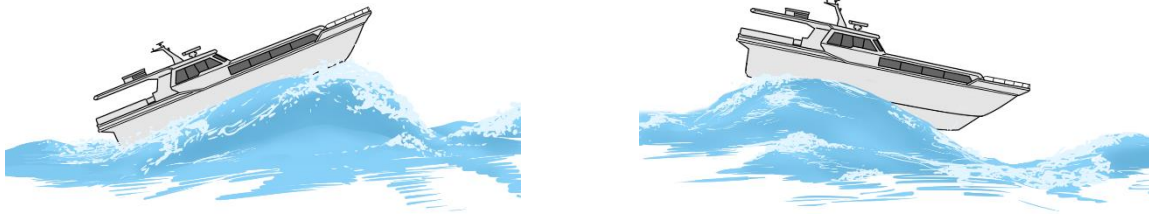
This type of accidents is caused by **pitching of the ship's body**. When the ship's body pitched up and down and the bow is lifted, bodies of the anglers were lifted up and fell.

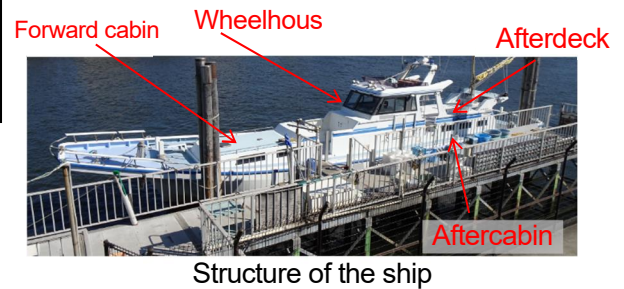
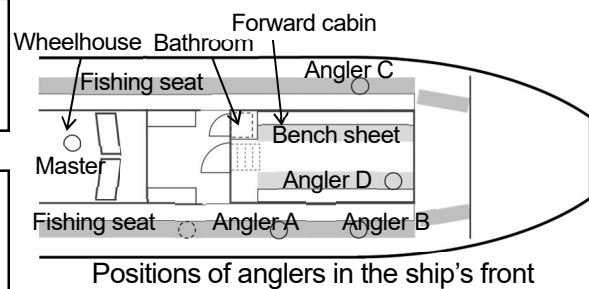
- Even after heavy surges were observed, the master **made an announcement prior to the arrival as usual** and allowed anglers to choose a waiting position, because the wave height was low and **heavy pitching and rolling were not felt after reducing the speed.**
- The master **could not feel heavy pitching and rolling at the bow** when the anglers were injured, because the master navigated the Vessel in the wheelhouse near the midship area and did not see how Angler A and Angler B on the starboard front.

**Cause:** In this accident, it is supposed that Angler A and Angler B who sit on the fishing seat on the starboard front were lifted up and then fell and their buttocks hit the fishing seat, because the starboard bow of the Vessel, while heading toward south-southeast at the speed of approximately 15 knots, pitched due to heavy surges.

- The masters and operators of recreational fishing vessels must **set standards for moving anglers to the stern side from the midship such as wind direction, wind speed, wave direction, and wave height (with respect to the vessel speed).**

- If the standards are exceeded while sailing, the masters and operators of recreational fishing vessels must **ensure safety by stopping to sail or reducing the speed sufficiently and then move anglers to the stern side from the midship.**

- The masters and operators of recreational fishing vessels must obtain information on winds and waves of sea areas where they plan to sail. If the standards are exceeded, the masters and operators of recreational fishing vessels must **set sail after verifying that anglers have moved to the stern side from the midship.**

- The masters of recreational fishing vessels, etc. must **comply with the operational rules (regulations on prevention of accidents involving injuries due to pitching and rolling).**

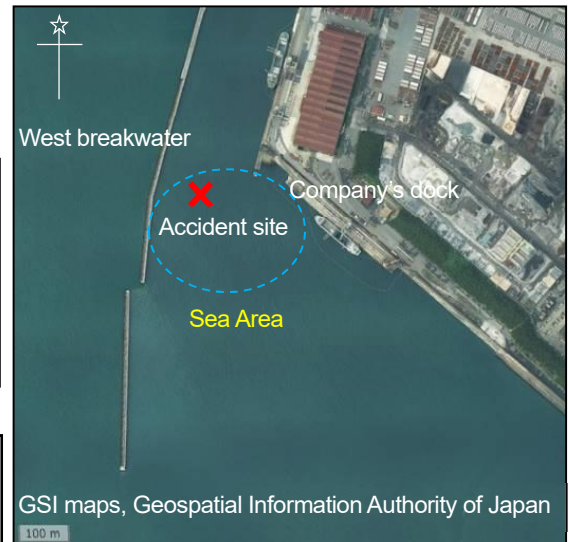
State of the Sea Area

- The master **has a lot of experience in sailing the Sea Area and knew that waves are higher than the coast.**
- According to the master’s experience, no angler on the forward deck has been injured in the past while sailing on the Sea Area.
- The master **thought that it was possible to safely sail by reducing the speed and did not move the anglers on the forward deck to the afterdeck.**

When waves hit a cliff coast or artificial breakwaters, it is possible that waves are bounced back and change their direction. This phenomenon is called reflection. In this case, **if the top of incident waves and that of reflective waves overlap, the height of waves can reach nearly twice as high as the original wave height.** (Japan Meteorological Agency’s website)

**Cause:** In this accident, the master continued to sail with 3 anglers on the forward deck, while the ship headed toward northwest on the Sea Area. The body of 3 anglers was hit on the deck when wave directions varied and the ship’s body pitched by receiving waves of approximately 1.0m.

- The masters of recreational fishing vessels must **check the ocean surface** while sailing and strive to control pitching and rolling due to waves by **sufficiently reducing the speed** or by other means. If waves are generated in a **sea area surrounded by breakwaters and docks**, it is possible that **wave directions vary due to reflection and the wave height rises.**
- The masters of recreational fishing vessels must **move anglers to the cabin or afterdeck** if pitching and rolling are expected.
- The masters of recreational fishing vessels must **promptly check** if there is any injured passenger, and **immediately take appropriate measures such as calling an ambulance** in cases where it is confirmed that any passenger is injured.
