3. Cases of the accident investigations (train derailment accident/level crossing accident)

Case (train derailment accident: gauge widening) Occurred at about 18:52 on April 14, 2019

Train derailed by the rail tilting, etc., due to the continuous defects of the sleepers and rail fastening devices

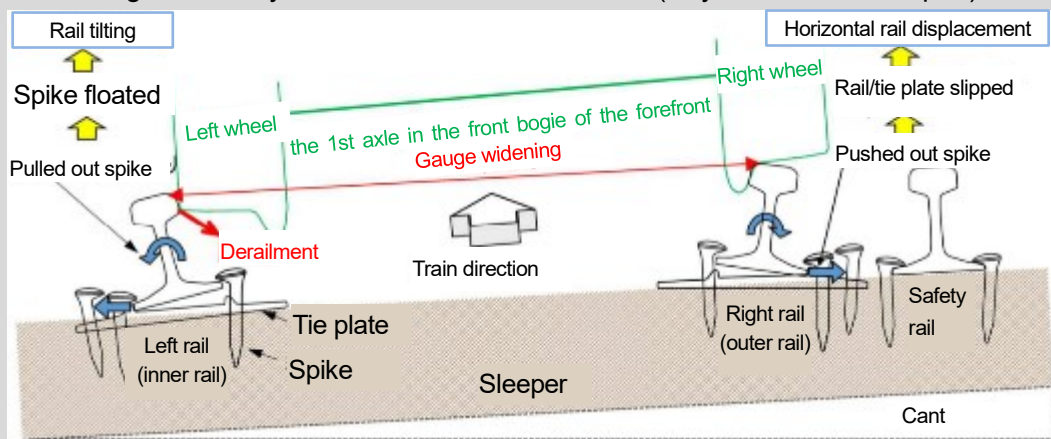
Figure 9: Image of derailment inside gauge of this accident

Dynamic gauge widened large due to rail tilting, etc., by the continuous defects of the sleepers and rail fastening devices.		The static irregularity such as the rail tilting occurred, with that the maintenance standard value for the irregularity of gauge was larger than the appropriate value at the point where the derailment started.
<div style="display: flex; justify-content: space-around; align-items: center;"> <div style="text-align: center;"> </div> <div style="text-align: center;"> </div> <div style="text-align: center;"> </div> </div> <p style="text-align: center; font-weight: bold;">Train derailed due to gauge widening</p>

It is probable that the concerned accident was caused as that the left wheel of the 1st axle in the front bogie of the forefront vehicle fell to inside gauge because the gauge widened significantly while the train was passing through the 160 m radius left curved track. As for the significantly widened gauge, it is probable that the gauge widened dynamically by the rail tilting, etc., due to the lateral force caused by the running train, because of the large static irregularity of gauge and the continuously existed poor sleepers and the poor rail fastening status in the concerned curved track. It is probable that the static irregularity of gauge had been large, related with that the maintenance standard value for the irregularity of gauge was larger than the appropriate value because the slack had not been considered. It is probable that the poor sleepers and the poor rail fastening status had been continuously existed, related with the insufficient repairing works for the sleepers and the rail fastening devices due to the inadequate records and measuring methods in the sleeper inspections. **The insufficient implementation of the measures responding to the opinion for the purpose to prevent the train derailment accident due to the wide gauge, issued by the Japan Transport Safety Board issued on June 28, 2018.**

- (1) Replace to PC sleepers in the steep curves

The aged wooden sleepers were replaced with the PC sleepers in the accident site. Moreover, the **wooden sleepers were replaced with the PC sleepers in a way that the ratio of PC sleepers becomes 1 out of 3 sleepers** in the steep curves whose radius is less than 250 m. In cases where it is difficult to install PC sleepers, a plan to install gauge ties was formulated. It should be noted that, until this work completes, the gauge is measured and the rail fastening devices are inspected once every three months.

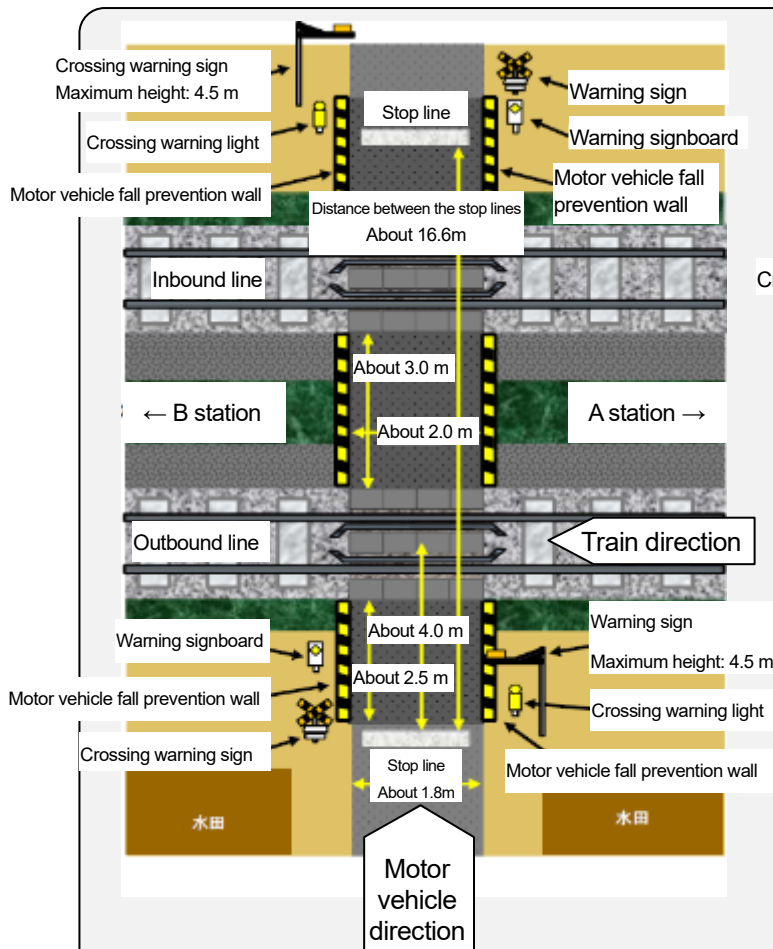
Figure 11: The level crossing where the accident occurred

Probable causes: It is highly probable that the accident occurred as the train collided with the automobile because the automobile entered the C level crossing (class 4 level crossings), class 4 level crossings without automatic barrier machine nor road warning device, in the situation that the train was approaching.

The class 4 level crossing, that is not equipped with the automatic barrier machine nor the road warning device, should be abolished or should be equipped with the level crossing protection device. Four accidents, including the concerned accident, had occurred since 1997 at this level crossing, where the passing trains have been operated in high speed in heavy railway traffic, and the crossing road was long as located in the double track section. Therefore, the relevant persons such as the railway operators, the road administrators, the regional inhabitants, etc., are required to discuss on the abolishment or the preparation of the level crossing protection devices, decide the policy as fast as possible, and promote the concrete measures, considering that the concerned level crossing is highly dangerous.
