## Case 2

### A crew member who was engaged in cargo unloading entered a cargo tank and died of suffocation caused by oxygen deficiency

Outline: At around 13:55, March 10, 2010, while the Vessel (same as the vessel in Case 1) was unloading about 380 tons of chemical liquid cargo containing tert-butyl alcohol (TBA) at the consignee's No. 2 pier (the Pier) in Kawasaki Section of Keihin Port, the chief officer who was engaged in cargo unloading entered portside No.2 cargo tank (the Tank), and died of suffocation caused by oxygen deficiency.

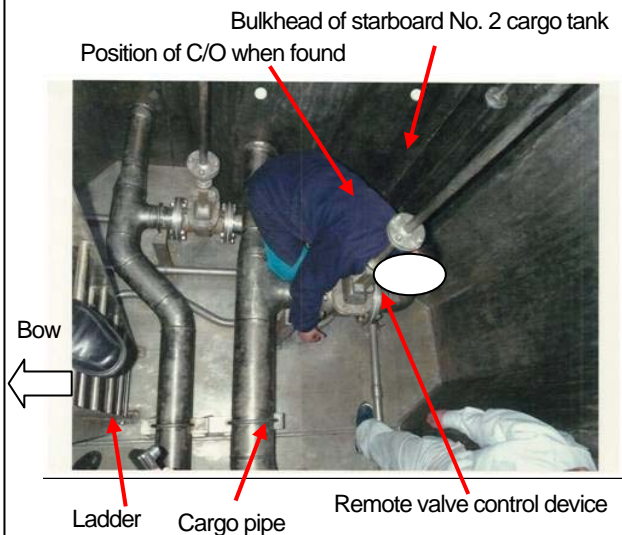
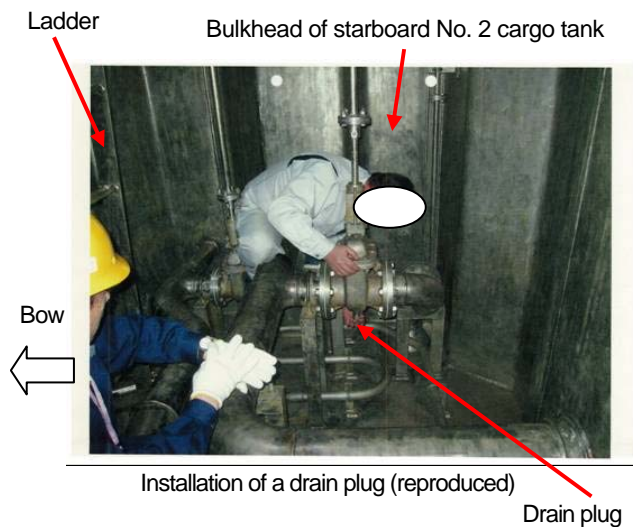
### Reproduction of the Accident Site

According to the findings that the drain plug was not restored in the drain hole of the cargo pipe inside the Tank, it is considered probable that air was absorbed through the drain hole while unloading, and it became unable to transfer TBA.

According to the findings that although the gas concentration inside the Tank was 16% at around 14:23, C/O stopped moving at around 13:55 soon after picking up the drain plug and fixing it in the drain hole by screwing it three times, it is considered somewhat likely that the gas concentration near the drain hole was not so high as to cause instant death, but to the extent of causing the loss of consciousness in a short time (10% or less).

✓ Drain plug: Although once removed for undergoing a pre-loading inspection, the drain plug should have been restored in the drain hole to prevent air from being absorbed while unloading.
