**AIRCRAFT SERIOUS INCIDENT
INVESTIGATION REPORT**

April 27, 2017

JAPAN AIR SELF-DEFENSE FORCE
ROTORCRAFT, CH - 47J, 57-4493
ALL NIPPON AIRWAYS CO., LTD.
BOEING 737-800, JA80AN
JAPAN TRANSOCEAN AIR CO., LTD.
BOEING 737-400, JA8938
LANDING ON THE RUNWAY BEFORE VACATING OF THE
AIRCRAFT THAT REJECTED TAKE-OFF
NAHA AIRPORT
AT 13:24 JST, JUNE 3, 2015

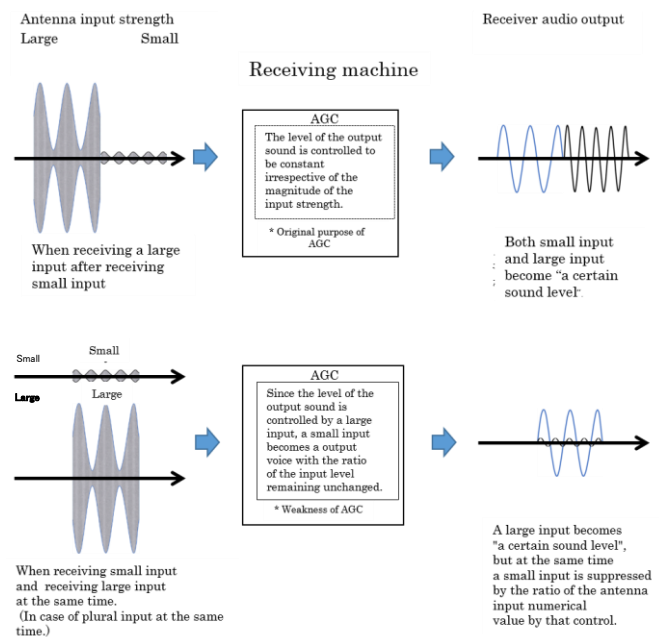
Figure 2: Objectives and weakness of AGC

Automatic gain control functions (AGC, see Fig2) are installed in the radio telephone receiver used for ground reception facilities for ATC communications in order that the receiver audio output becomes constant even if the antenna input strength changes. With this AGC, even if there is a difference in antenna input strength from each aircraft, Air Traffic Controllers and others can hear at a certain sound level (the purpose of the AGC).

On the other hand, because a function of this AGC controls the receiver output by large antenna input when plural aircraft transmit a message at the same time, the receiver output by small antenna input remains small (a weakness of the AGC). As the antenna input difference becomes larger, the receiver audio output with small antenna input becomes smaller, it may be suppressed to a level that cannot be heard at all. If the difference in antenna input strength is small, in many cases, transmission contents cannot be heard due to deterioration of voice quality or generation of noise due to the beat phenomenon, the received air traffic controller and others can be recognized that there was the simultaneous transmission.

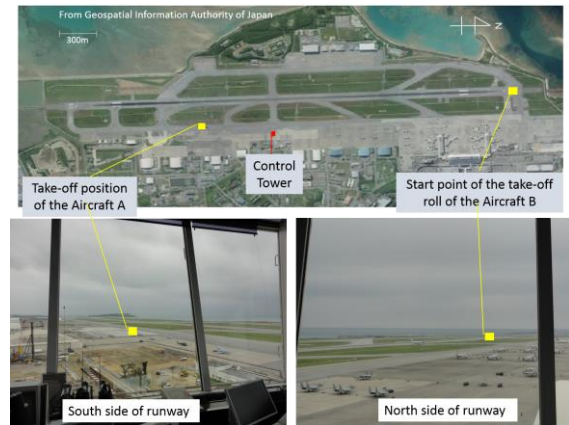
Photo 4: Position relationship of the Control Tower, Aircraft-A and Aircraft-B

The active runway when this serious incident occurred was the Runway 18, the position at which the Aircraft B commenced take-off roll and the position at which the Aircraft C landed was on the right side as seen from the control Tower, and the taxiway where the Aircraft A took off was on the left side as seen from the control Tower. (See Photo 4)

As described in 2.1.2 (2), the Aircraft A took off from the Taxiway A-5 parallel to the Runway 18 while hovering the nose toward the take-off direction. In this case, it is probable that the Pilot who was seated in the right-seat could not sufficiently visibly recognize the condition of the take-off and landing aircraft on the runway.

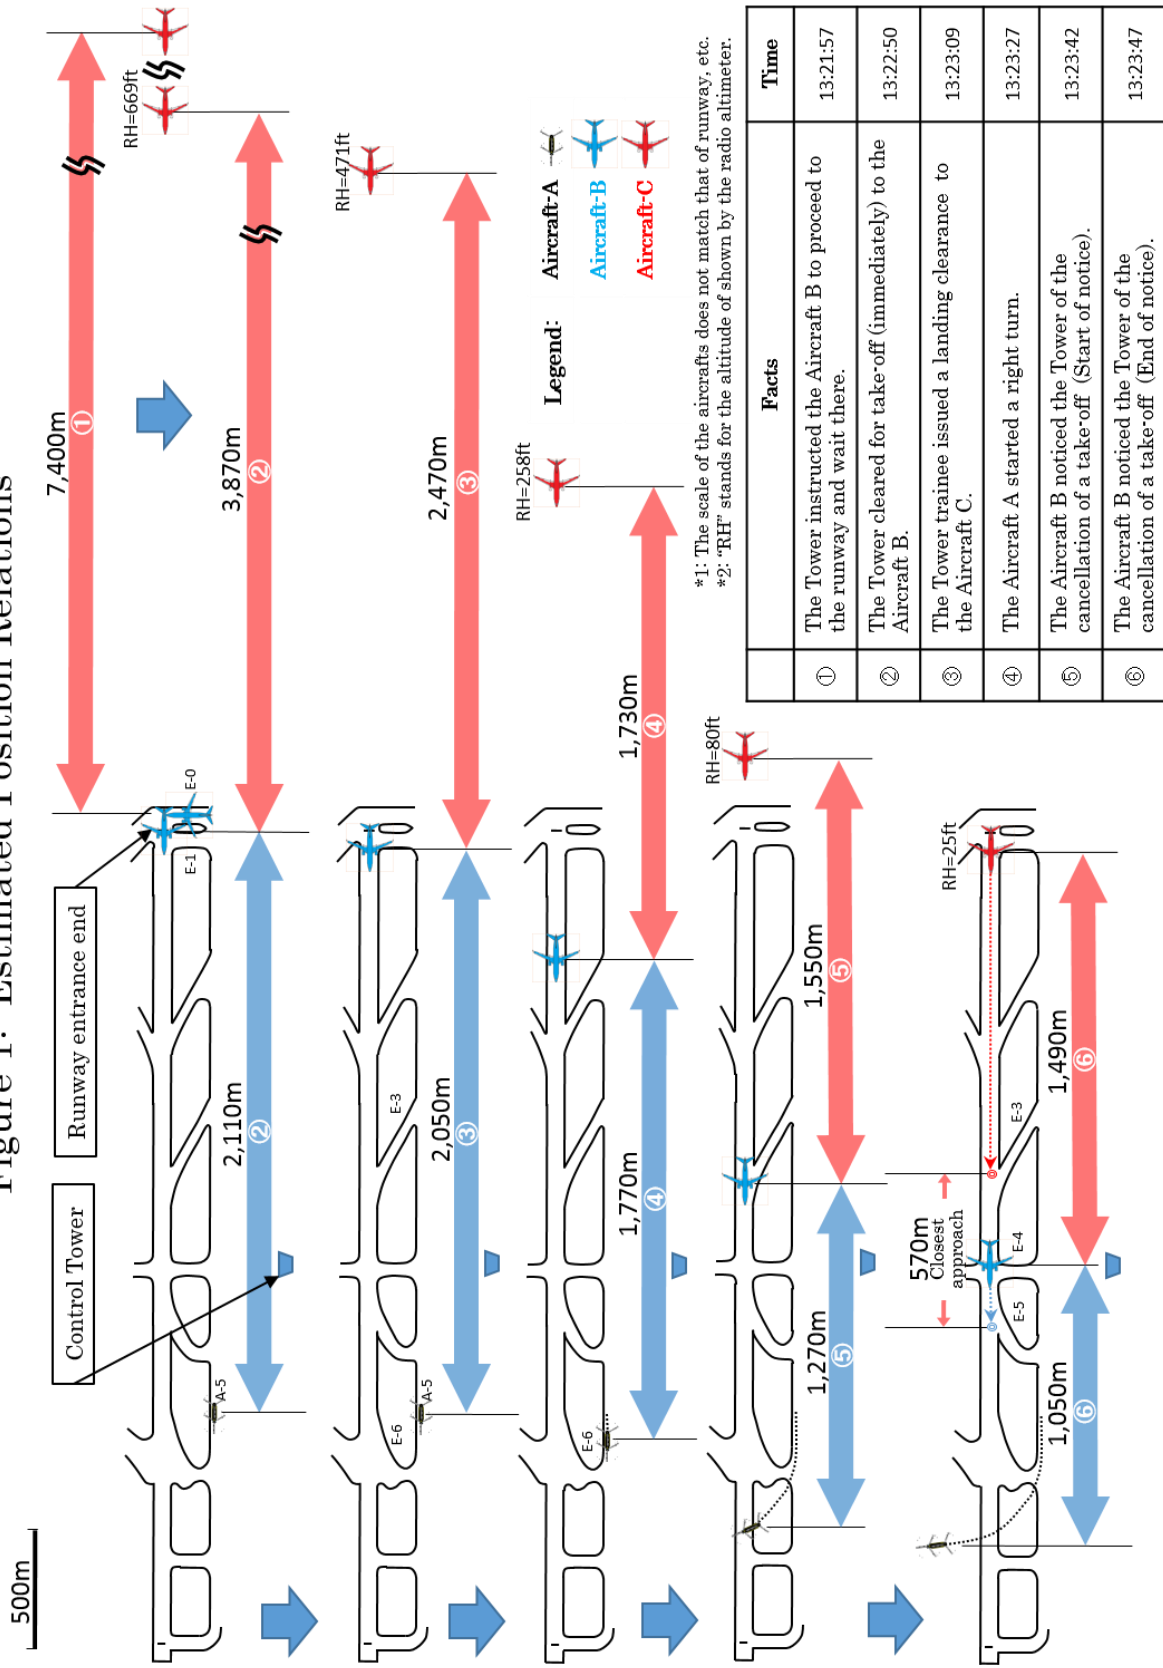
Figure 1: Estimated Position Relations

Facts	Time
①	The Tower instructed the Aircraft B to proceed to the runway and wait there.	13:21:57
②	The Tower cleared for take-off (immediately) to the Aircraft B.	13:22:50
③	The Tower trainee issued a landing clearance to the Aircraft C.	13:23:09
④	The Aircraft A started a right turn.	13:23:27
⑤	The Aircraft B noticed the Tower of the cancellation of a take-off (Start of notice).	13:23:42
⑥	The Aircraft B noticed the Tower of the cancellation of a take-off (End of notice).	13:23:47
