**AIRCRAFT SERIOUS INCIDENT  
INVESTIGATION REPORT**

**KAWASAKI HEAVY INDUSTRIES, LTD.  
7033**

**June 30, 2022**

RUNNING OFF THE SIDE OF A RUNWAY  
KAWASAKI HEAVY INDUSTRIES, LTD.  
P-1 FIXED WING PATROL AIRCRAFT, 7033  
GIFU AIRFIELD  
AT ABOUT 16:00, SEPTEMBER 7, 2021

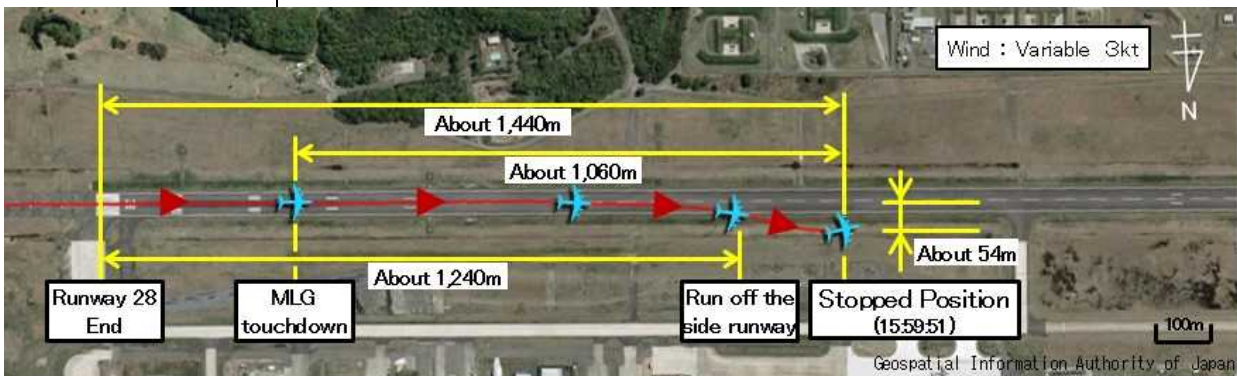
Figure 2: Estimated ground track  
 (2) Statements of the captain, the FO and the flight engineer  
 Although the captain recognized that the travel direction of the Aircraft changed to the right around the time when the reverser levers had

After landing on Runway 28 (runway direction: 281°) at Gifu Airfield at about 15:59JST (JST: UTC+9 hours; unless otherwise noted, all times are indicated in JST in this report on a 24-hour clock), the Aircraft came to stop in the grassy area located on the right side (north side) of the runway and was disabled to perform taxiing. The crew members disembarked the Aircraft by themselves, and no one was injured.

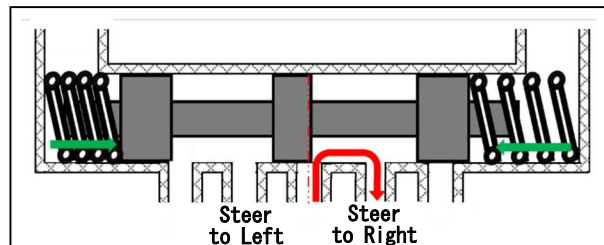
Figure 5: Null Position of the Spool of the Aircraft

On the other hand, the JTSB concludes that the neutral position of the spool most likely remained the position where the hydraulic oil would flow in the right steering direction because it was confirmed that the hydraulic oil would flow in the right steering direction with no electric signals from the SCU (see Figure 5).

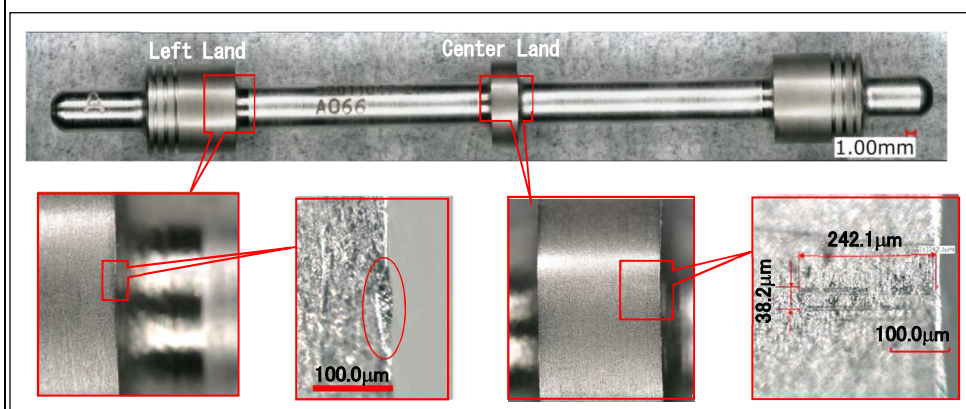
Figure 6: Scratch Marks on the Spool

Furthermore, part of the scratch marks on the right side of both the left land and the center land of the spool (see Figure6) likely resulted from foreign objects caught between the sleeve and the spool when the spool moved in the right direction (in the left steering direction).

From the above, the JTSB concludes that regardless of the pilots' operations, the steering angle more likely continued to change to the right because the foreign materials caught between the sleeve and the spool of the SCV and restricted the spool movement while the neutral position of the spool had remained the position where hydraulic oil would flow in the right steering direction.

The scratch marks found in the detailed examination of the steering systems after this serious incident were too small to determine the materials of foreign objects that caused the scratch marks on the spool.

The foreign objects most likely got mixed into the SCV during the SCV manufacturing process or an aircraft assembly process because the Aircraft was brand-new immediately after production.

On the other hand, since the materials not used in the steering systems were found in the mixed foreign objects, they most likely got mixed during the aircraft assembly process such as jointing between the SCV and S-ACT joining.

- (1) Measures to protect steering systems from contamination caused by foreign objects
  1. They requested the Manufacturer of the Parts to clearly specify in the work instructions about the cleaning operation for each component performed in production job site.
  2. They implemented education for persons in charge of work so as to fully enforce preventive measures against contamination by foreign objects when those related works are performed during aircraft manufacture and regular maintenance.

In order to ensure capturing of foreign objects in the function test of steering systems during the manufacturing process, they increased the number of times of steering operation with the SCV return port filter removed.

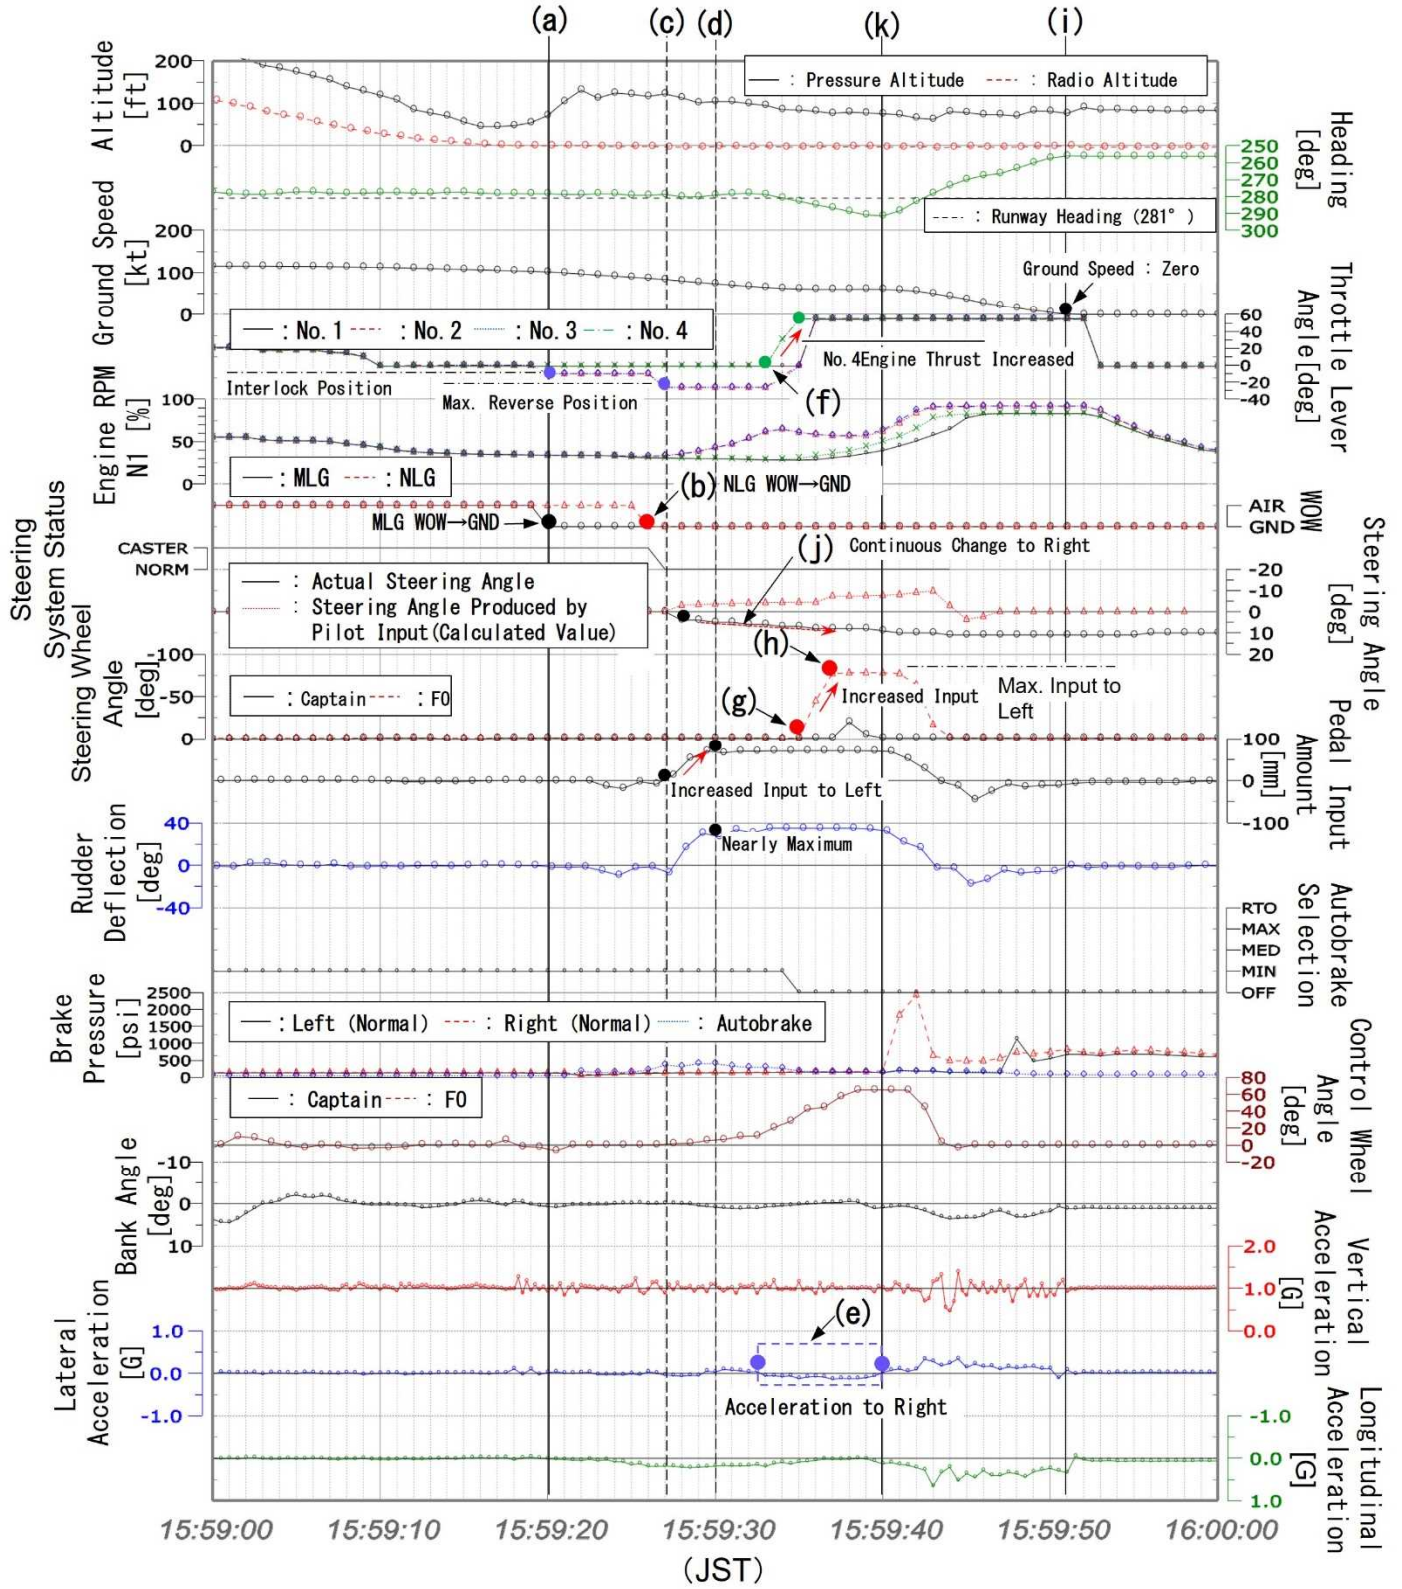
Appended Figure Records of Flight Recorder and OMC

Time	Flight Recorder	OMC
15:59:20	<ul style="list-style-type: none"> <li>• The WOW* 3 of main landing gear changed to the Ground Mode.</li> <li>• The reverser levers for No.2 and No. 3 engines were in the interlock position*4. (See (a) in Appended Figure).</li> <li>• Heading: 278°</li> <li>• Ground speed: 102 kt</li> </ul>

15:59:26	<ul style="list-style-type: none"> <li>• The WOW of nose landing gear changed to the Ground Mode. (See (b) in Appended Figure)</li> <li>• Heading: 279°</li> <li>• Ground speed: 87 kt</li> </ul>

15:59:27	<ul style="list-style-type: none"> <li>• The position of the reverser levers for No.2 and No. 3 engines were set at the maximum.</li> <li>• The left rudder pedal input increased. (See (c) in Appended Figure.)</li> <li>• Heading: 279°</li> <li>• Ground speed: 84 kt</li> </ul>

change to the left were almost maximized. (See (d) in Appended Figure.) • Heading: 279° • Ground speed: 73 kt	
15:59:31	“It’s veering awfully.” (Captain)

15:59:33	• The acceleration to the right continued. (~ 15:59:40) (See (e) in Appended Figure.) • The no.4 engine throttle lever angle increased in the direction to enlarge the thrust. (See (f) in Appended Figure.) • Heading: 279° • Ground speed: 67 kt	• Steering angle: Right 6°

15:59:35	• Heading: 282° • Ground speed: 62 kt	• The status of autobrake selection was set to “OFF”. • The steering wheel angle for the right pilot seat changed to the left. (See (g) in Appended Figure.) • Steering angle: Right 7°

15:59:37	• Heading: 287° • Ground speed: 61 kt	• The operation to the left on the steering wheel of the right seat pilot side became its maximum. (See (h) in Appended Figure.) • Steering angle: Right 8°

15:59:40	• Heading: 291° • Ground speed: 61 kt	• The right brake pressure rose. (~ 15:59:42) • Steering angle: Right 10°
15:59:51	• Ground speed became zero. (See (i) in Appended Figure.) • Heading: 256°
