AI2008-1

AIRCRAFT SERIOUS INCIDENT INVESTIGATION REPORT

**TRANSMILE AIR SERVICES (Malaysia)
McDonnell Douglas MD-11F, 9M-TGS
OVER THE SEA 30km SOUTHWEST OF CAPE ASHIZURI, KOCHI
PREFECTURE (Japan)
JANUARY 10, 2007**

**Aircraft and Railway Accidents Investigation Commission
Ministry of Land, Infrastructure and Transport**

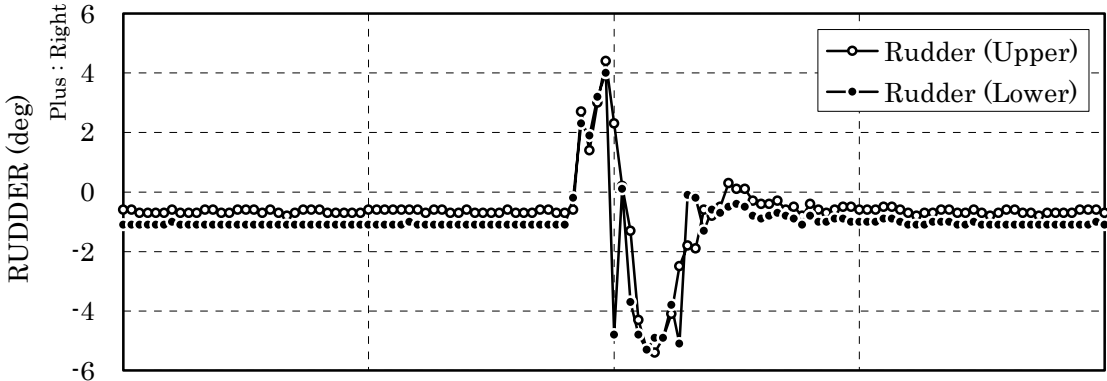
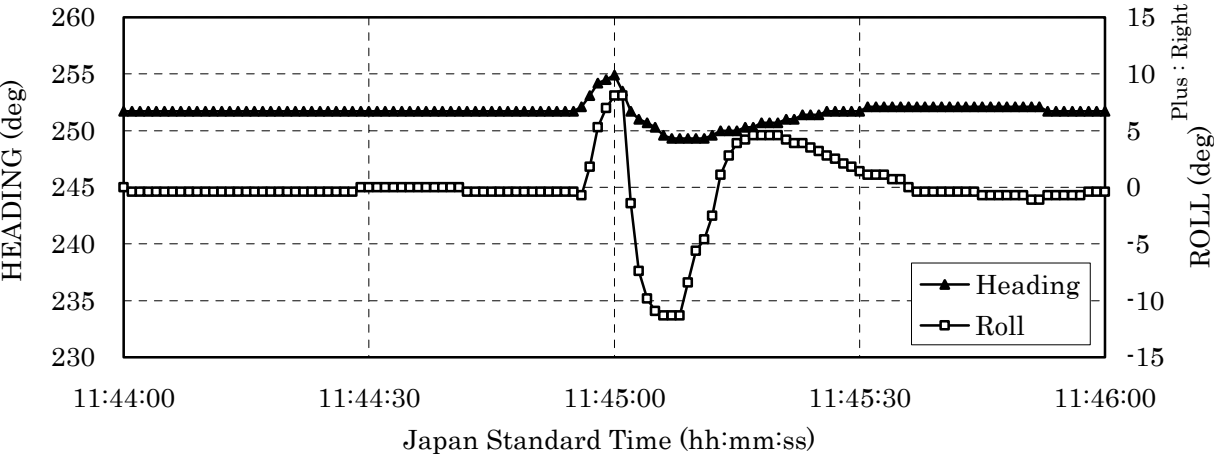
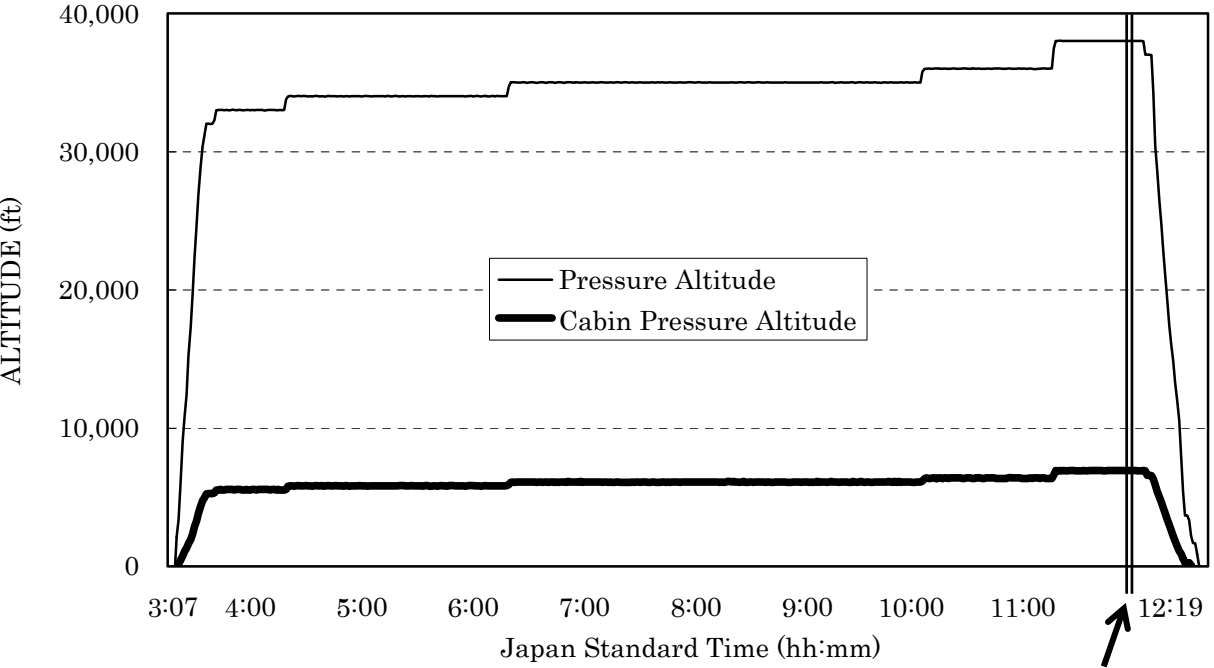
Figure 3 DFDR Data

The aircraft was flying by autopilot when the serious incident took place, and the data recorded during the period from 11:44:56 to 11:45:10 indicates rudder movement of approximately 4° at the maximum to the right and 5° at the maximum to the left, roll attitude change of approximately 8° at the maximum to the right and 11° at the maximum to the left, and heading change of approximately 3° at the maximum to the right and 2° at the maximum to the left. The cabin altitude at that time was recorded as approximately 7,000 ft. (See Figure 3)

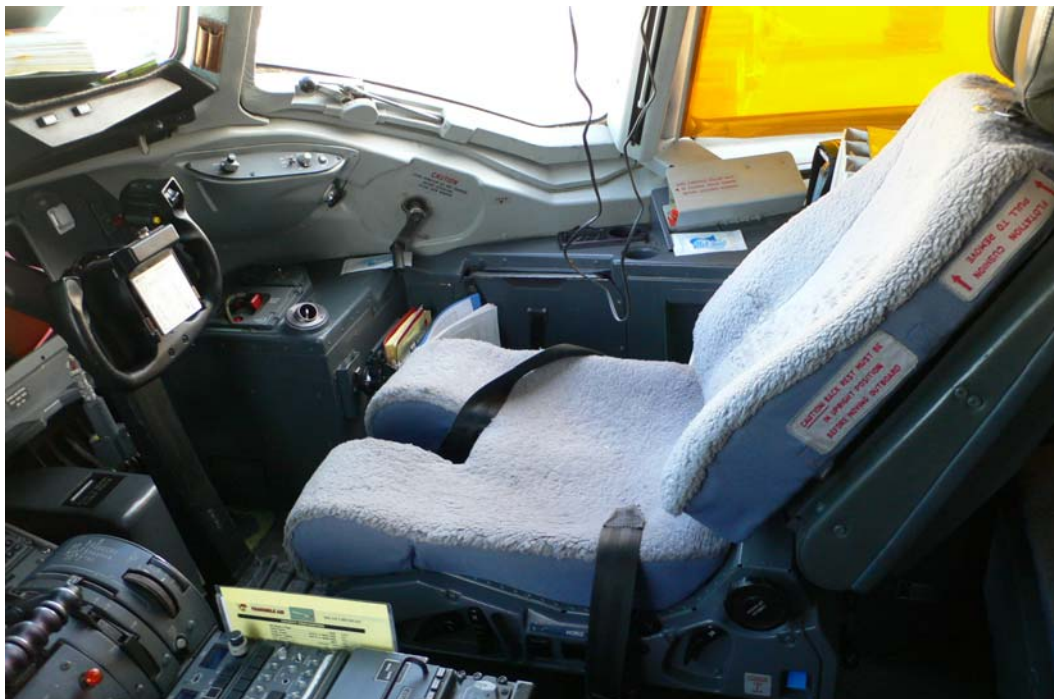
Photo 2 Left seat where "SIC" seated
(Pulled backward, leaned back support)
