**AIRCRAFT ACCIDENT  
INVESTIGATION REPORT**

**TIGERAIR TAIWAN  
B 5 0 0 1**

**CABIN CREW MEMBER INJURY BY THE AIRCRAFT SHAKING**

**AIRBUS A320-232, REGISTERED B50001**

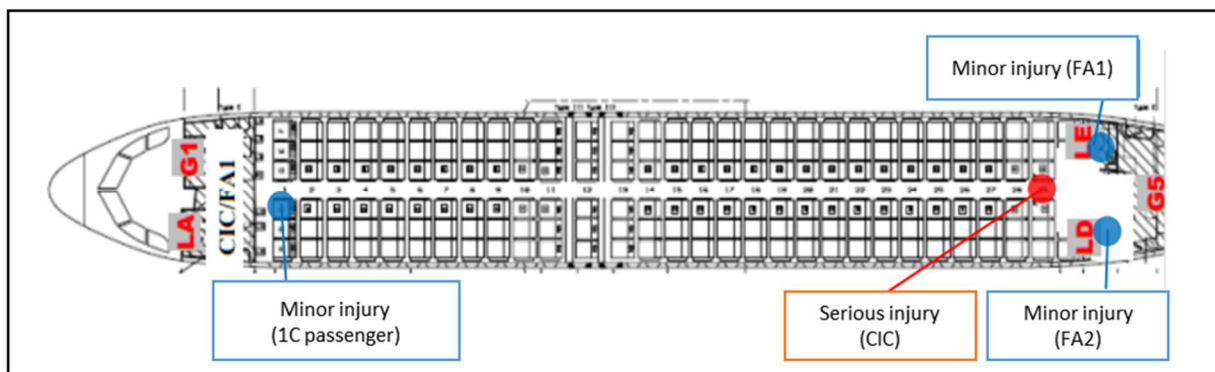
- There were many things scattered such as foods, etc. in the cabin.
- A passenger sitting in the seat 1C sustained a minor lumbar injury, and there was no passenger else injured.
- CIC (Crew in Charge) performing safety check in the aft passenger cabin fell and had the ankle sprained when the CIC began walking forward to return to a cabin crew seat (hereinafter referred to as “the Jump Seat”) in the forward as seatbelt sign was illuminated.
- FA1 (a cabin crew member covering the forward area of the passenger cabin) fell near the aft galley and hurt the back.
- FA2 was seated in the Jump Seat and had the right hand slightly injured.
- The ceilings over passenger seats and door panels, etc. were damaged.

Figure 1 Positions of the injured when the accident occurred

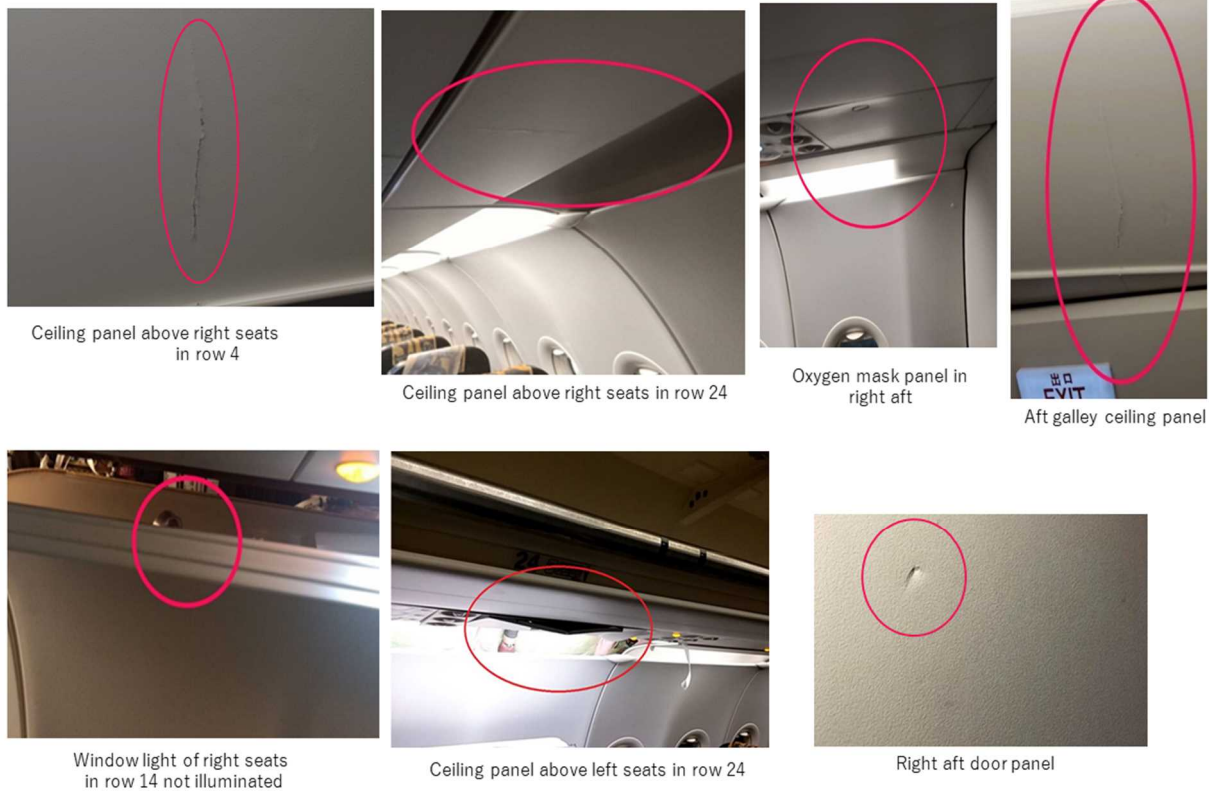
The CIC disembarked from the aircraft using a wheelchair and was diagnosed as the right ankle sprain at the airport clinic. The CIC, however, went to hospital following day because of the pain the CIC kept suffering, and was diagnosed as the right ankle bone fracture. Immediately after the aircraft had landed at Taiwan Taoyuan International Airport, mechanics at the maintenance station of Taiwan Taoyuan International Airport inspected the aircraft. As a result of the inspection, the engines and airframe were found to be free from damage. The inspection found damage to the ceilings above passenger seats and door panels at seven points that were assumed to have been caused by the impact of cabin crew and passengers during the turbulence (see Figure 2).

Figure 2 Damage inside passenger cabin

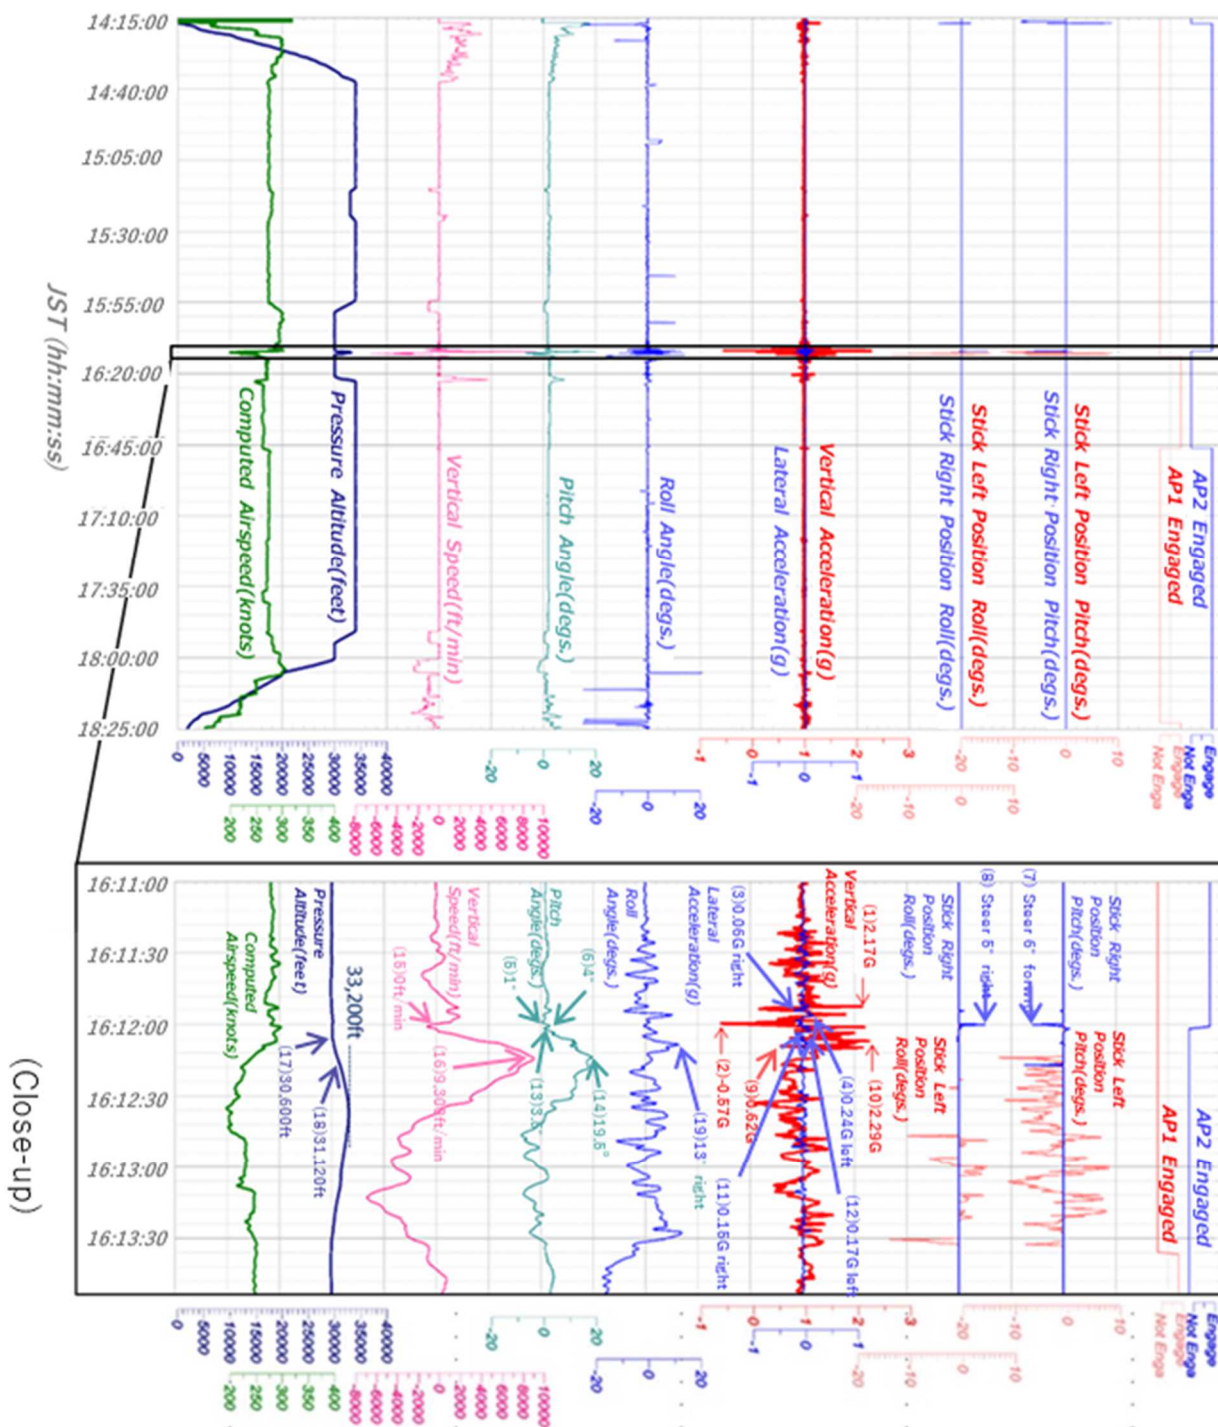
Figure 9 FDR record

According to the FDR of the accident aircraft, vertical acceleration fluctuated in the range from 2.17 G (see Figure 9 (1)) to minus 0.57 G (see Figure 9 (2)). Lateral acceleration at that time fluctuated in the range of 0.06 G maximum to the right (see Figure 9 (3)) and 0.24 G maximum to the left (see Figure 9 (4)). Pitch angle fluctuations were from 1° (see Figure 9 (5)) to 4° (see Figure 9 (6)). When vertical acceleration began to increase from minus 0.57 G (see Figure 9 (2)) at 16:12:01, the FO as PF pushed the sidestick to 6° forward (see Figure 9 (7)) and 5° to the right (see Figure 9 (8)), which caused the Autopilot to be disengaged at 16:12:03. In the following 13 seconds, there was no record that flight crew pushed the sidestick in the right pilot and left pilot seats. During the period from 16:12:02 until 16:12:15, vertical acceleration

fluctuated in the range between 0.62 G (see Figure 9 (9)) and 2.29 G (see Figure 9 (10)). Lateral acceleration at that time fluctuated in the range of 0.15 G maximum to the right (see Figure 9 (11)) and 0.17 G maximum to the left (see Figure 9 (12)). Pitch angle increased from 3.5° (see Figure 9 (13)) to 19.5° (see Figure 9 (14)). Vertical speed increased from 0 ft/min (see Figure 9 (15)) to 9,300 ft/min (see Figure 9 (16)), and pressure altitude rose from 30,600 ft (see Figure 9 (17)) to 31,120 ft (see Figure 9 (18)). About 16:12:10, roll angle temporarily leaned 13° to the right (see Figure 9 (19)).

The JTSB concludes, from the record of the FDR, that the Autopilot is highly probable to have been disengaged at 16:12:03.

It is probable that the FO unintentionally pushed the sidestick forward when the aircraft fiercely shook, and the steering amount exceeding the threshold value (5° forward) preset for the Autopilot disengagement led to the Autopilot disengagement.
