**AIRCRAFT ACCIDENT
INVESTIGATION REPORT**

KOREAN AIR LINES CO, LTD.

H L 7 4 7 3

PASSENGER INJURY BY THE SHAKING OF THE AIRCRAFT KOREAN AIR LINES CO, LTD. BOEING 747-400, HL7473 (THE REPUBLIC OF KOREA) AT AN ALTITUDE OF APPROX. 22,000 FT, ABOUT 160KM NORTH-NORTHEAST OF TOKYO INTERNATIONAL AIRPORT AT 20:30 LOCAL TIME, JULY 5, 2012

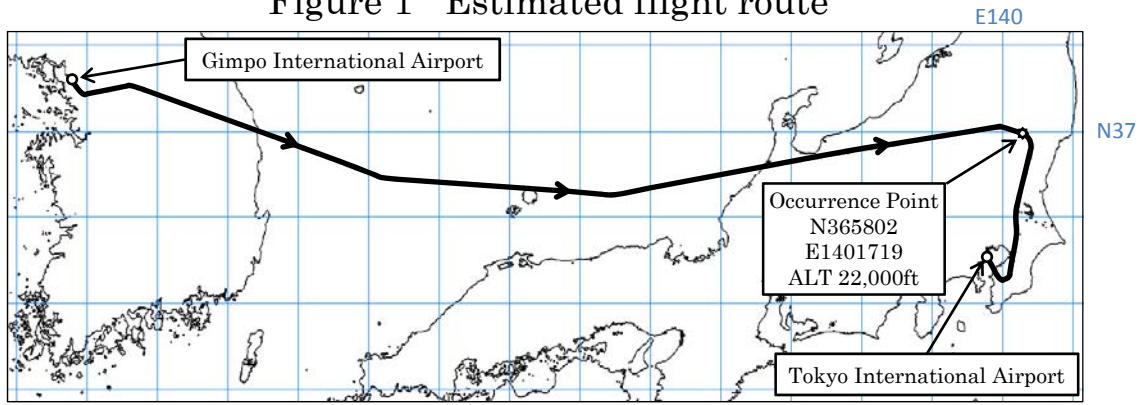
Figure 1 Estimated flight route

The accident occurred around 20:30 at an altitude of approximate 22,000 ft (6,700 m) about 160 km north-northeast of Tokyo International Airport (Latitude 36°58'02" N and Longitude 140°17'19" E). (See Figure 1 and 2)

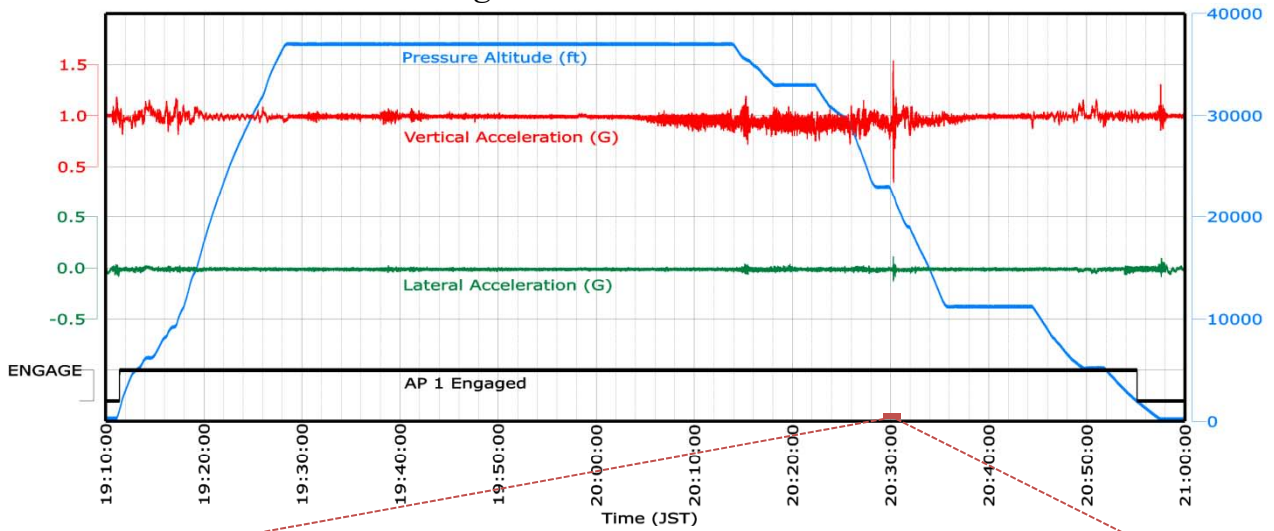
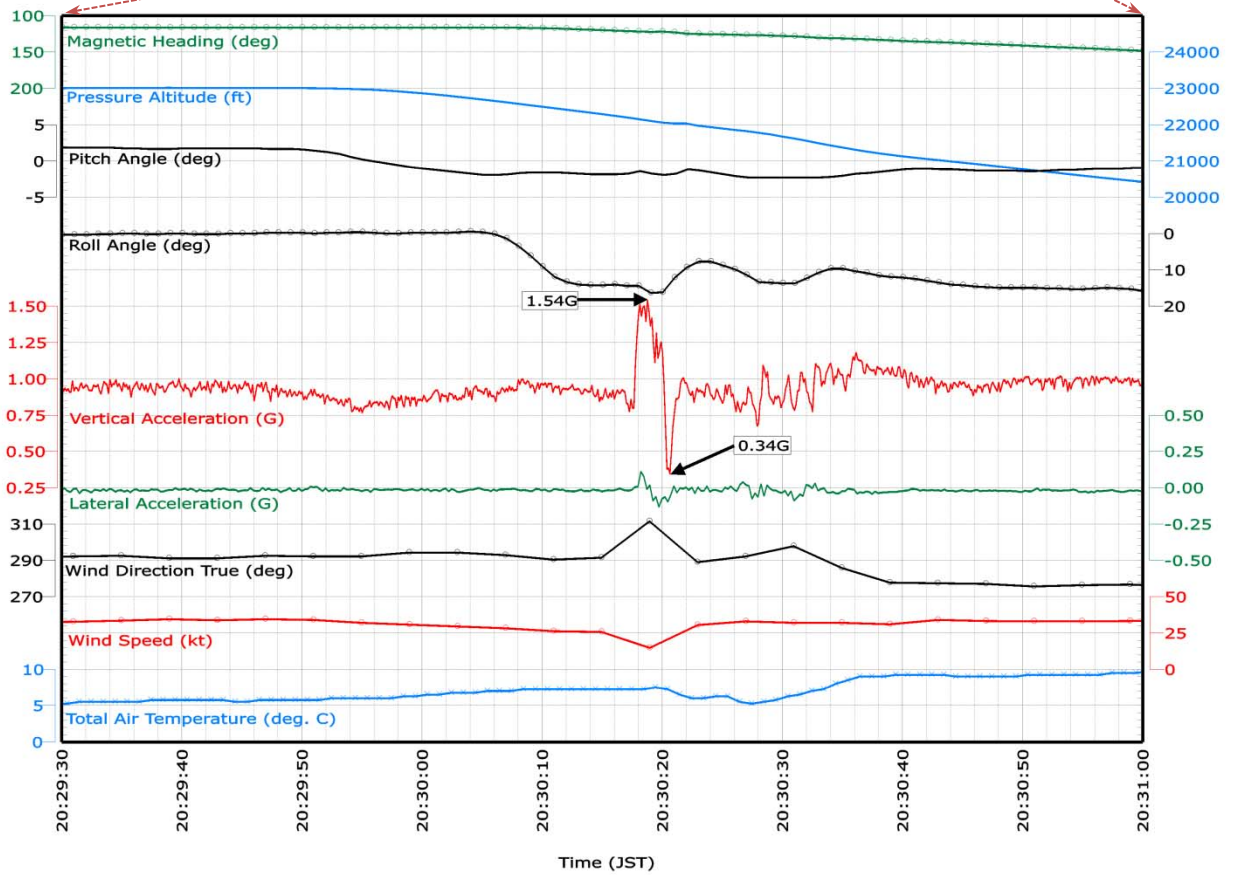
Figure 2 DFDR Records

3.1 Involvement of Weather	Yes
3.2 Involvement of Pilots	None
3.3 Involvement of Airplane	None
3.4 Analysis of Findings	<p>(1) In view of the history of the flight, it is highly probable that the sudden violent shaking of the aircraft corresponds to the sole significant change of the DFDR vertical acceleration data. During this shaking, a passenger standing in the aisle to go to the lavatory was thrown off-balance, bumped into the L4 door on his back, and fell on the floor.</p> <p>(2) According to the hourly analysis chart, the sporadic VWSs had been observed in the vicinity of the accident airspace; therefore, it is possible that factors related to the emergence of the turbulence existed there. According to the statements, no radar echo was observed on the onboard weather radar screen; however, the weather radar imagery by the Japan Meteorological Agency (JMA) showed emerging and enlarging echoes between 20:00 and 20:40, indicating the existence of atmospheric conditions where convective clouds could develop. Further, when the aircraft encountered a violent shaking, the DFDR recorded a</p>

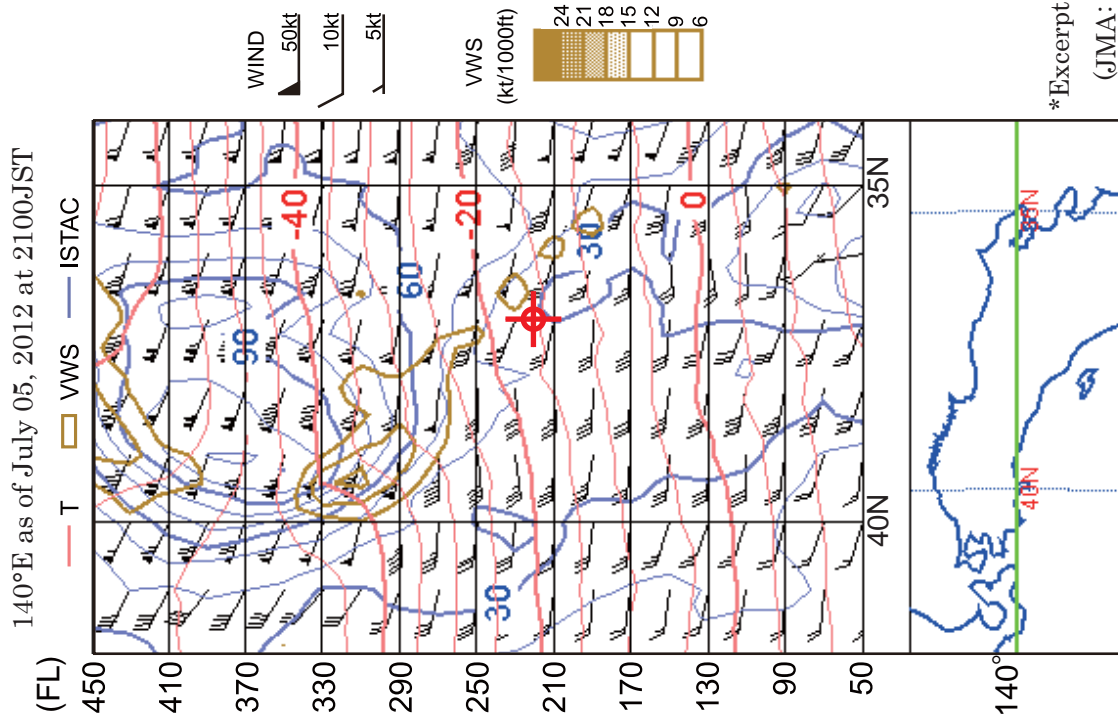
Figure 3 Hourly Analysis Chart
(vertical cross section)

<p>existed at altitudes 37,000-41,000 ft. At altitudes 23,000-26,000 ft, sporadic vertical wind shears (VWS) of 6-9 kts/1000 ft had been forecast.</p> <p>(3) Weather Radar Imagery (Strength and Top Height)</p> <p>According to the weather radar imagery before and after the accident time, no radar echo overlapped the accident airspace as of 20:00, but at 20:20, an echo with top heights of 20,000-30,000 ft and central strength of 80 mm/h overlapped the airspace. The area of the echo further expanded as of 20:40; however, there was no echo to the south where its future course extended.</p> <p>(4) According to the DFDR records, gradual changes in the wind direction and velocity showed a temporal quick wind fluctuation, around 20:30 by 20° in the direction and 10 kts in the velocity.</p> <p>(5) An in-cloud light-plus turbulence, which is weaker than a moderate one denoting shakings demanding attention for cabin walking had been observed regarding its flight route and filed as a PIREP (a weather-related pilot report).</p> <p>According to the PIC, the turbulence information he received from an automatic terminal information service (ATIS) was the weather condition at a point off its flight route: about 100 km south of Tokyo International Airport.</p> <p>(See Figure 2, 3 and 4)</p>
