AI2012-6

**AIRCRAFT SERIOUS INCIDENT
INVESTIGATION REPORT**

**AIR BUSAN CO., LTD.
HL 7517
JAL EXPRESS CO., LTD.
JA 8998**

**1. AIR BUSAN CO., LTD.
BOEING 737-400, HL7517
2. JAL EXPRESS CO., LTD.
BOEING 737-400, JA8998
ON RUNWAY 34 AT FUKUOKA AIRPORT, JAPAN
AROUND 11:34 JST, DECEMBER 26, 2010**

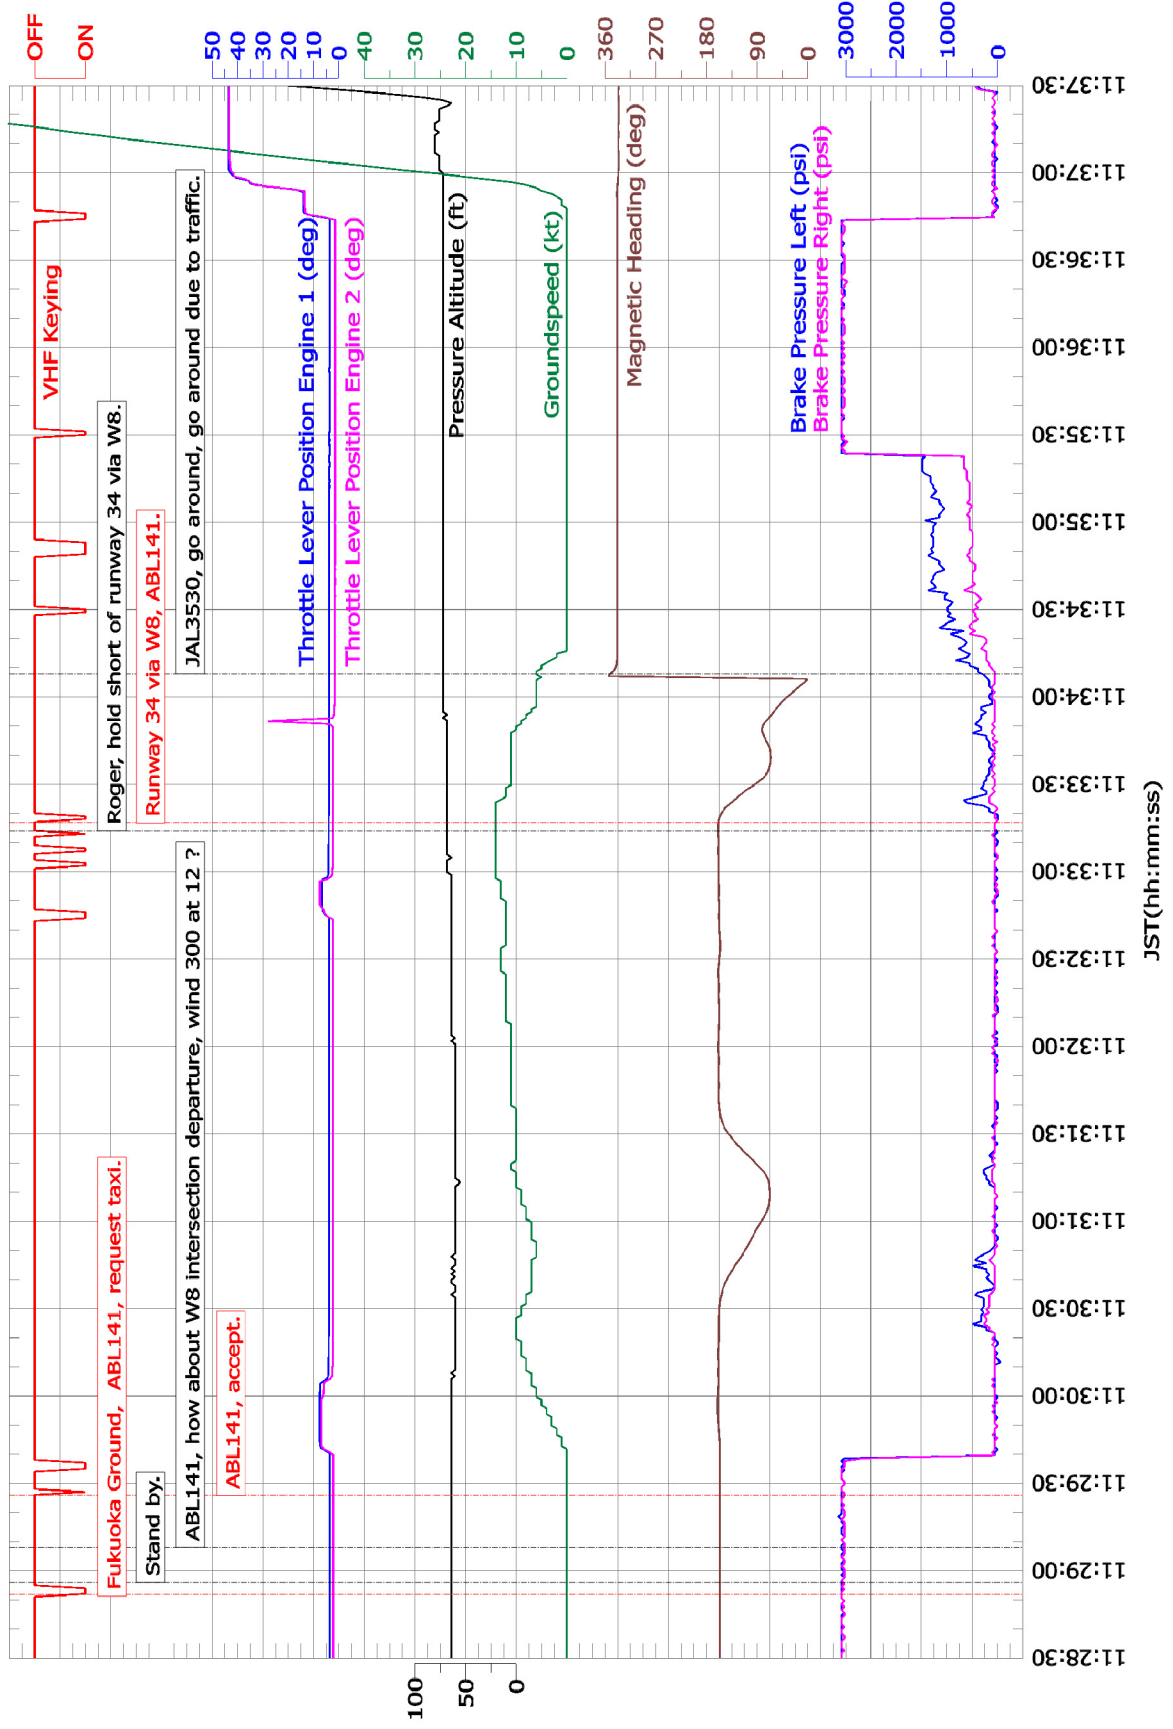
Figure 2: DFDR Records of HL7517

11:33:17 HL7517 replied to the local controller saying “RUNWAY 34 VIA W8, ABL141” and then, started to turn into W8 from parallel taxiway B.

11:33:44 At first HL7517 turned its nose to the right from W8 and then, made a left turn toward the runway.

11:34:11 HL7517 aligned itself with the runway center line.
