**AIRCRAFT ACCIDENT
INVESTIGATION REPORT**

**ENGINE FIRE DURING TAKE-OFF ROLL
KOREAN AIR LINES CO., LTD.
BOEING 777-300, HL7534**

**ON RUNWAY 34R
AT TOKYO INTERNATIONAL AIRPORT
AT AROUND 12:38 JST, MAY 27, 2016**

July 6, 2018

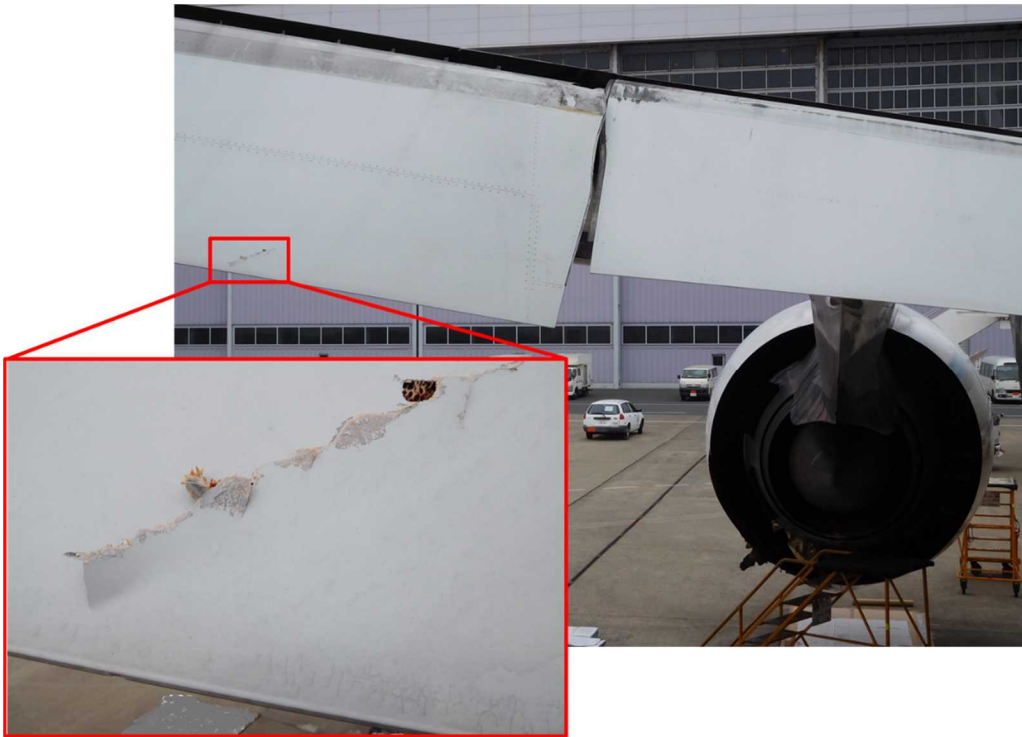
Photo 2. Outboard flap showing the cracks

flap showing the cracks.)

(Note: The flap position shown in this photo is differed from the takeoff flap position at the time of accident.)

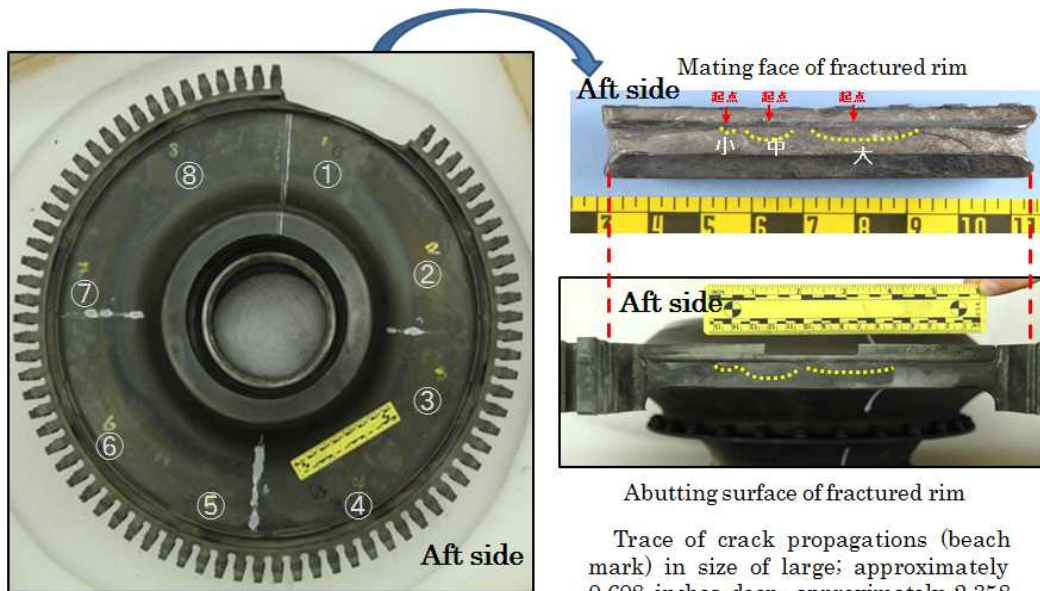
Photo 3-1. Fractured Rim

To investigate, divided the rim into eight parts and assign number to parts in a clockwise direction from the fractured parts. (Slot① to Slot ⑧) There were 73 blade slots in the disk and 9 blade slots in the recovered piece of the rim. The 1st stage turbine disk has 82 blade slots.

Trace of crack propagations (beach mark) in size of large; approximately 0.608 inches deep, approximately 2.358 inches long, medium; approximately 0.282 inches deep, approximately 1.000 inches long, and small; approximately 0.088 inches deep, approximately 0.489 inches long, which was originating at the aft side of disk, were confirmed.

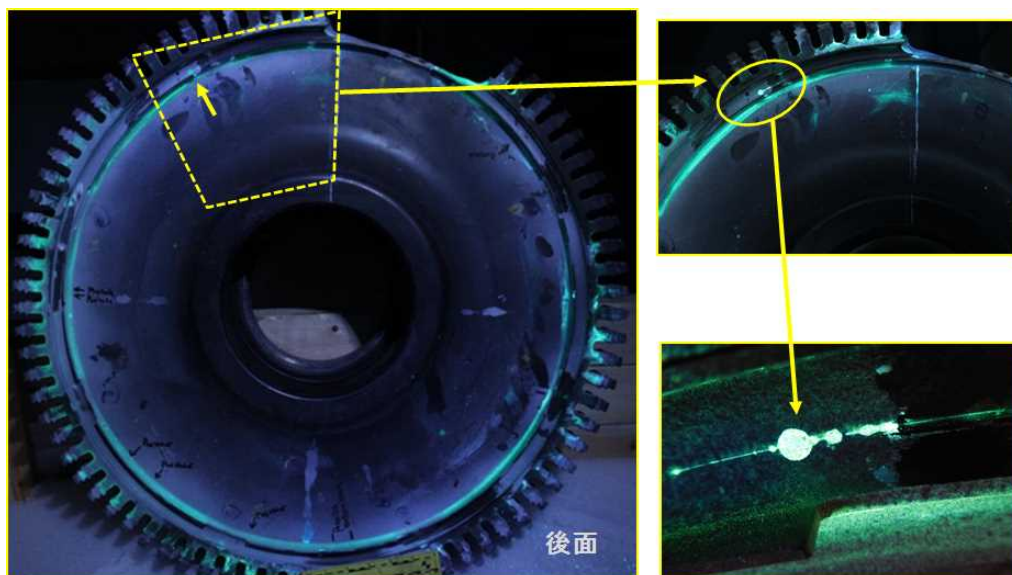
Photo 3-3. U-shaped groove and crack 2

FPI at the aft side of the disk
(Clear Crack was confirmed at the left side slot of the fractured part)

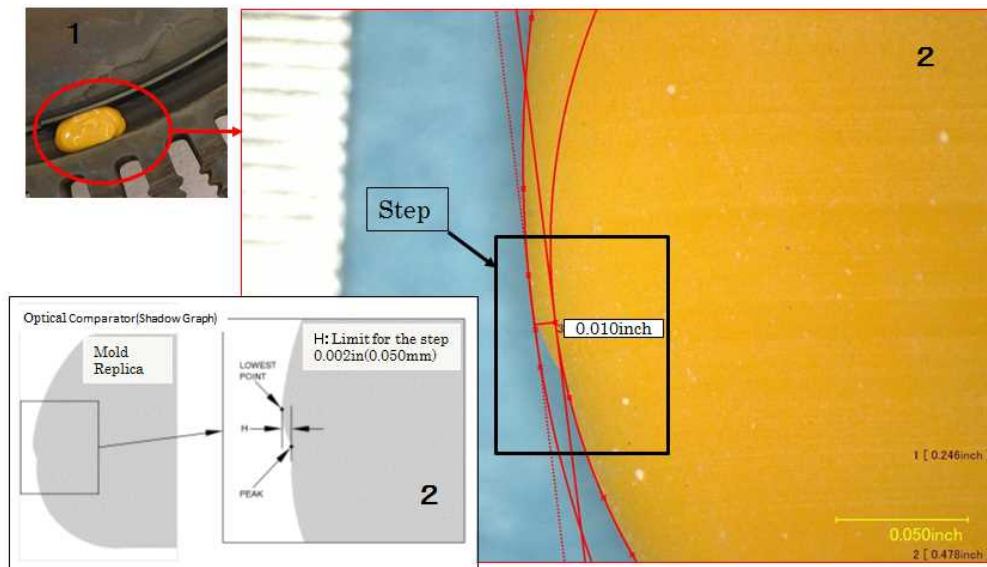
Photo 4. Created Replica of the Step

- 1 . The U-shaped groove was used to make multiple replicas using a thermosetting rubber compound.
- 2 . Setting the replica on an optical comparator, measure the machined step (mismatch) based on two machine radii. The step is 0.010 inch (0.25mm) *(Limit for the step is 0.002inch(0.050mm)).

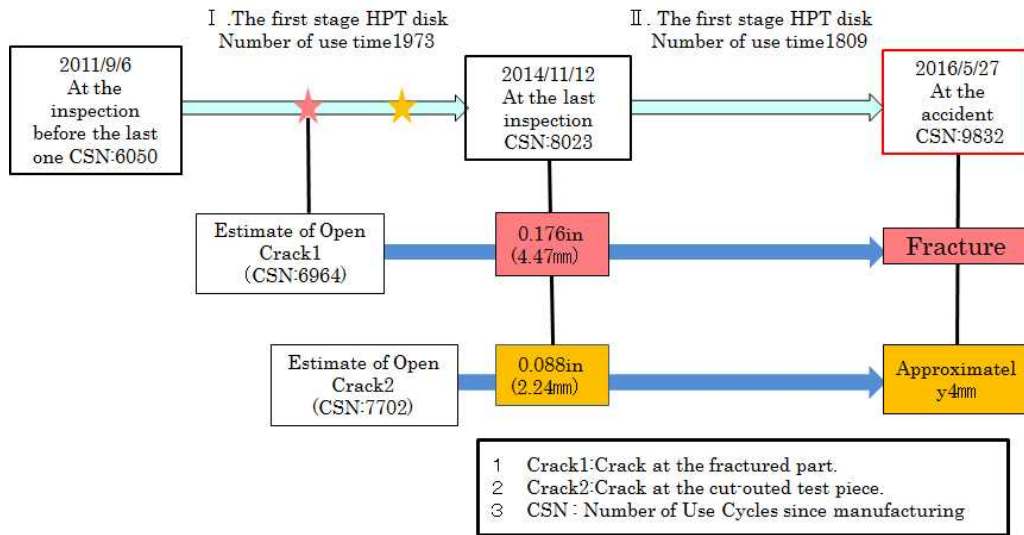
Furthermore, from the numerical analysis based on the counting at the crack surface, values of 0.088 to 0.176 inches (2.24 mm to 4.47 mm) along the surface were obtained on the cracks at the latest inspection at the engine repair shop of the Company.

Figure 6. Number of Cycles of the Disk estimated from the analysis of the fracture surface of rejected fragment

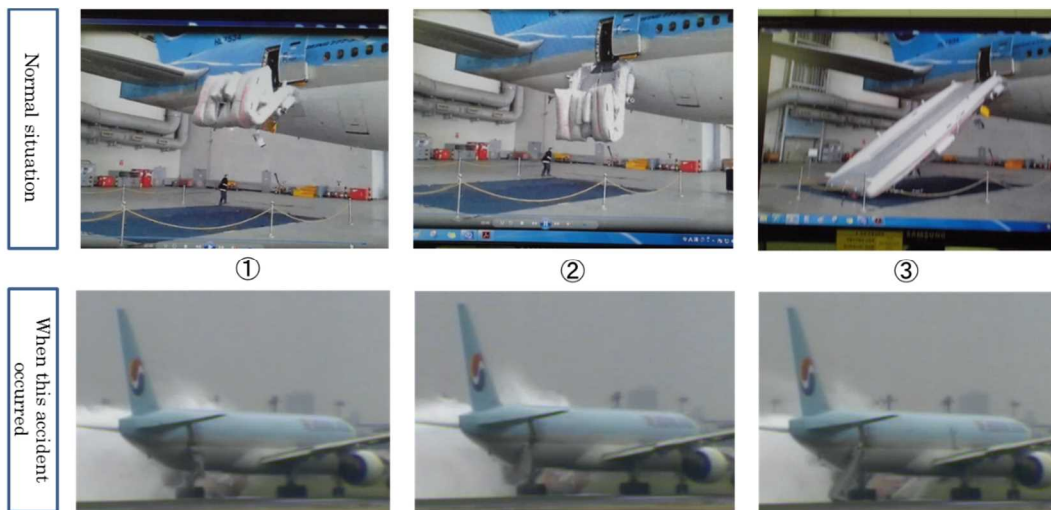
Photo 6. Comparison of R5 slide deploying status

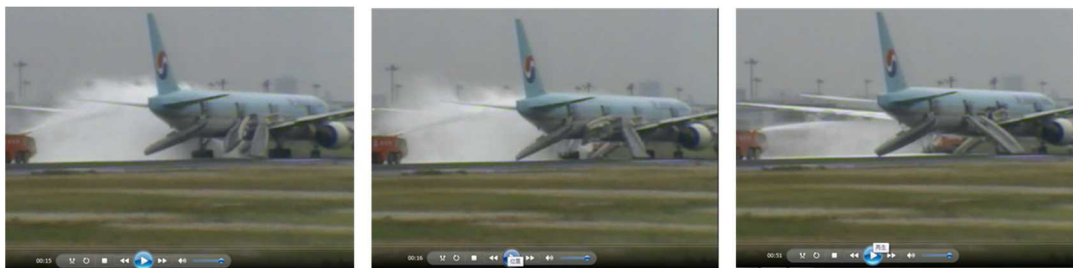
Photo 7. shows the deploying situations of R3, R4 and R5 slides of the Aircraft at the time of the accident. Furthermore, the R3 slide is narrower in width and shorter in length compared to the R4 and R5.

Photo 7. Deploying situations of slides at R3, R4 and R5

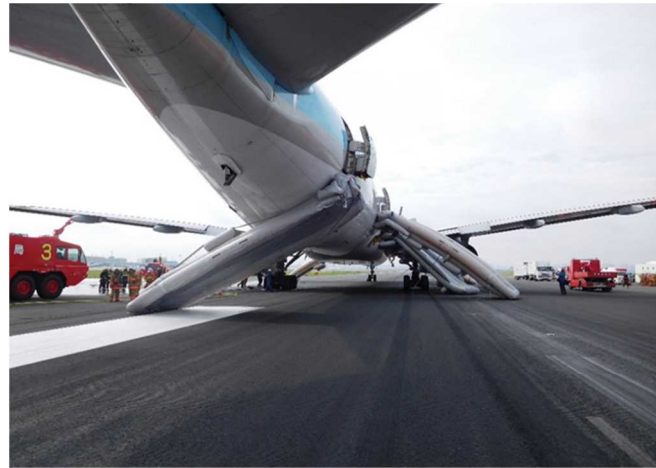
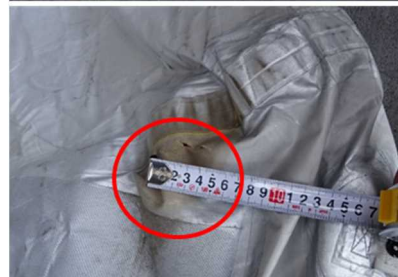
Photo 8. R5 Slide

Outer materials had approximately 5cm long tear at the right lower bottom corner of R5 slide

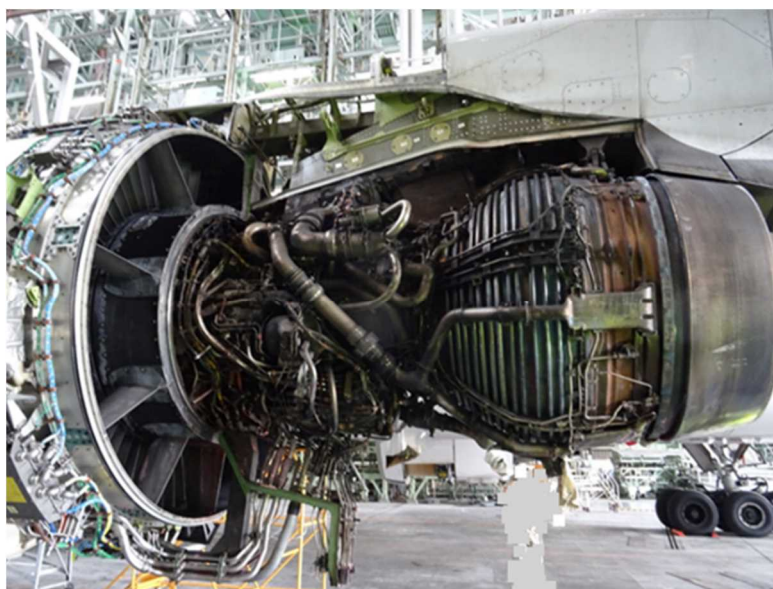
Photo #2. The left side of the No.1 engine

The left side of the No.1 engine and the external components were burnt and sooted. (See Photo #2. The left side of the No.1 engine.) The right side of the engine did not have any sooting or thermal damage. The insulation blanket over the fuel and hydraulic lines and the covering on the lines was undamaged. (See Photo #3. the right side of the No.1 engine.) The main gearbox deoiler vent tube was severed in line with the hole in the HPT case.

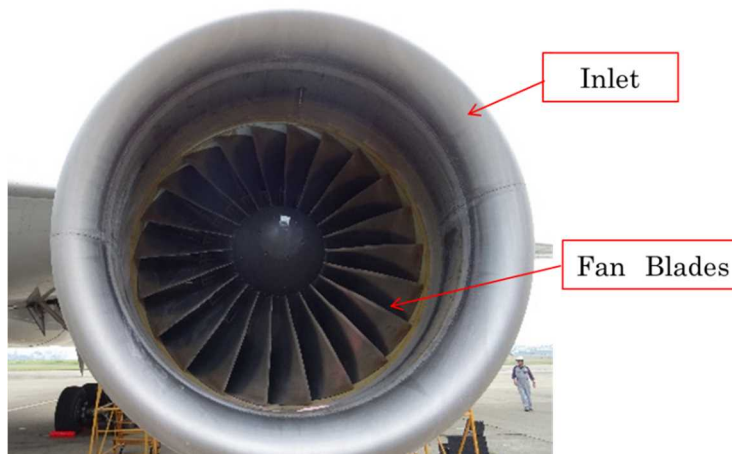
Photo#4. Inlet and Fan Blades

The inlet and fan blade did not have any apparent damage. There were no trace of sucking objects like birds from outside. When the fan was rotated, the LPT rotated concurrently. (See Photo #4. Inlet and Fan Blade.)

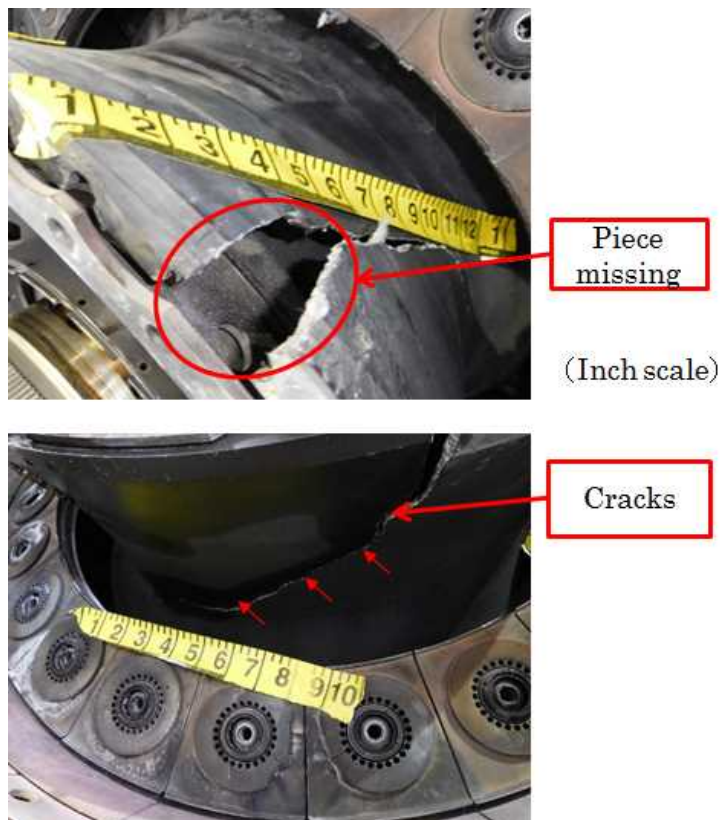
Photo #5. Inner diffuser case

The outer diffuser case did not have any indications of a rupture or thermal distress. The diffuser case rear flange between about 5:30 and 6:30 was bent radially outward. The inner diffuser case had five cracks between the aft flange and the center part of the case that varied in length from 1.5 (3.81) to 10.5(26.67) inches. At about 12 o'clock, there was an approximately 2 inch (5.08 cm) by 1 inch (2.54 cm) piece missing from the case. (See Photo #5 Inner Diffuser Case)

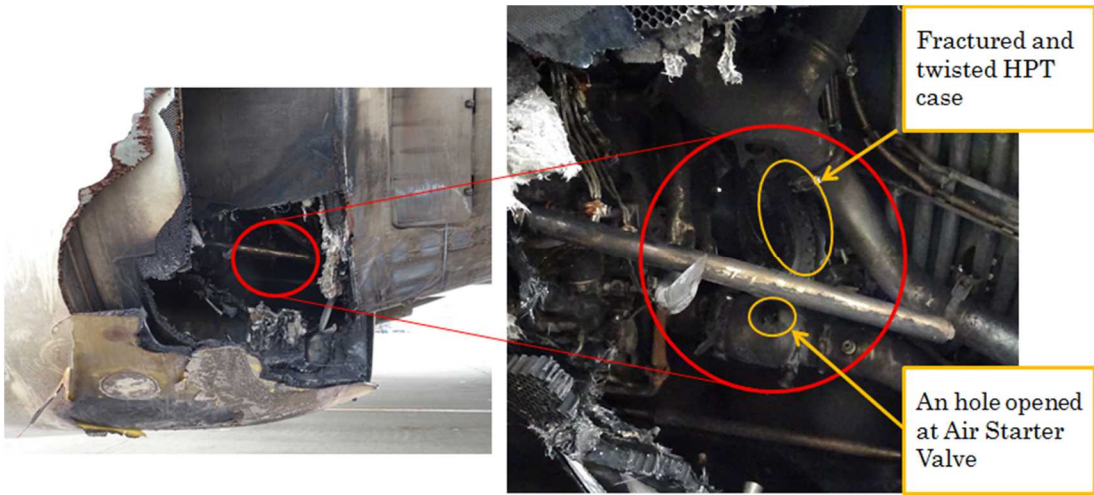
① The HPT case wall between 5:30 and 7 o'clock was bent radially outward and twisted which was approximately 36 cm (approximately 14 in) long and approximately 11.4 cm (4.5 in) wide along the periphery. (See Photo #6-1. The damage of the HPT case and Photo #6-2. The damage of the HPT case.)

Photo #6-1. The damage1 of the HPT case

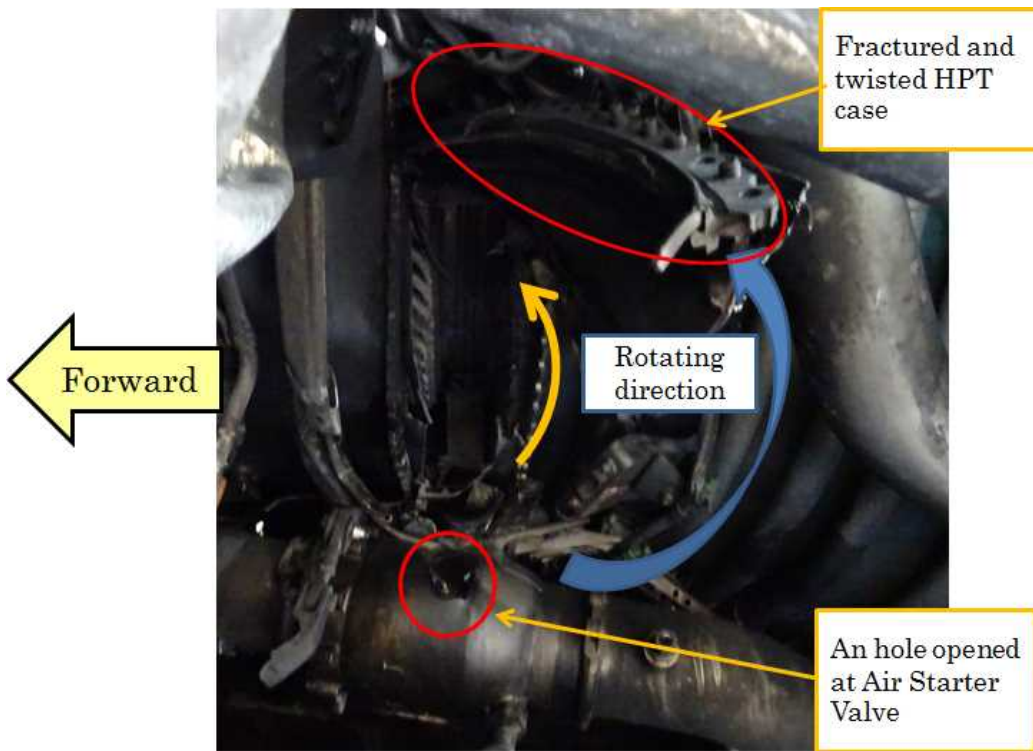
Photo #6-2. The damage2 of the HPT case

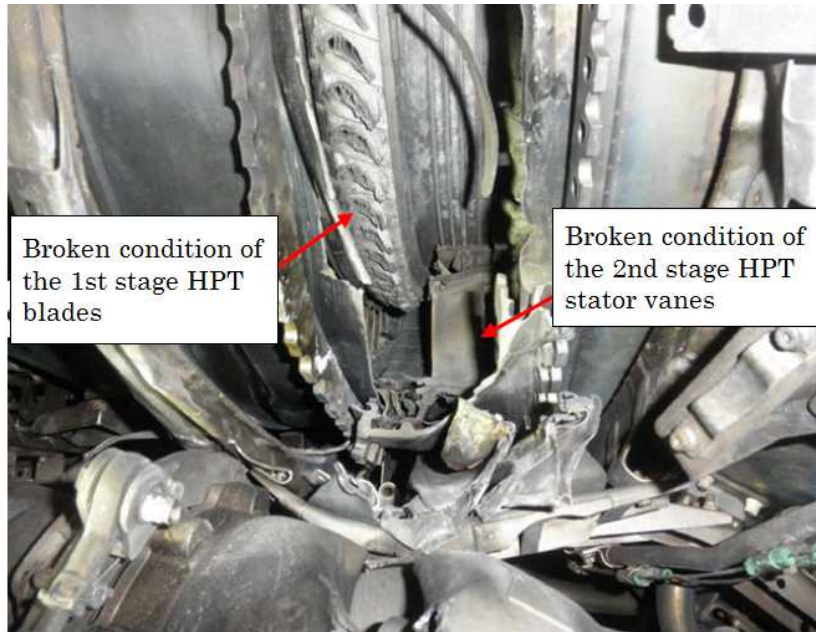
It was confirmed that the 1st stage HPT blades and the 2nd stage HPT stator vanes were missing from the roots. (See Photo #7. Fractured condition of the 1st stage HPT blades and the 2nd stage HPT stator vanes.)

Photo #7. Fractured condition of the 1st stage HPT blades and the 2nd stage HPT stator vanes

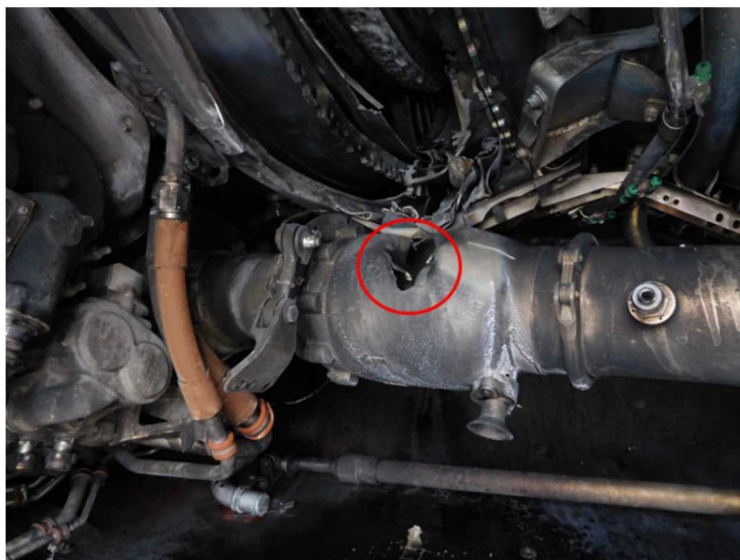
② There was a raised edge on the edge of the tab that corresponded to a notch in the edge of the hole in the starter air duct valve. (See Photo #8. A Hole opened in Air Starter Valve.)

Photo #8. A Hole opened in Air Starter Valve

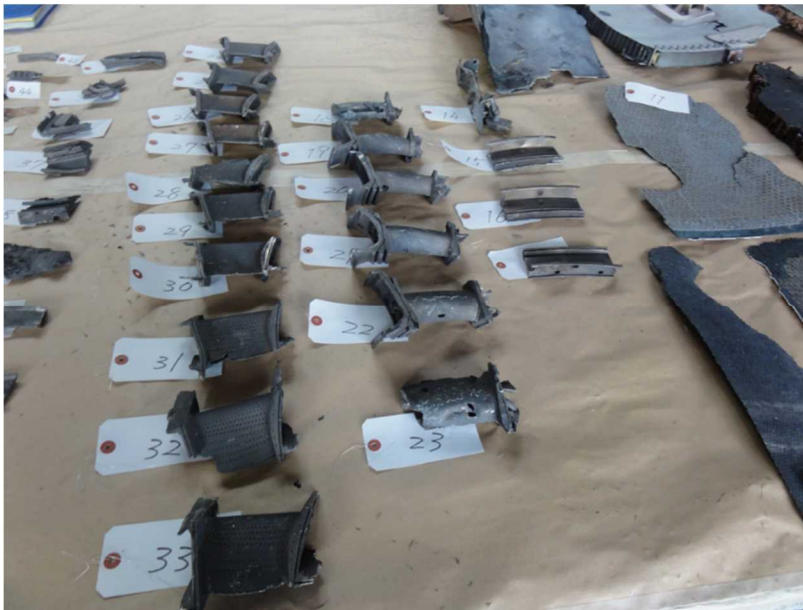
- ③ The HPT case's forward flange was missing bolts between 3:30 and 8:30 and the aft flange was missing bolts between 5:30 and 7:30.
- ④ Investigating the runway and an adjacent area after the accident, stator vanes and others of the 1st stage HPT and the 2nd stage HPT were recovered. (See Photo #9. Recovered Stator Vanes and others.)

Photo #9. Recovered Stator Vanes and others

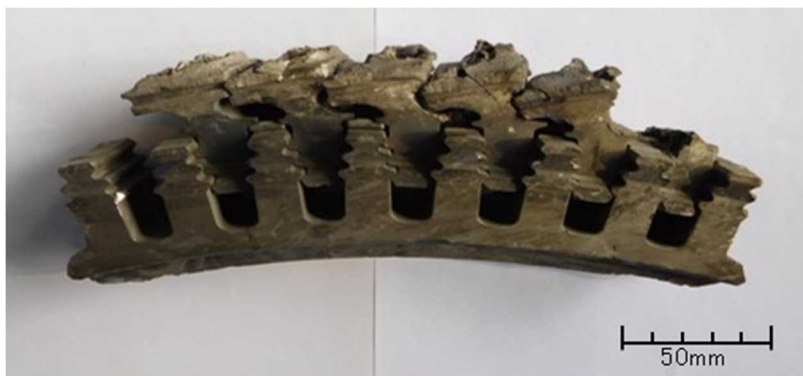
- ⑤ A piece of the 1st stage turbine disk rim was recovered from amidst the debris that was recovered from Runway 34R. The piece was about 7.8 inches (20 cm) long and weighed 1.875 kg (4.134 lb) with seven blade slots. (See Photo #10. Piece of the 1st stage HPT disk rim.)

Photo #10. Piece of the 1st stage HPT disk rim

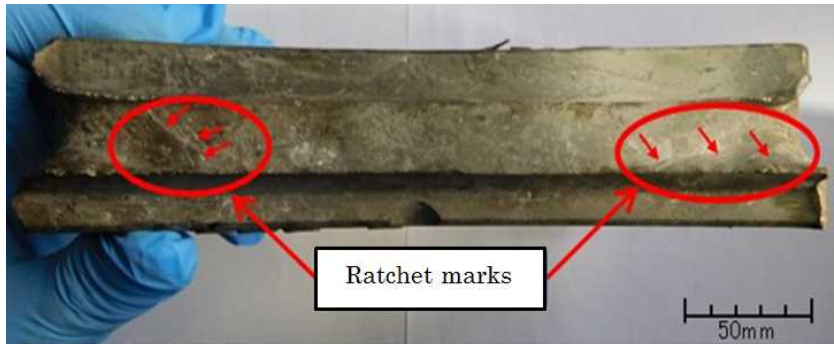
There was a ratchet mark¹⁷ on the fracture surface at the 1st stage HPT disk rim. (See Photo #11. Ratchet Marks.)

Photo #11. Ratchet Marks

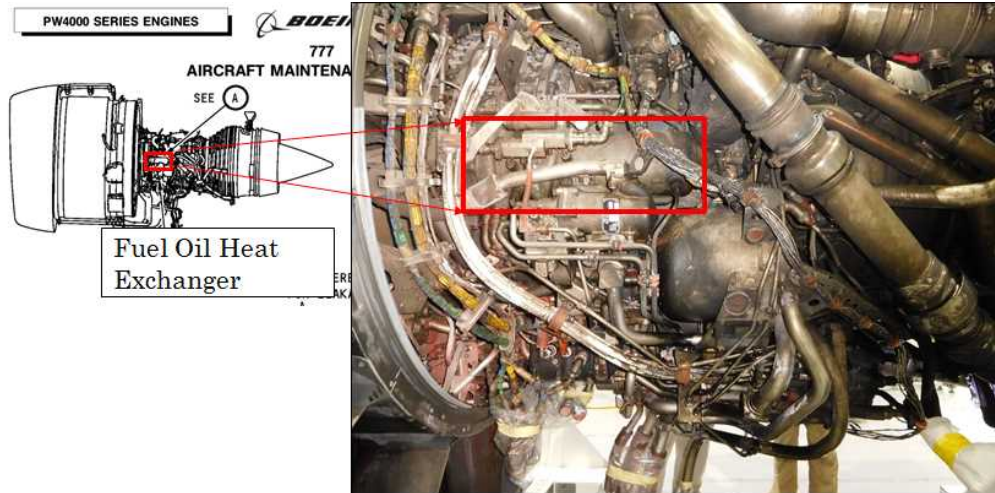
Photo #13-1. Fuel Oil Heat Exchanger

The main body case of Fuel Oil Heat Exchanger located at 8 o'clock of the HPT case had cracks and soot by thermal damage, but there were no damage impacted from outside. Three cracks were confirmed at the rear of the main body, and the longest crack was approximately 34 cm (13.4 in) long. (See Photo #13-1 Fuel Oil Heat Exchanger and Photo #13-2 Cracks of Fuel Oil Heat Exchanger.)

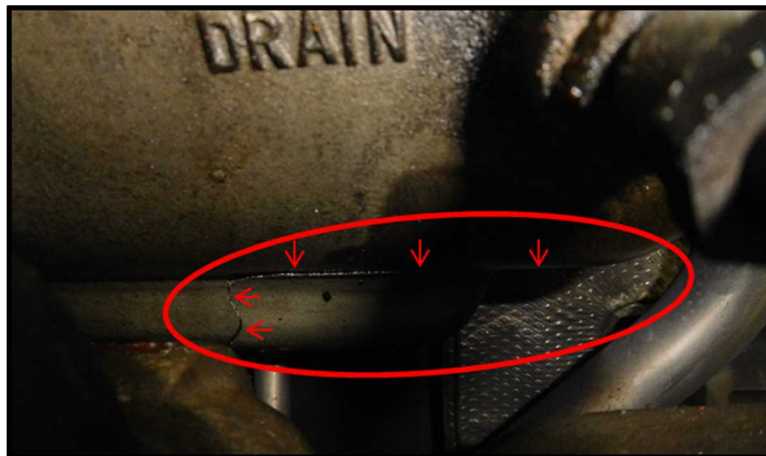
Photo #13-2. Cracks on the Fuel Oil Heat Exchanger

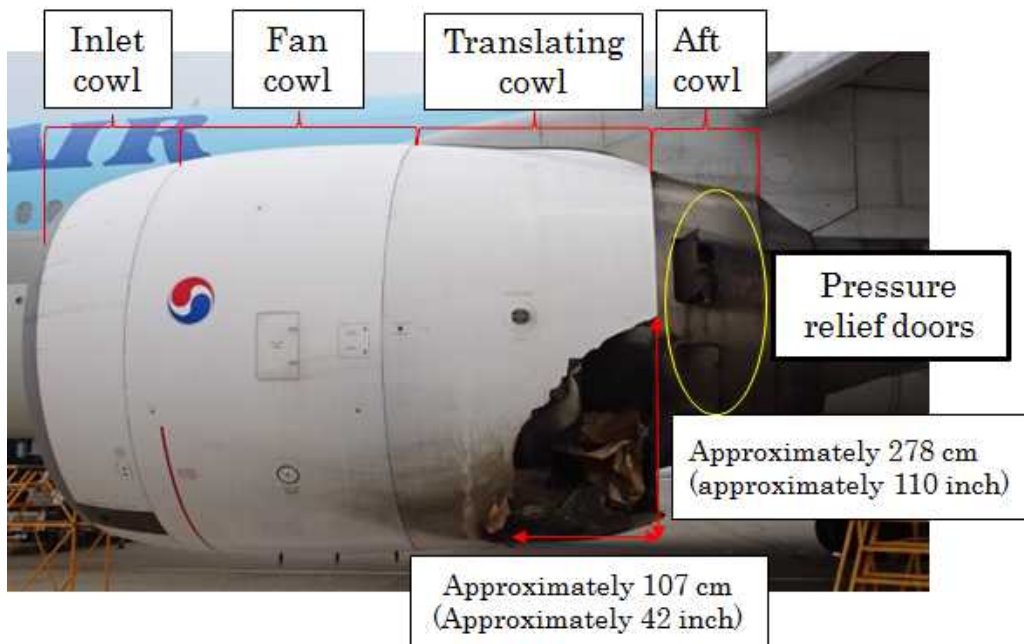
The aft cowl pressure relief doors at 2, 4, 8 and 10 o'clock were all open.

Photo # 14. Damage of Translating Cowl

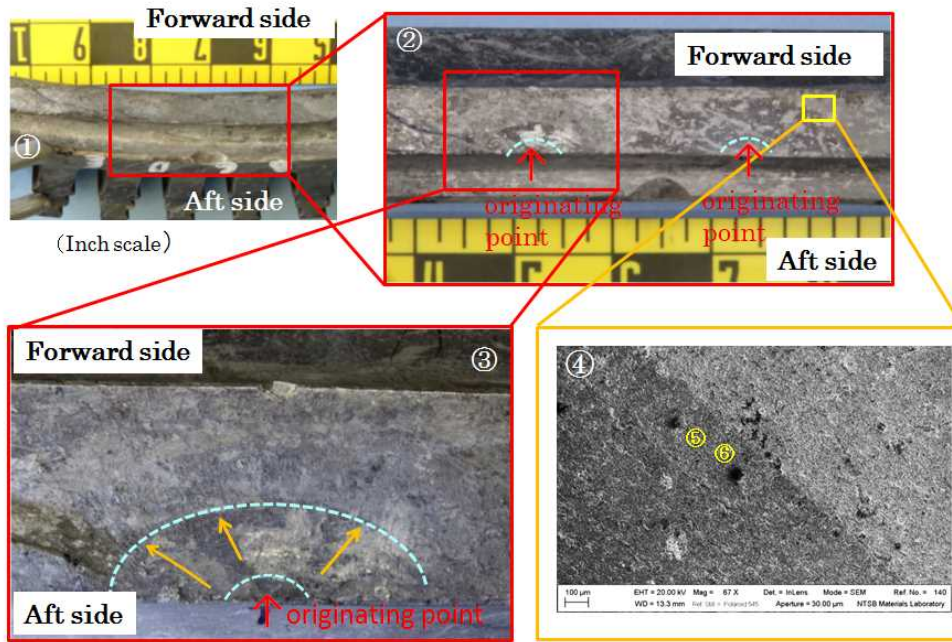
Photo ① and ②: Beach mark (Seashell pattern) from the originating point was confirmed at the fatigue crack propagation area at the fractured surface of fractured and ejected debris of the 1st stage HPT disk rim part.

Photo ③ : Crack propagates from originating point at the aft side of the disk to the forward side. The fractured surface exhibited significant mechanical damage. The fatigue progression exhibited a bluish heat tint.

Photos ⑤ and ⑥ was the pictures enlarged and photographed parts enclosed by yellow lines shown in Photo ④ via Scanning Electron Microscope (SEM) and striation which is a characteristics of fatigue fracture surface was confirmed.

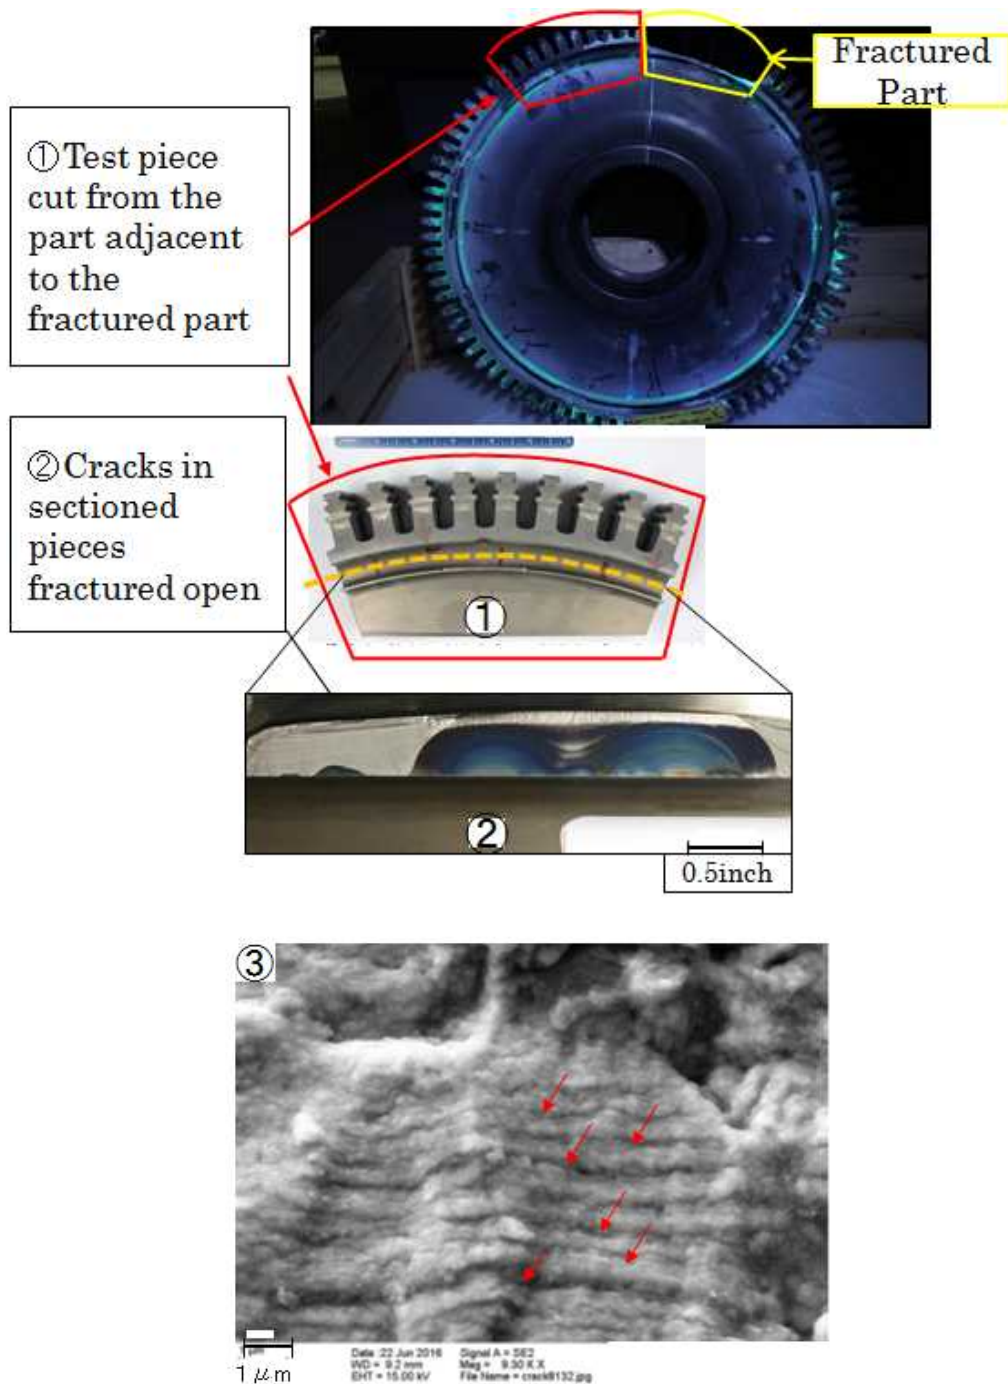
③ Magnify a crack via an electron microscope. (Stable striations (Red Arrows) were confirmed.)
