**AIRCRAFT ACCIDENT  
INVESTIGATION REPORT**

**PRIVATELY OWNED  
JA001T**

**June 30, 2022**

<b>Company</b>	Privately owned
<b>Type, Registration Mark</b>	Cessna 525A JA001T
<b>Incident Class</b>	Damage to the airframe from a bird strike
<b>Date and Time of the Occurrence</b>	At about 08:11 Japan Standard Time (JST: UTC+9 hours), April 14, 2021
<b>Site of the Accident</b>	Approximately 2 nm west of Yao Airport at an altitude of approximately 500 ft

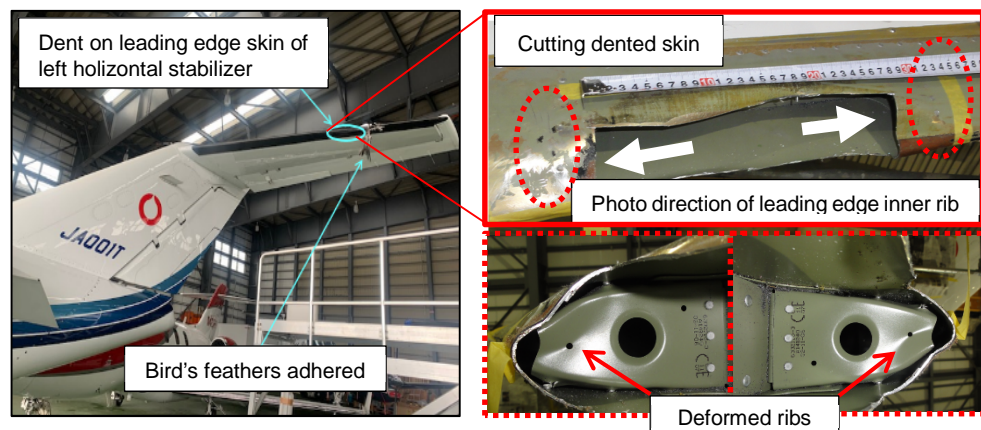
Figure 2 Damaged portions

Conditions of damage: dent on the leading edge skin of the left horizontal stabilizer and deformed ribs (size of dent: 9 cm long, 41 cm wide, and 5 cm deep; all figures are approximate)

(1) The JTSCB concludes that it is most likely that since the dent and the bird’s feathers adhered on the leading edge of the left horizontal stabilizer, which were not observed during the preflight inspection, were observed during the post-landing inspection of the aircraft; furthermore the captain heard the sound supposedly of collision of a bird with the aft airframe when the flock of the birds passed by during the take-off climb at the indicated airspeed of 150 kts at an altitude of 500 ft over approximately 2 nm west of the airport, the JTSCB concludes that it is most likely that the aircraft collided with the bird among the flock at this moment and sustained the damage to the airframe.

The JTSCB concludes that the probable cause of the accident was most likely that the aircraft collided with the bird approximately 2 nm west of Yao Airport at an altitude of approximately 500 ft during the take-off climb from the airport that caused the damage to the airframe.
