**AIRCRAFT SERIOUS INCIDENT  
INVESTIGATION REPORT**

**JAPAN AIRLINES INTERNATIONAL CO., LTD.  
J A 0 0 2 D**

**ENGINE FIRE DURING TAKE OFF CLIMB  
JAPAN AIRLINES INTERNATIONAL CO., LTD.  
MCDONNELL DOUGLAS MD-90-30, JA002D  
AN ALTITUDE OF ABOUT 5,500 FEET, ABOUT 11 KILOMETERS  
WEST OF SENDAI AIRPORT, JAPAN  
AUGUST 15, 2010**

June 8, 2012

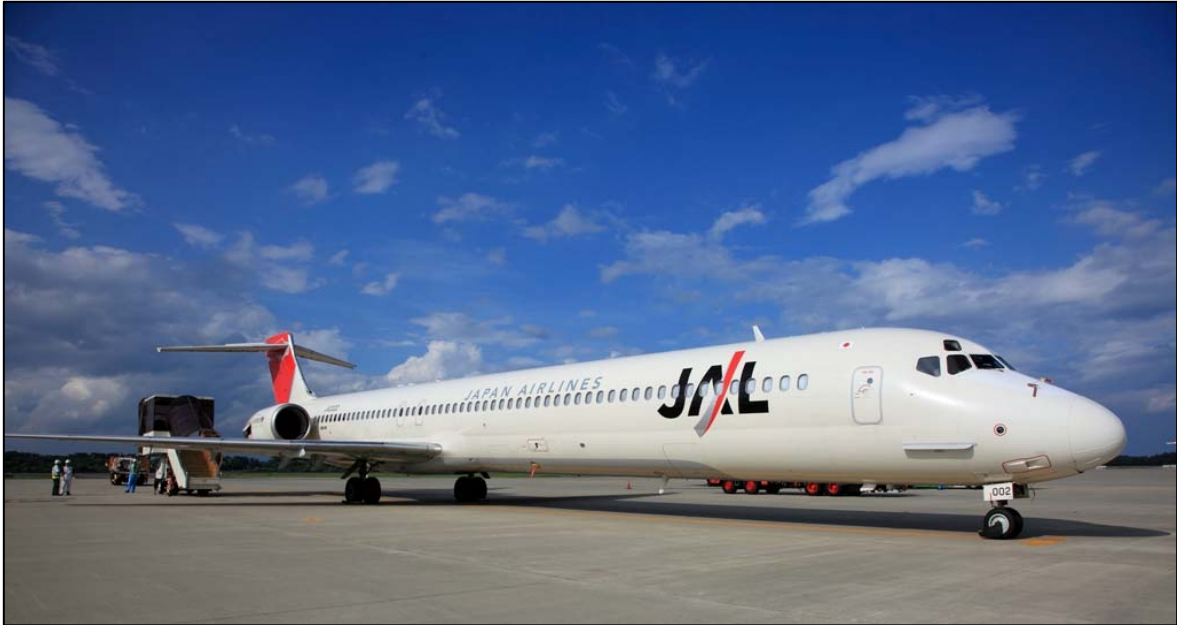
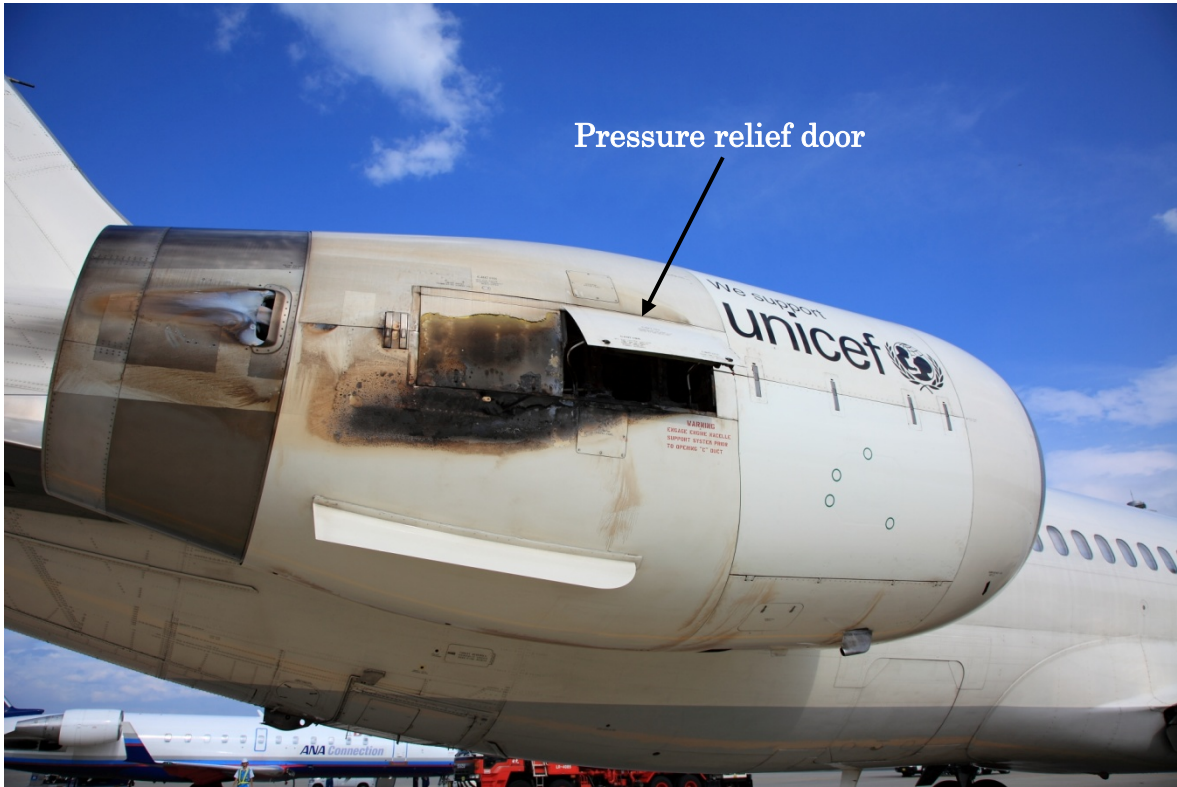
# Photo 1 The Serious Incident Aircraft

On the right engine cowling, the pressure relief door was open, from which the rear portion was heat-damaged and turned to brownish color. The No.4 Bearing Scavenge Tube (hereinafter referred to as "the Tube") which extends from the No.4 Bearing underneath the Diffuser Case (hereinafter referred to as "the Case") was found detached and the trace of oil leak was found. Inside of the lower cowl to which the oil adhered was partly burnt out, and soot was stretching upward from the lower part of the Case and the turbine module.

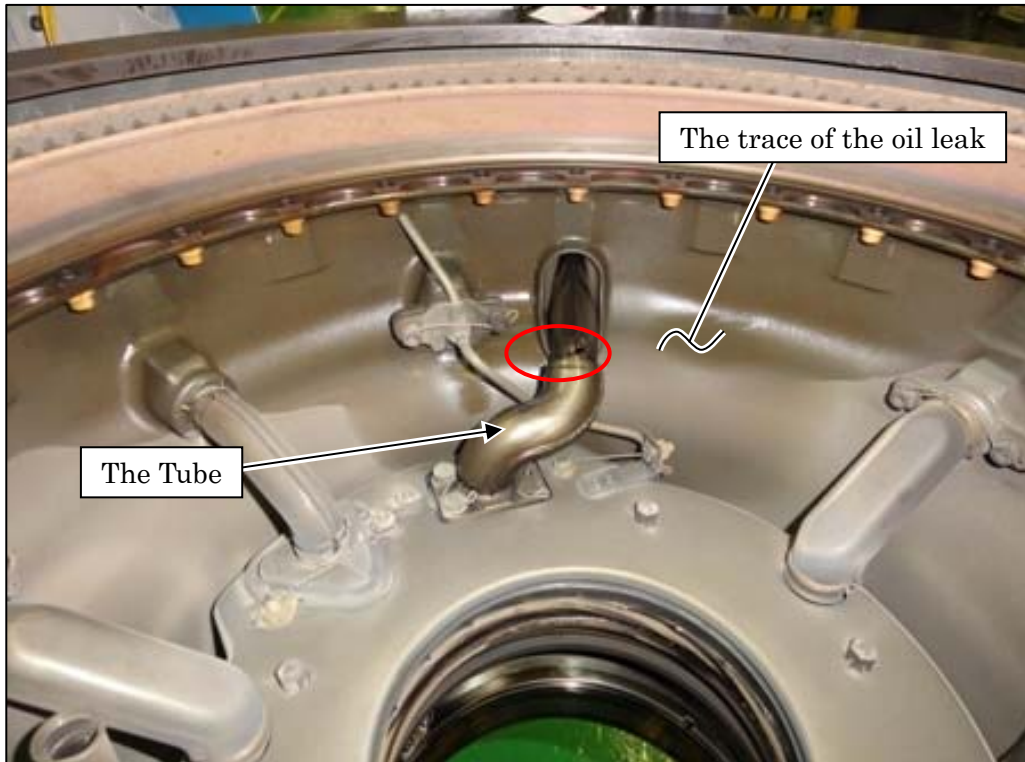
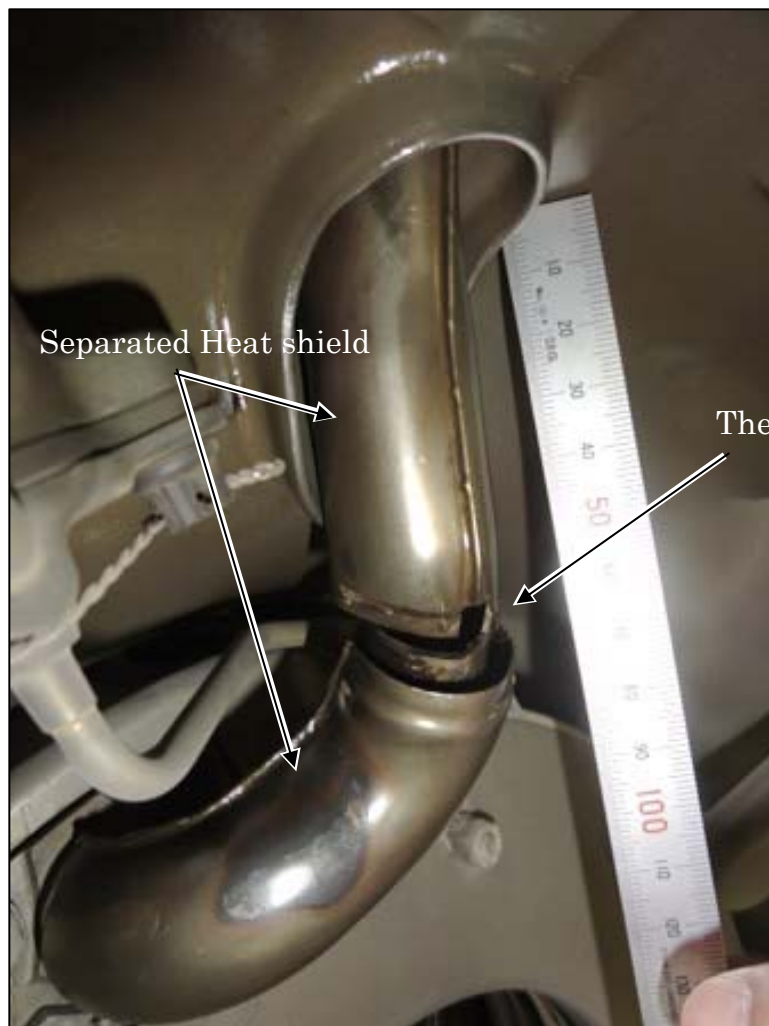
Photo 3 The Tube in the Case

The engine was delivered to the engine manufacturer's designated facility; accordingly, the fractured Tube was detached from the Case and visually examined. The examination discovered a circumferential fracture near the bend and straight cracks along the straight portion of the Tube. The fracture and the cracks extended along the weld beads that were formed in the process of manufacturing of the Tube. Oil was leaking at the circumferential fracture. There was no oil leak in other parts of the engine nor other defects relevant to the fire. There was no defect in the fuel system and in the combustion gas flow passage.

It is probable that because the Tube fractured at the bend, the straight portion lost its support; broke loose from the Case to make an opening, and from which the engine oil blew out into the high temperature section of the engine to get ignited.

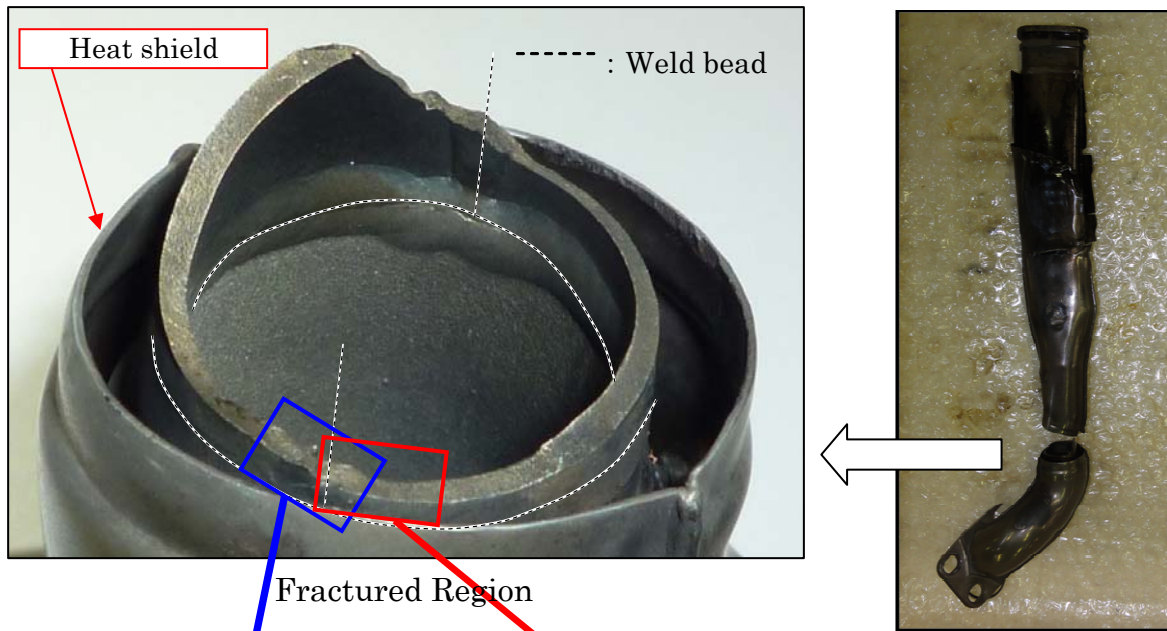
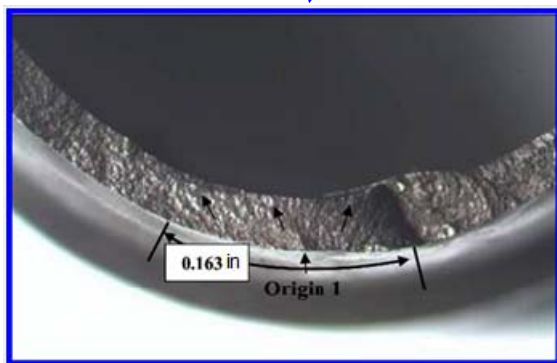
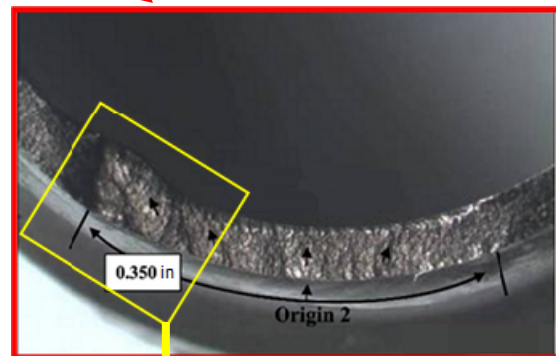
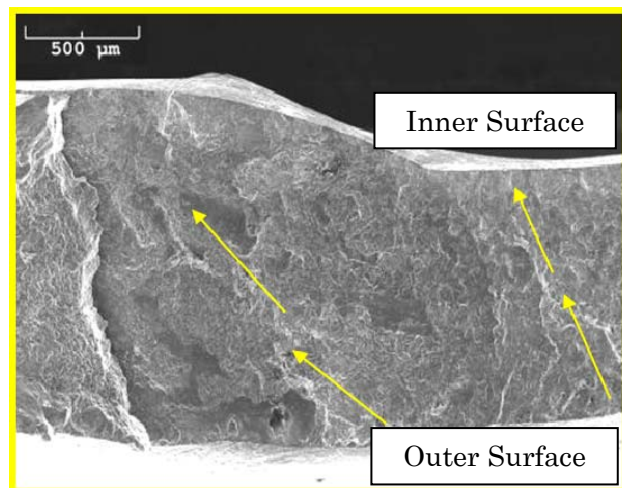
Photo 4 Fractured Region of the Tube

- (1) Binocular microscopic examination of the circumferential fracture at the bend part of the Tube showed the trace of fatigue crack progressed from the outer diameter to the inner diameter of the Tube, and conditions consistent with overload fracture were observed at outside of the fatigue crack region. The fatigue crack was 0.513 in in length, and two major origins of the crack were identified on the outer surface of the Tube along the circumferential weld bead.

Scanning electron microscope evaluation on the fracture surface also showed cyclic striations that were typically associated with low cycle mode of fatigue, and striation count was about 1900.

As described in 2.8.1, the Tube is in the Case, one end of it is bolted to the No. 4 Bearing Compartment (housing), while the other end is fixed to an opening of the Case with a seal (a piston ring) to maintain airtight condition of the Case. Because of this, it is highly probable that the region around the bend of the Tube gets repeated stress associated with engine operation when the sealed end is pushed outwards as the pressure and the temperature inside the Case rise in proportion to the engine thrust. Also, as described in 2.9.2 (1), origins of the fracture were found on the outer diameter of the Tube along the circumferential weld bead at the bend, and the trace of the progress of fatigue crack from the outer diameter to the inner diameter was observed on the fracture surface. Therefore, it is highly probable that the repeated stress associated with engine operations generated the fracture origins; from which further repeated stress caused the progress of the fatigue crack followed by the final fracture.

In the serious incident, it is highly probable that the fatigue crack originating from the outer diameter of the No.4 Bearing Scavenge Tube progressed into the fracture, whereas the Tube is covered with the heat shield, making it impossible to have a direct inspection of the relevant spot during a regular maintenance work. Therefore, it is recommended that the manufacturer review the Tube design and overhaul inspection method thereof in order to prevent the recurrence of similar cases.

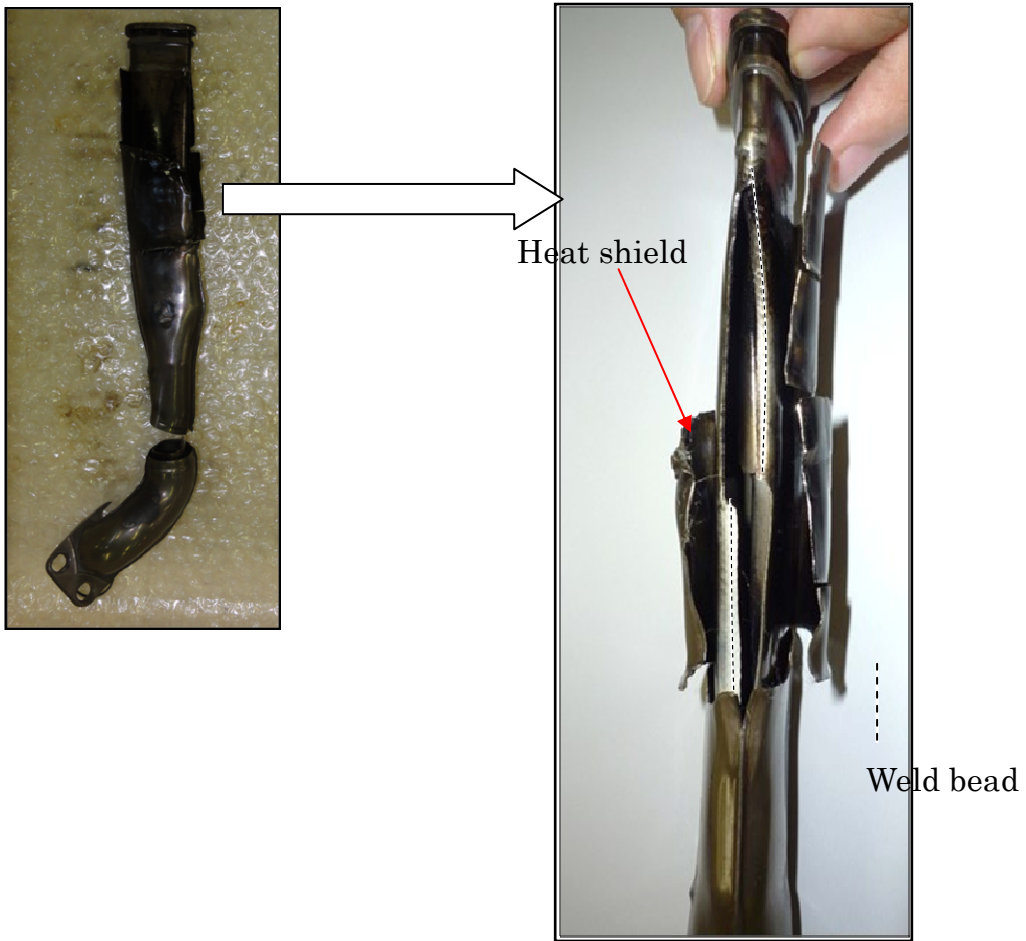
Photo 5 Cracks in the Tube

- (2) There were three longitudinal cracks along the longitudinal weld bead on the Tube; the length of each crack was 2.10 in, 2.65 in and 3.70 in, respectively. Scanning electron microscope evaluation on the crack surfaces showed a number of small dimples, consistent with a overload, which were a trace that progressed crack rapidly from the inner diameter to the outer diameter through the Tube wall.
- (3) The Tube conformed to the engineering drawing specification in thickness and the hardness, no material or processing abnormalities were detected, and no abnormalities were found in the welds.

As described in 2.9.2 (2), there were traces on the longitudinal crack surfaces of the Tube that showed the rapid occurrence of cracks from the inner diameter to the outer diameter of the Tube. Also, as described in 2.8.1, the Case is filled with the 10th Stage Air which exceeds the flash point of the engine oil during takeoff. Therefore, it is possible that the longitudinal cracks on the straight portion were caused by the rapid increase of the inner pressure which resulted from the ignition of the oil upon touching the 10th Stage Air which entered from the fracture.
