**AIRCRAFT ACCIDENT
INVESTIGATION REPORT**

J A 0 0 7 P

AIRCRAFT DAMAGE DURING TAKEOFF RUN FROM WATER, A PRIVATELY OWNED CESSNA T206H (AMPHIBIAN), JA007P LAKE SHINJI, TAMAYU TOWN, MATSUE CITY, SHIMANE PREFECTURE, JAPAN AT AROUND 11:23 JST, APRIL 15, 2017

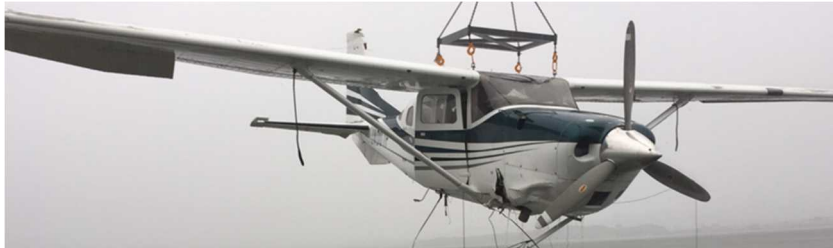
<p>Photo 2 Salvage of the Aircraft</p>

line. The Aircraft collided with wave when it entered the north-side water area of the cape (Yumachi-Hana), stopped, was drifted downwind (to east side) for about 1,500 m, and was sunk as the float separated while drifting.

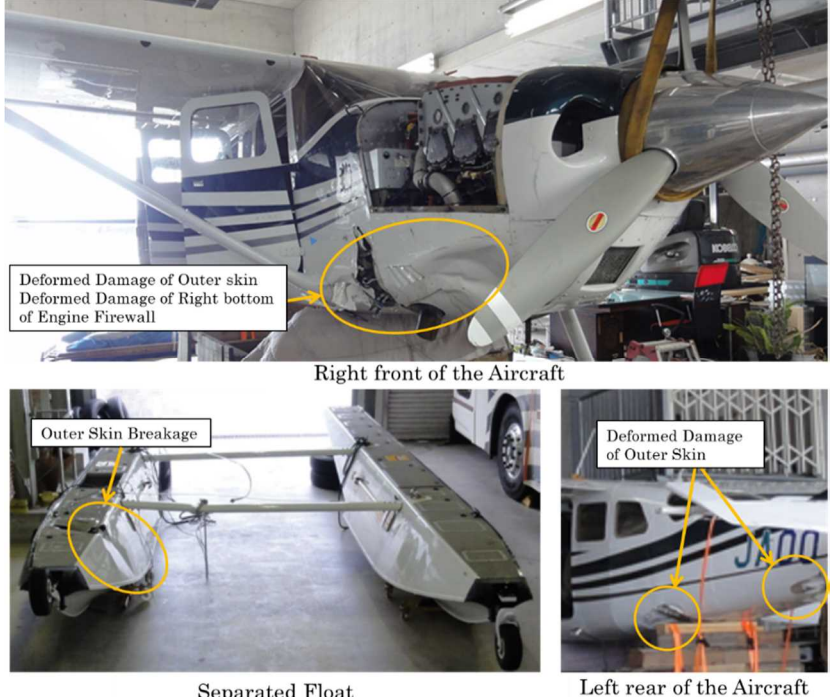
<p>Photo 3 Damage of the Aircraft</p> </div>

<p>around 11:23 on April 15, 2017. (See Fig. 1 Area Map of Accident Site, Fig. 2 Accident Site and Photo 2 Salvage of the Aircraft.)</p>
<p>2.2 Injuries to persons</p>	<p>None</p>
<p>2.3 Damage to Aircraft</p>	<p>Extent of the damage on the Aircraft: substantial</p> <p>① Nose Propeller; Deformed damage Right side bottom of the nose; Outer skin deformed damage Right bottom of Engine Firewall; Deformed damage</p> <p>② Float; Separated from the Aircraft and the float outer skin had breakage.</p> <p>③ Fuselage; Deformed damage on the left bottom of outer skin of fuselage</p> <div style="text-align: center;">

It is probable that when the Aircraft was about to become airborne as performing about 500 m takeoff run from water, it is suffered damage because it collided with such a big wave which was too high to pass over.
