**AIRCRAFT SERIOUS INCIDENT  
INVESTIGATION REPORT**

**J A 0 1 E P**

## OCCURRENCE OF SMOKE IN THE AIRCRAFT PRIVATELY OWNED BEECHCRAFT B200, JA01EP AROUND 10:10 JST, APRIL 6, 2017 OVER KOMATSU CITY, ISHIKAWA PREFECTURE, JAPAN AT AN ALTITUDE OF APPROXIMATELY 20,000 FT

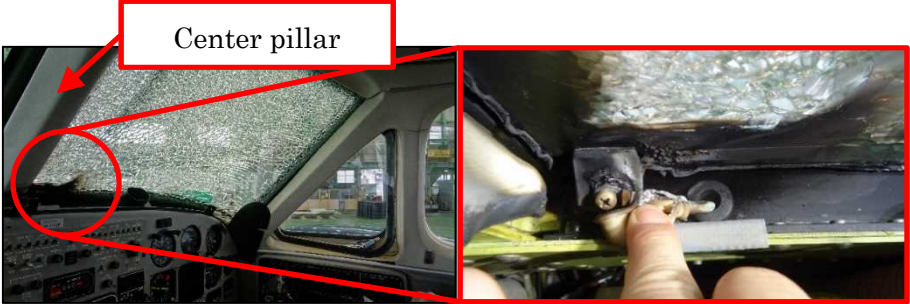
<b>2.2 Injuries to persons</b>	None																																																															
<b>2.3 Damage to Aircraft</b>	<ul style="list-style-type: none"> <li>• Cracks of the right windshield</li> <li>• Burnt marks at/around the terminal block of the right windshield</li> </ul> <div style="text-align: center; margin: 10px 0;">

Cracks like spider-web were found in a whole of the inner glass of right windshield. Cracks looked spreading radially from the originating point in the vicinity of the terminal block. Hump seals which was pasted to fill gaps of the outer-side windshield had no damage due to deteriorations or others.

Right windshield terminal lug was loose and there was gap of 0.05mm between the screws and the terminal lugs.

<p>likely that the odor in the past is generated from the windshield heater. It is desirable to take proper maintenance works as required, by finding the causes thoroughly on any indications and symptoms of malfunction which were occurring repeatedly.</p> <p>(3) Cracks in the windshield</p> <p>Crack in the right windshield were spreading radially from the starting point in the vicinity of the terminal block. It is probable that the glass at the lower corner of the windshield was partially expanded due to the heat from the terminal block and cracks were generated, and which spread to the surroundings.</p>
--	---

<p>In this serious incident, it is probable that because screw of the terminal block at the right windshield had being loosened, the electrical resistance at the contact point increased and the terminal block was overheated, the surrounding combustible parts and components were burned out and the smoke was generated in the aircraft.</p> <p>Regarding loosening of the screw at the terminal blocks, it is somewhat likely that because the tightening torque was insufficient when replacing the windshield, the loosening grew bigger by the vibration caused in flights.</p> <p>Furthermore, it is somewhat likely that it was contributed to the generating of the incident that proper measures were not taken to correct indications and symptoms of malfunctions which were occurring repeatedly.</p>
--
