**AIRCRAFT SERIOUS INCIDENT
INVESTIGATION REPORT**

**OKAYAMA AIR SERVICE CO., LTD.
J A 0 1 H J**

RUNNING OFF THE SIDE OF THE RUNWAY

HONDA AIRCRAFT MODEL HA-420, JA01HJ

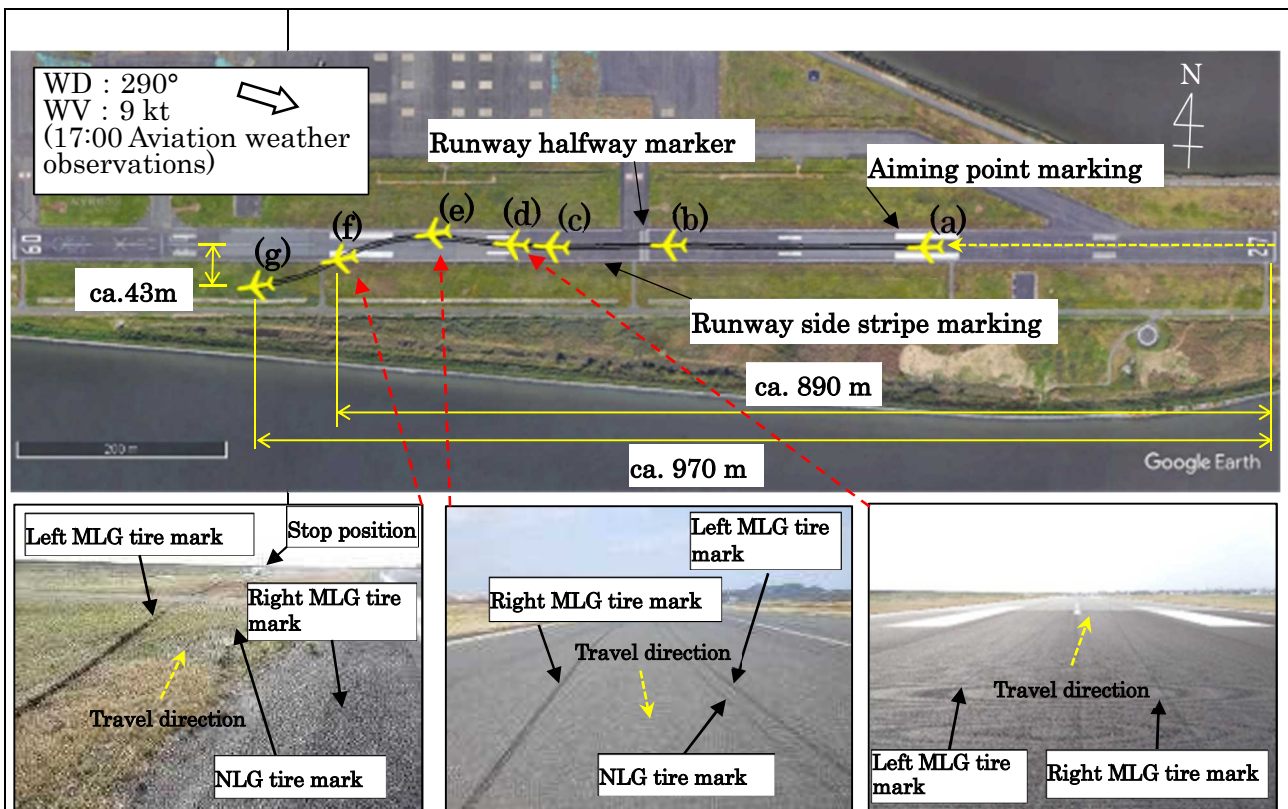
Figure 2: Estimated runway path and tire marks

As the travel direction of the aircraft slightly veered to the left after touchdown (see (a) in Figure 2), the trainee tried to maintain the aircraft's direction along the runway centerline while operating the rudder pedals.

The trainee started to depress the brake pedals in order to decelerate near the runway halfway marker as usual (see (b) in Figure 2) and corrected the aircraft's deviation to the left from the runway centerline by using the steering or braking, and then the aircraft's nose greatly veered to the right (see (c) in Figure 2). Therefore, the trainee depressed the left rudder pedal to correct the travel direction to the left (See (d) in Figure 2).

As the aircraft veered to the left abruptly, the captain felt the aircraft would run off to the left side (south side) of the runway and depressed the right rudder pedal (see (e) in Figure 2). The captain felt that there was a possibility that the load might not be fully placed on the nose landing gear and the main landing gear.

The captain and the trainee tried to correct the travel direction to the right by depressing the right pedal, but the aircraft entered the grassy area after passing the runway side stripe marking (see (f) and (g) in Figure 2).

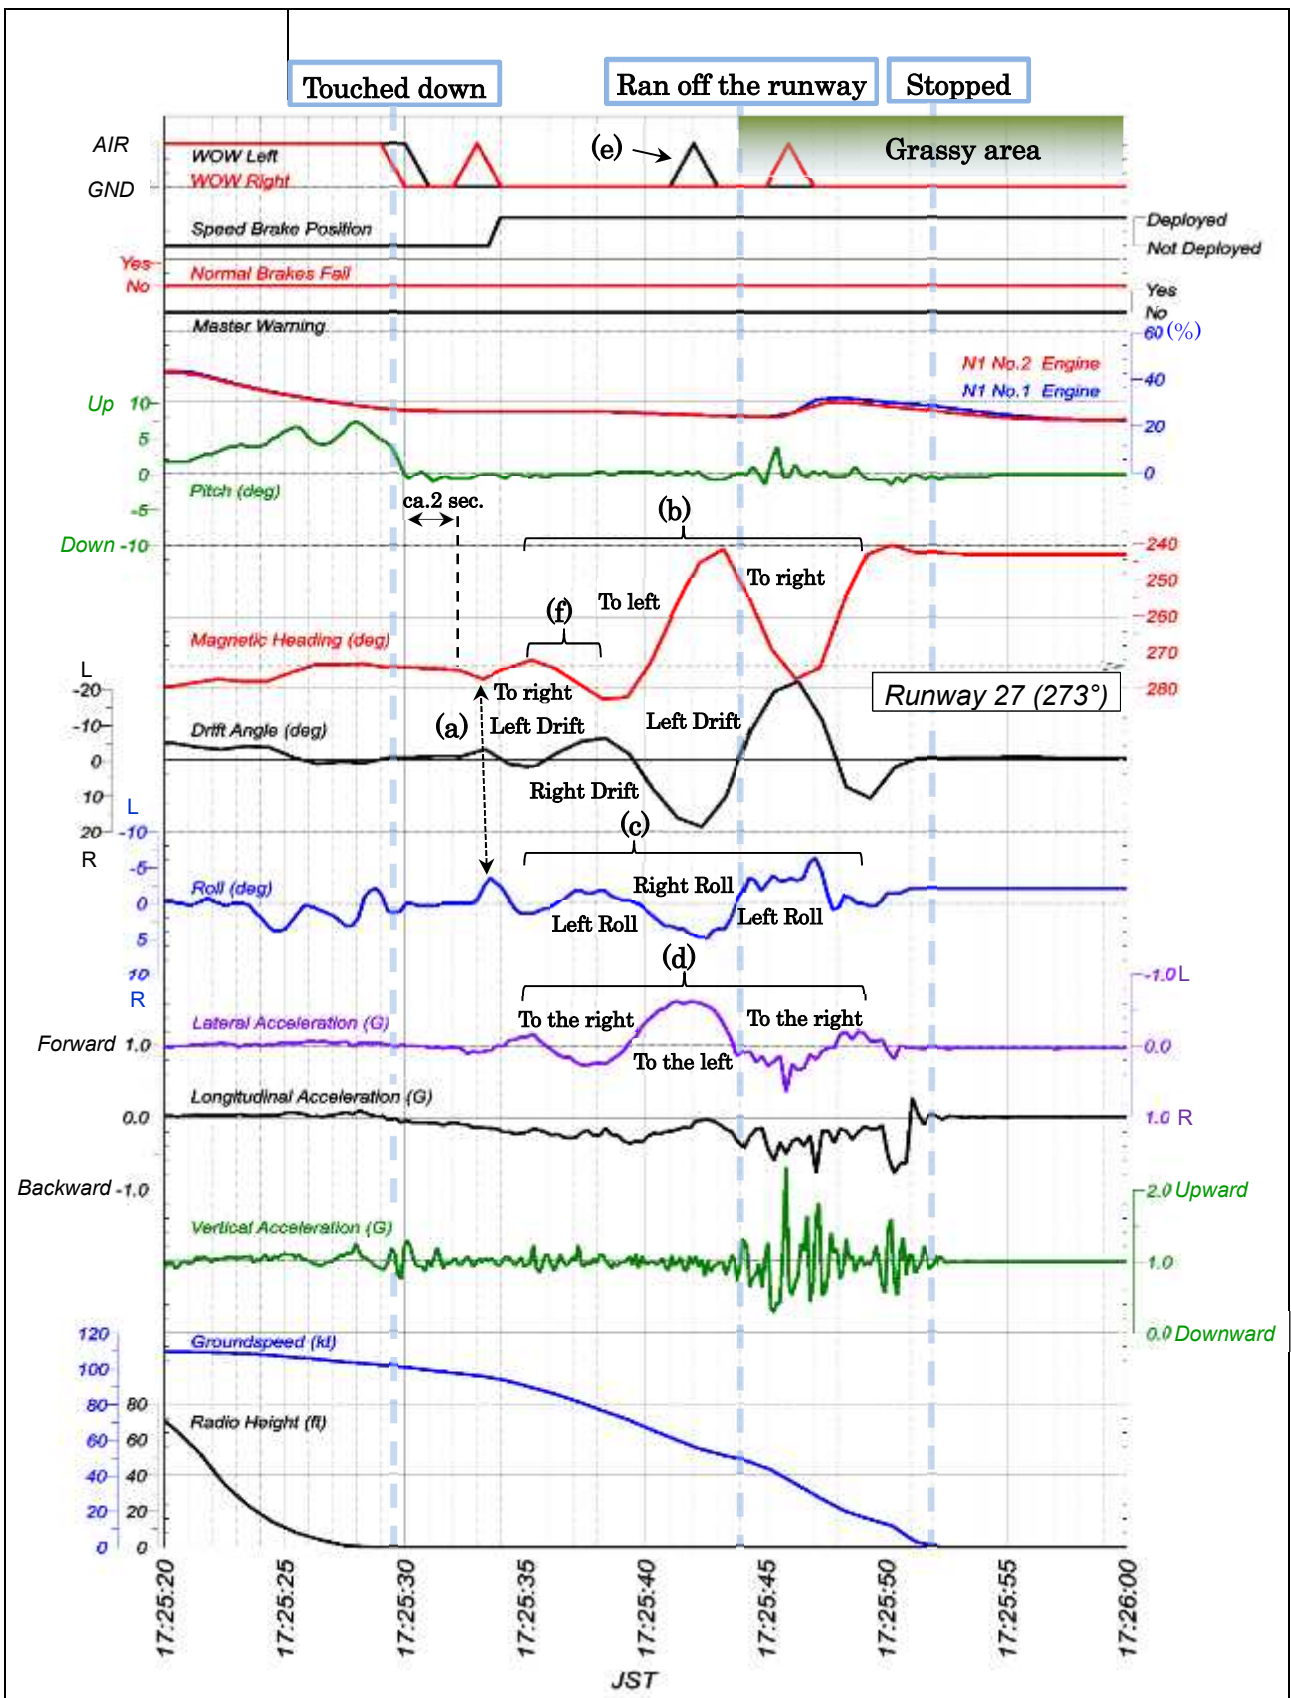
Figure 3: Records from flight recorder and CMF

From approximately five seconds after the aircraft touched down, the change in heading became apparent (See (b) in Figure 3). This change was most likely caused by the operations of the trainee who corrected the aircraft's leftward deviation from the runway centerline, and subsequently corrected the travel direction, while starting to depress the brake pedals in order to decelerate near the runway halfway marker. The fact that the heading started to change to the left was likely caused by the operations of the trainee, who might abruptly switch his depressing rudder pedal from the right to the left, or might not apply the left and right brake pedals symmetrically. Furthermore, the change in heading more likely became greater than 15° per second due to repeated corrections made every time the heading changed. Furthermore, it was recorded that as the heading direction greatly changed, the aircraft was tilted (See (c) Figure 3), lateral acceleration was generated (see (d) in Figure 3), and the WOW of the left main landing gear changed to the Air Mode at about 17:25:42 (see (e) in Figure 3). In addition, judging from the tire marks of the left or right main landing gear, which were left close to those of the nose landing gear, it is probable that the aircraft's tires skidded and the steering control capability and the braking capability of the main landing gear had decreased.

From the above, as the tires skidded during the landing roll and the aircraft was unable to control its travel direction, the aircraft more likely ran off the side of the runway, stopped in a grassy area, and was unable to perform taxiing. It is probable that as the aircraft was tilted and large lateral acceleration was generated due to the excessive corrections on the travel direction, the tires skidded and the travel direction could not be controlled, resulting in the reduced capability of steering control and the main landing gear braking control, and leading to the lost control of the travel direction. However, as the data regarding the input amount of brake pedals and rudder pedals were not recorded by the flight recorder, it could not be determined which operation was responsible for the direct cause.

After the aircraft's heading changed to the right, about three seconds passed before it turned to the left (see (f) in Figure 3), therefore the captain should have more likely given the trainee necessary advice, or taken over the control at an early stage.
