**AIRCRAFT ACCIDENT
INVESTIGATION REPORT**

**JAPAN AIR COMMUTER CO., LTD.
JA01JC**

**CABIN ATTENDANT INJURY
BY THE SHAKING OF THE AIRCRAFT
JAPAN AIR COMMUTER CO., LTD.
ATR 42-500, JA01JC
AT AN ALTITUDE OF APPROX. 10,800 FT (APPROX. 3,300 M)
OVER ABOUT 57 KM NORTH-NORTHWEST OF
TANEGASHIMA AIRPORT
AROUND 11:19 JST, OCTOBER 12, 2019**

July 2, 2021

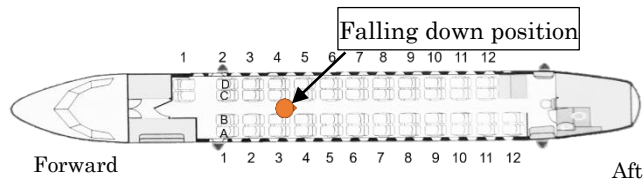
Figure 2: Falling down position of the cabin attendant

was floating and felt a pain in her right ankle because the Aircraft was suddenly shaken when she was walking toward the aft cabin along the aisle around seat row 4 (See Figure 2). The cabin attendant, who was not able to stand up by herself, went to the cabin attendant seat located in the aft cabin with support from a passenger then remained seated in it until the Aircraft landed. After the Aircraft parked, the cabin attendant was taken to a hospital by an ambulance waiting there, and was diagnosed with suspected right anterior talus ligament injury. A fracture of the posterior malleolus of the right ankle was diagnosed, when going to the hospital again on October 15, 2019 for an MRI examination.

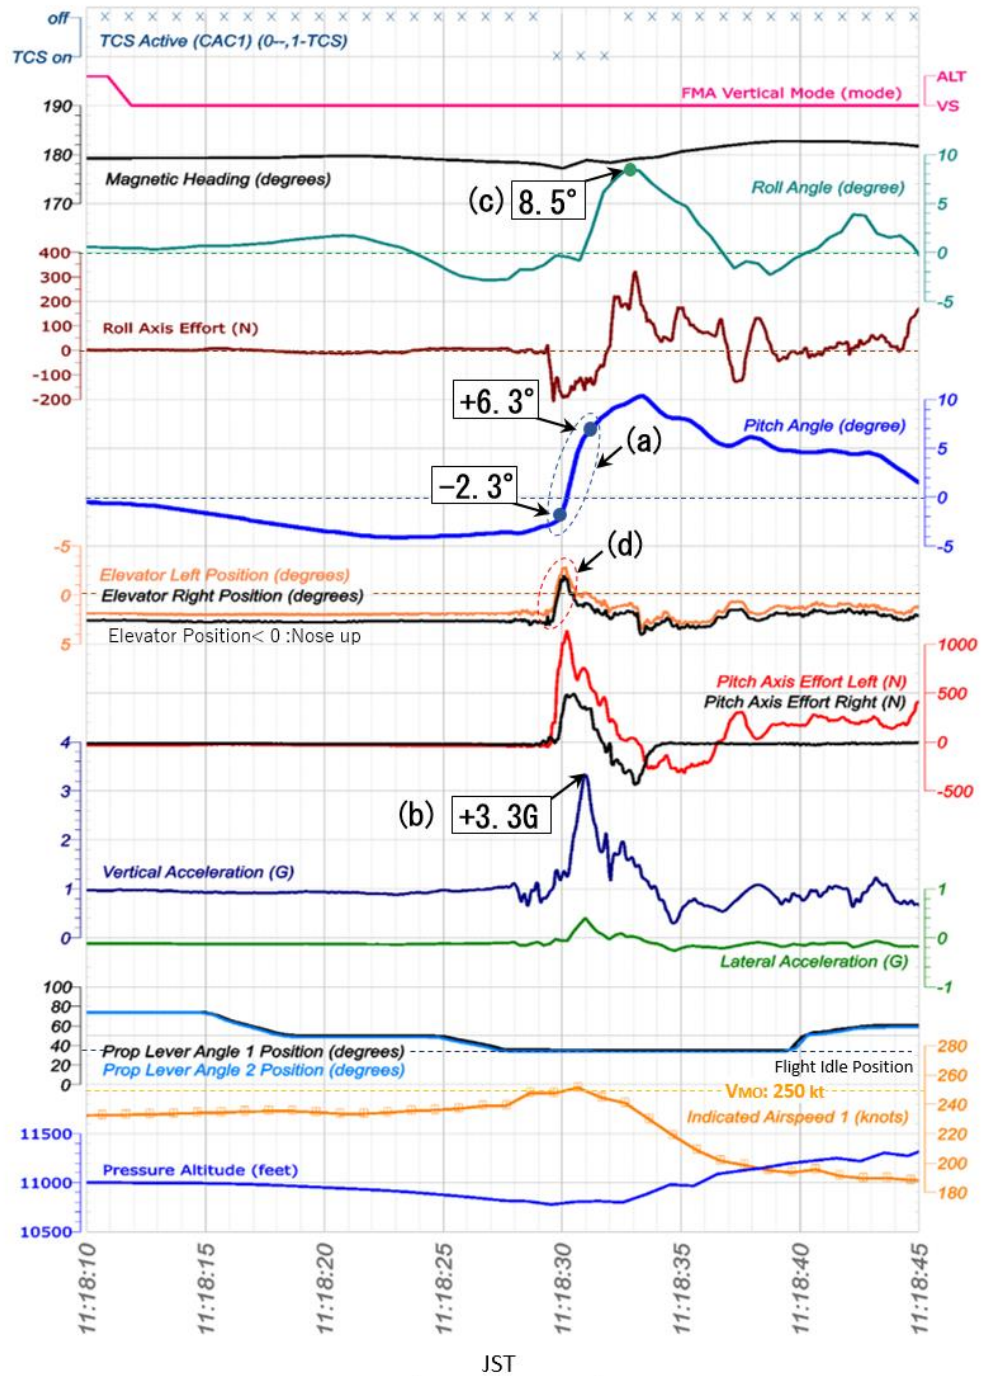
Figure 3: FDR records

According to FDR records, the pitch angle changed in width from -2.3° to $+6.3^\circ$ for about one second around 11:18:30 (See Figure 3 (a)), the vertical acceleration was $+3.3\text{ G}$ around 11:18:31 (See Figure 3 (b)), and immediately after that, the roll angle changed by 8.5° in the right direction (See Figure 3 (c)). Besides, around 11:30:43, when the Aircraft was flying at an altitude of 8,000 ft in the vicinity of the accident site on

was recorded, the elevator had deflected about 5 degrees in about one second (See Figure 3 (d)) and the pitch angle had increased 8.6 degrees in about one second.

As shown in Figure 3, the changes in the Aircraft’s vertical acceleration (about +0.6 G to about +3.3 G) had been recorded in FDR from around 11:18:28. In addition, when the Aircraft was flying in the vicinity of the accident site on the way back to Kagoshima Airport, the changes in the vertical acceleration (about +0.2 G to about +1.6 G) were recorded, therefore, it is highly probable that the Aircraft had been shaking before its IAS approached the V_{MO} . It is probable that the Aircraft was shaken because it encountered localized changes in the wind direction and wind velocity shown in Figure 6 (a).

Besides, it is probable that the maximum vertical acceleration of +3.3 G recorded in FDR around 11:18:31 was the result that the vertical acceleration was added because the Aircraft attitude changed when the PIC and the FO pulled the control columns strongly in order to avoid exceeding the V_{MO} when the IAS had approached the V_{MO} while the Aircraft had been shaking. Furthermore, the result of the calculation by the Design and Manufacturer has given +2.7 G as the vertical acceleration caused by the fact which the PIC and the FO aggressively pulled the control columns, and the maximum vertical acceleration of +2.8 G has been obtained from the examination which simulated the Aircraft’s attitude changes using a simulator.

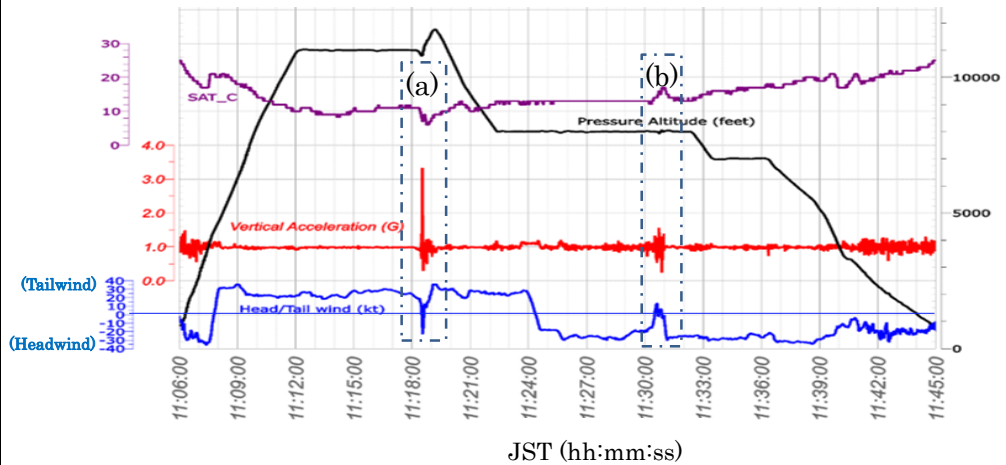
Figure 6: Changes in tailwind/headwind, outside air temperature and vertical acceleration

Figure 6 shows the elements of headwind (sign -) / tailwind (sign +) estimated from the true air speed and ground speed recorded in FDR and the outside air temperature from the take-off from Kagoshima Airport to the landing at Kagoshima Airport.
