**AIRCRAFT SERIOUS INCIDENT  
INVESTIGATION REPORT**

**J A 0 1 K Y**

**J A 2 4 7 1**

UNINTENTIONAL RELEASE OF OBJECT (TOW ROPE)  
1. JAPAN STUDENT AVIATION LEAGUE  
DIAMOND AIRCRAFT HK36TTC SUPER DIMONA, JA01KY  
(TOW PLANE) (MOTOR GLIDER)  
2. JAPAN STUDENT AVIATION LEAGUE  
ALEXANDER SCHLEICHER ASK21, JA2471  
(TOWED PLANE) (GLIDER)  
AT AN ALTITUDE OF APPROX. 150 M OVER VICINITY  
OF KOMATSU AIRPORT, ISHIKAWA PREFECTURE  
AT ABOUT 12:03 JST, SEPTEMBER 16, 2019

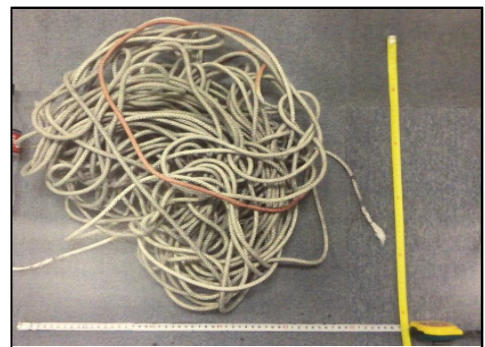
Figure 2 Dropped the tow rope

The dropped tow rope was found in a grassy area on the side of the eastern taxiway shoulder in the vicinity of 310 m south of runway 24 threshold of the Airport. There was no damage to the ground as the grassy area was far from the audience seats. The length and weight of the dropped tow rope were approximately 61m and 1.7 kg, respectively.

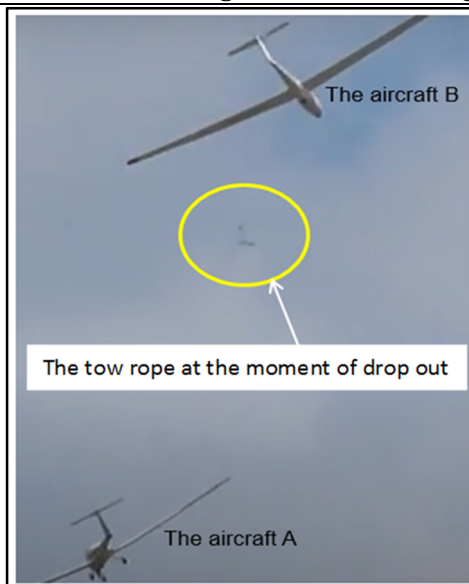
Figure 5 Footage showing the moment the tow rope dropped

Footage taken by a witness on the ground recorded how the tow rope was dropped out during left circling in the second round of the demonstration flight. According to the footage, the tow rope, which was dropped out almost simultaneously from the Aircraft A and B sides, instantly retracted gathering in the center, and dropped like a bunch.

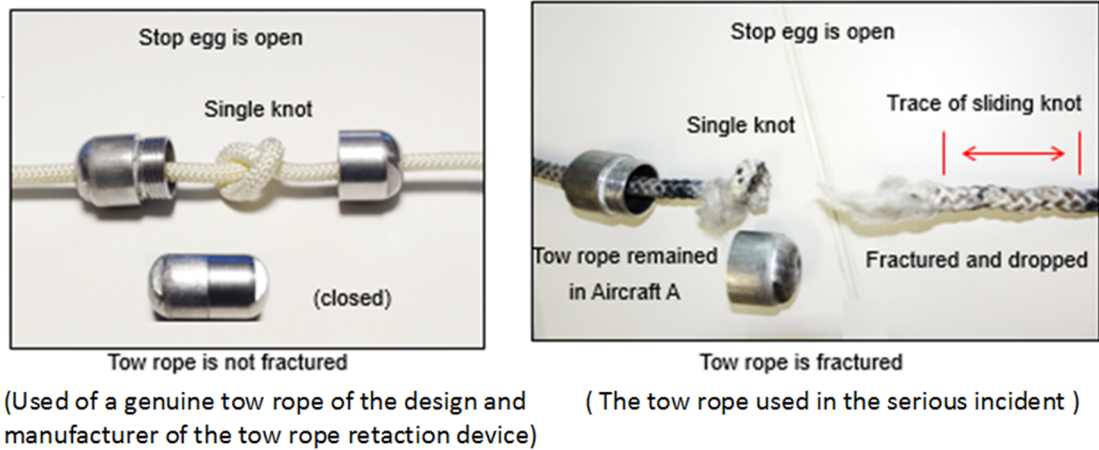
Figure 6 Fractured the tow rope (The aircraft A)

The tow rope remained in the Aircraft A side (approximately 5.5m long) had a knot that was fractured like tearing off within the egg stop (see Figure 6).

The JTSC concludes that the probable cause of the serious incident was most likely that, when the aircraft A was flying towing the aircraft B in the serious incident, the tow rope connecting both aircraft was fractured on the aircraft A side, and the knot made within the end piece on the aircraft B side was untied almost simultaneously, which led to dropping of the tow rope on the grassy area of the Airport.

Furthermore, the Design and Manufacturer revised DAI-WI No. 28 stipulating that a knot within the stop egg is to be a single knot.

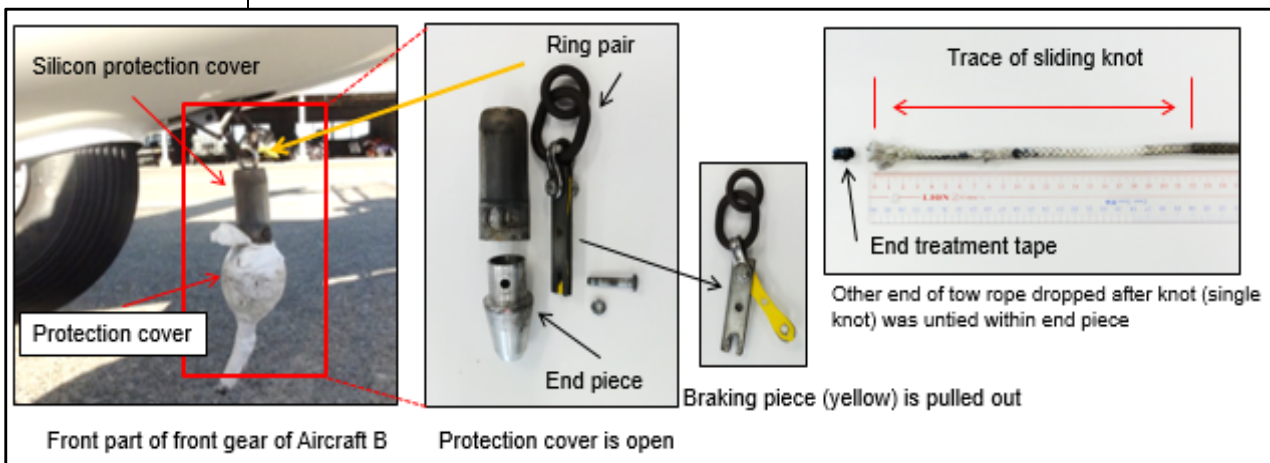
Figure 7 End piece and the tow rope with untied knot (The aircraft B side)

On the other hand, the tow rope went missing from the end piece\*<sup>2</sup> attached to the aircraft B, and only the end treatment tape was found in the protection cover. The braking piece\*<sup>3</sup> attached to the end piece was not cut. Besides, one end of the dropped tow rope was fractured like it was torn off (right photo in Figure 6) similar to the tow rope remained in the aircraft A side, and the tow rope on the aircraft B side had an untied knot (see Figure 7).

From the results of sliding tests of part of knots, it was confirmed that a single knot is easier to slide than a figure-eight knot. From this, the JTSC concludes that it is likely that the knot in the tow rope threaded onto the end piece on the aircraft B side and used in the serious incident was a single knot, not a figure-eight knot.

Besides, when attaching a tow rope within the end piece, figure-eight knot is required to be securely made and be contained within the end piece.

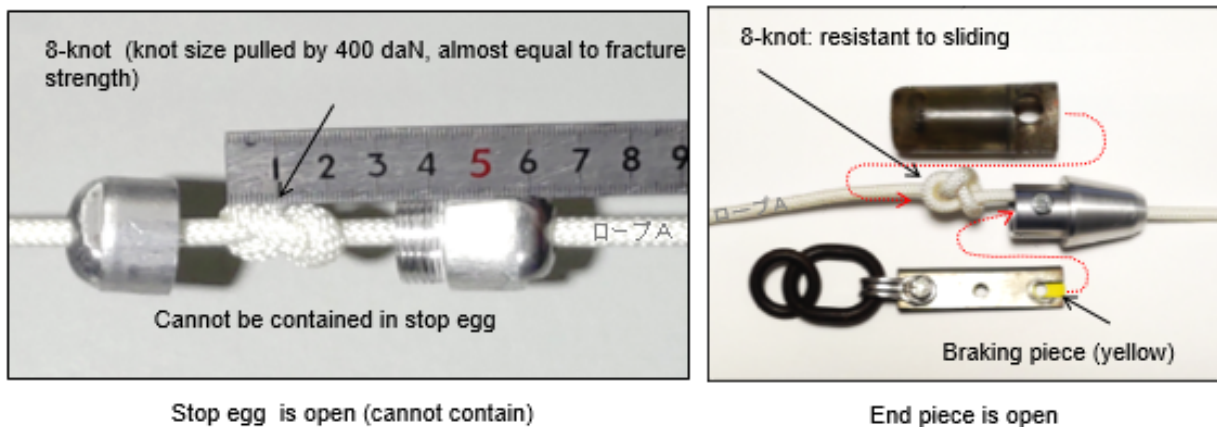
Figure 9 The tow-rope treatment based on DAI-WI No. 28(Rope A)

In the investigation, figure-eight knot was made in a genuine tow rope of the design and manufacturer of the tow rope retraction device (hereinafter referred to as “the Rope A”) in an attempt to verify whether the knot could lie within the stop egg and end piece. As a result, it was confirmed that figure-eight knot was difficult to lie with the stop egg. A single knot could lie within the stop egg. Besides, figure-eight knot could lie within the end piece.

Attaching a tow rope to the stop egg is to be appropriately conducted in accordance with DAI-WI No. 28. However, through the investigation, it was revealed that figure-eight knot of the Rope A was too big to be contained within the stop egg. Inquiry on this point was made to the Design and Manufacturer of the aircraft A, which responded that DAI-WI No. 28 was revised to make a single knot within the stop egg according to DAI-WI No. 28.
