**AIRCRAFT ACCIDENT
INVESTIGATION REPORT**

**Japan General Aviation Service Co., Ltd. (JGAS)
J A 0 1 T C**

Company	Japan General Aviation Service Co., Ltd. (JGAS)
Type, Registration Number	Cirrus SR20, JA01TC
Accident Class	Damage to Aircraft during Landing
Date and Time of the Occurrence	At about 11:05 Japan Standard Time (JST: UTC+9 hours), December 26, 2022
Site of the Accident	On Runway at Amakusa Airfield, Kumamoto Prefecture (32°28'50" N, 130°09'45" E)

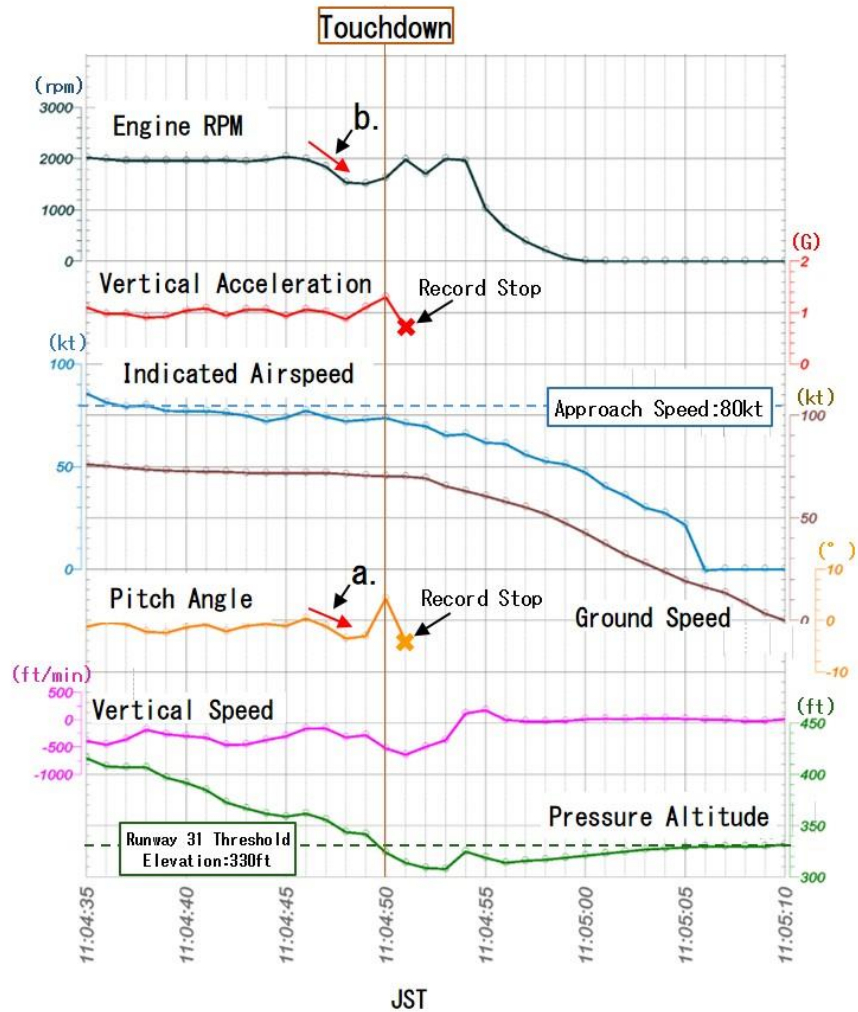
The aircraft was approaching the threshold of Runway 31, but the descent path was low and the speed was also below the approach speed, therefore, the captain instructed Trainee A to execute a go-around by saying, "Go around." However, as the aircraft's nose went down (see Figure 1: Records of Flight Data Logging Function *1 a.), the captain said again, "Go around" and tried a take-over, but the aircraft touched down on the nose landing gear first and traveled on the runway with a part of nose landing gear including the tire fractured, and then was disabled on the runway. Trainee A stated that Trainee A felt as if having pushed the control yoke forward when trying to execute a go-around following the captain's instruction.

Regarding that Trainee A having pushed the control yoke forward, it is possible that because pilots would move the power lever forward with the right hand when executing go-around operations in the left pilot seat, Trainee A, who flew in the right pilot seat of Cirrus SR20 for the first time, gave the control yoke which Trainee A operated with the right hand the input to the power lever. In addition, it is possible that because pilots would pull the control yoke when executing go-around operations in the left pilot seat, Trainee A gave the power lever which Trainee A operated with the left hand the input to the control yoke, pulling it backward, and it is probable that the decrease in engine power of the aircraft (see Figure 1 b.) contributed to the nose-down of the aircraft.

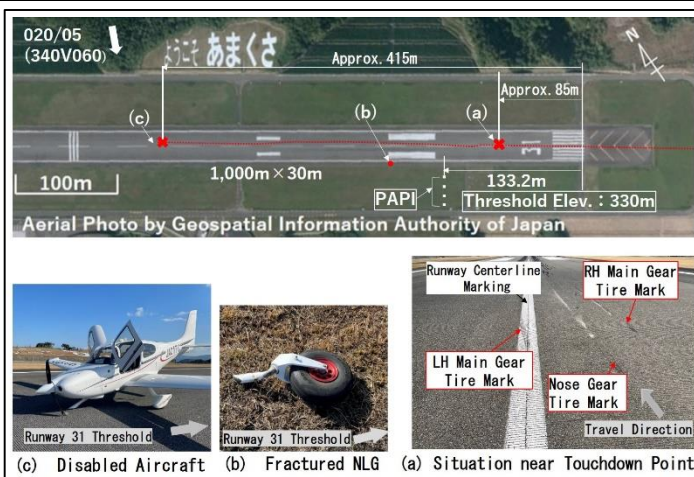
Figure 2: Estimated Flight Route and the Accident Site

The JTSCB concludes that it is most likely that because the aircraft's nose went down when the go-around was attempted as instructed by the captain, the aircraft touched down on the nose landing gear first, and then was disabled on the runway.

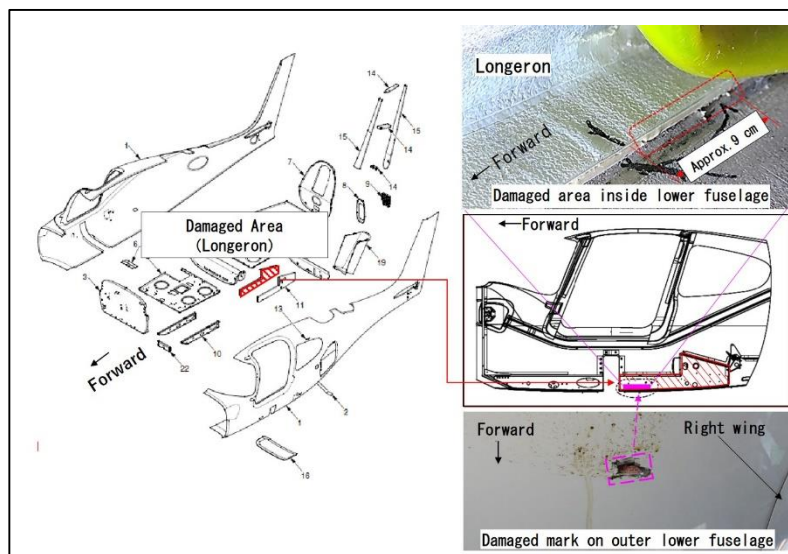
Figure 3: Damaged Area at the lower fuselage

Besides, in the inspection of the inner fuselage, as shown in Figure 3, at the right-side central lower structure of the fuselage (Longeron), damage equivalent to major repair (separation of the adhesive surface between the fuselage outer skin and Longeron) was found.

The JTSB concludes that it is highly probable that when the aircraft touched down on the nose landing gear first, its propellers touched on the runway surface and were damaged. After that, it is highly probable that a part of the nose landing gear was broken along with the tire, and it hit the tire cover and then lower fuselage and the lower surface of the left horizontal stabilizer. Furthermore, it is highly probable that the lower structure of the right central fuselage (Longeron) was damaged when the broken nose landing gear hit the lower fuselage.

The JTSB concludes that the probable cause of this accident was most likely that because the nose went down when the Aircraft tried to execute a go-around, the lower structure of the right central fuselage (Longeron) was damaged when the broken landing gear hit the lower fuselage after the Aircraft touched down on its nose landing gear first on the runway.

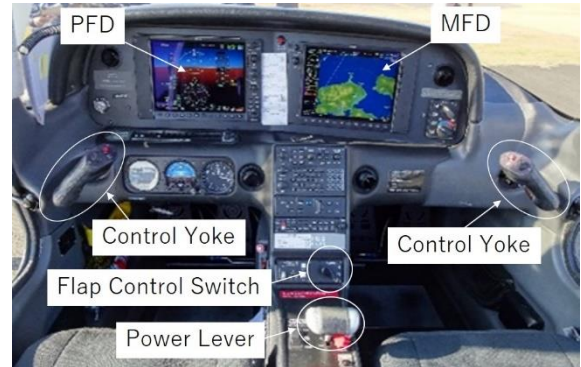
Figure 4: Cockpit of the Aircraft

The control yoke of the aircraft is a side control type (see Figure 4). Fore and aft movement of the control yoke controls the pitch axis, and tilting it to the left and right controls the roll axis.

Regarding the fact that the aircraft's nose went down, Trainee A probably pushed the control yoke forward when trying to execute a go-around, and it is possible that Trainee A in the right pilot seat moved the control yoke handled by the right hand forward instead of the power lever.

- a. It is probable necessary for the Company to provide an environment conducive to flight training after sorting out the differences in flight operations between the right and left pilot seats including that when trainees conduct flight operations in the right pilot seat, their left and right hands operate different devices, and how different looks have the instrument displays between the right and left pilot seats, and preparing well in advance.
- b. It is necessary for the Company to verify the points to be noted when a trainee takes flight training in the right pilot seat, clarify the procedures for the trainee to control the airplane sitting in the right pilot seat as well as reeducate about the takeover by the instructor during the flight training.
