AI2017-4

**AIRCRAFT SERIOUS INCIDENT
INVESTIGATION REPORT**

PRIVATELY OWNED CIRRUS SR22T, JA01YK INABILITY TO OPERATE DUE TO DAMAGES OF THE LANDING GEAR OF THE AIRCRAFT KAGOSHIMA AIRPORT AT ABOUT 13:20 JST, MARCH 21, 2016

July 21, 2017

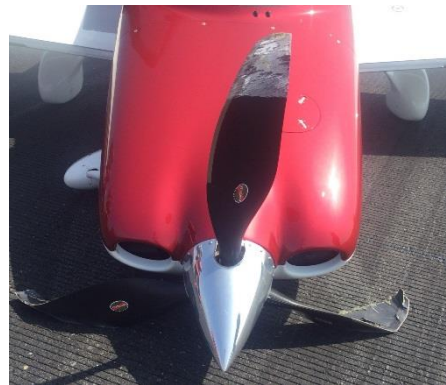
Photo 1 Propellers and its periphery

| (1) Fuselage | : Damage at lower parts of Engine Cowling |
| (2) Propeller | : Blades (all three blades) damage |

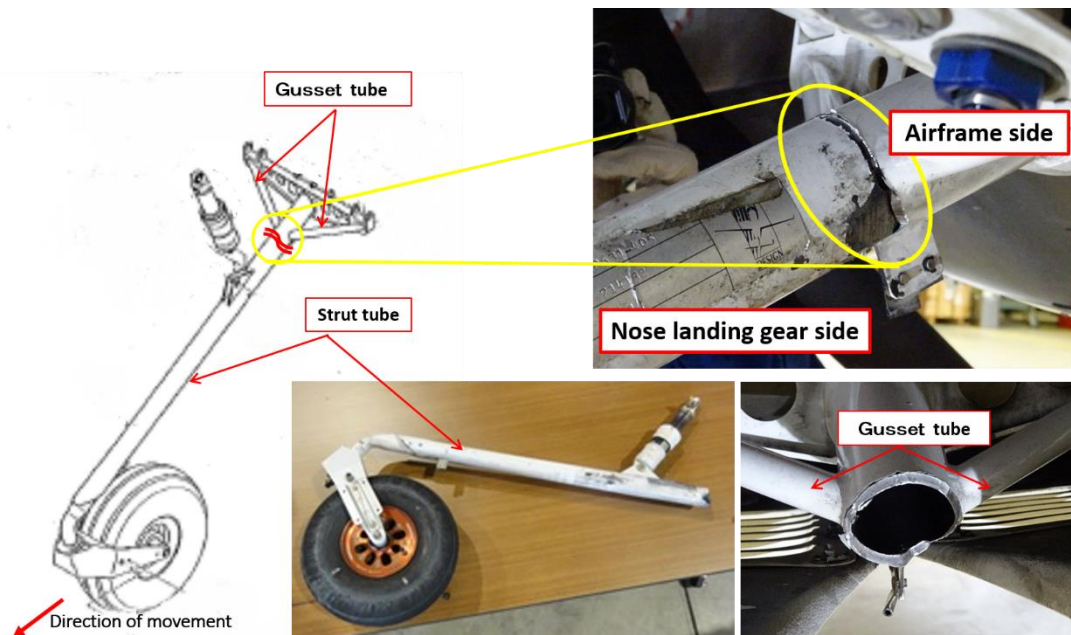
Figure 2 Nose landing gear and the Fractured Strut tube

| (3) Nose Landing Gear | : Fracture of the Strut tube |

As described in 3.6.2, it is probable that because the strength of the nose landing gear strut tube decreased significantly due to the progress of the open crack, the nose landing gear strut tube resulted in the fracture, attributable to the load of the landing at the time of the occurrence of the serious incident. Thereby, it is highly probable that downing the nose had the propellers in contact with the runway and caused the damages to the airframe.

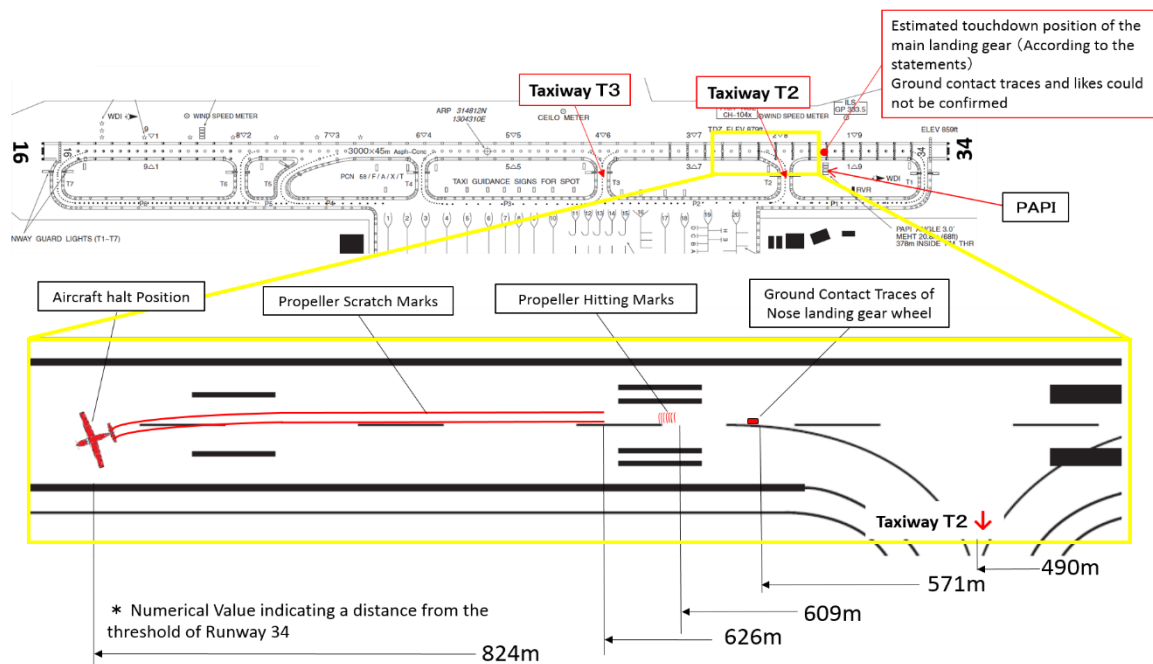
Figure 3 Traces on the runway

- (1) The Aircraft halted at 824 m inside of the runway 34 threshold.
- (2) Dark and short-stroked contact traces which is matching width of tire (10 cm) of the nose wheel was at 571 m inside of the runway 34 threshold, but the tire marks of the main landing gear wheel could not be identified.
- (3) Hitting marks by the propellers were left on the runway 34 from 609 m inside of the threshold for about 8 m intermittently. Furthermore, the scratch marks by the propellers were left from the 626 m inside of the runway 34 threshold to the Aircraft halt position.

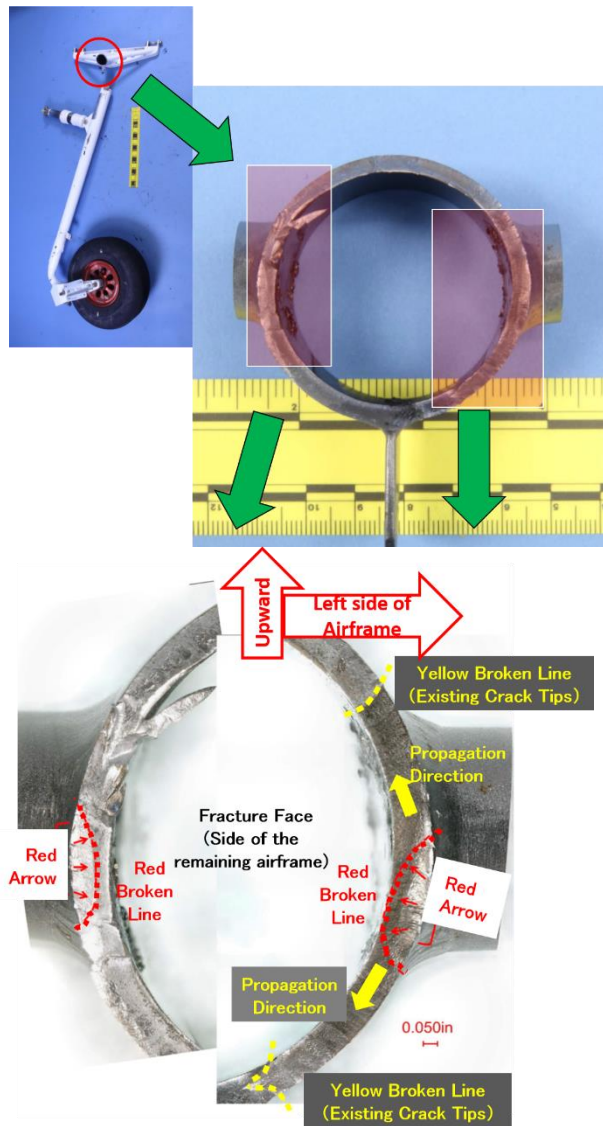
Figure 4 Fracture Surface Analysis of the nose landing gear strut tube

- (1) The strut tube had a fatigue crack that generated prior to the occurrence of the serious incident.
- (2) The left side of the fracture surface (the right side in Figure 4);

- ① The red broken lined parts indicates the progress of the crack which was generated at the forward toe of the Gusset tube weld bead of the strut tube(hereinafter referred to “the Edge of the strut tube”).
- ② The red arrow indicates the progress of the generated multiple cracks starting from the Edge of the strut tube.
- ③ The crack which penetrated the wall of the strut tube in the red broken lined parts indicates the occurrence of repeated stress in this part.
- ④ The yellow arrow indicates further progress of the penetrating crack to the top and bottom direction along the circumference of the strut tube and the advancement of the crack to the yellow broken line right before the fracture.

(3) The right side of the fracture surface (the left side in Figure 4);

As same as the left side of the fracture surface, the red broken line parts had the traces of the progressed crack starting from the multiple places at the Edge of the strut tube due to a fatigue. However, there was no penetration nor progress along the circumference direction due to cracks.

(4) The electron microscopic observations indicated the traces associated with repetition of the opening and closing of the crack on the fracture surface, and the welded part had even more small cracks at the Edge of the strut tube where the fatigue originated.

Based on the fracture surface analysis done at NTSB, it is highly probable that the crack was progressed by the repeated application of the load.

As shown in Figure 4, the progress of the crack indicated by the red arrows at the fracture surface of the nose landing gear strut tube were seen evenly on the right and the left and it is somewhat likely that the repeated occurrences of shimmy contributed, mainly.

Furthermore, about the large progress of the crack in the yellow arrows which is spreading at outside of the red arrows and seen only at the left side of the airframe on the fracture surface, as described in 3.5.2, it is probable that it is because of the operation to start the left turn without sufficient deceleration in order to vacate the runway after landing, and it is probable that a high tensile force were generated due to the moment to bend the strut tube to the right wing side on the left side of the Edge of the strut tube. It is probable that the open cracks were progressed from the left side of the nose landing gear strut tube because this operation were executed for many times at landing, at each time a high stress was generated on the strut tube end, repeatedly.

The Company examined the increasing a thickness around the welded part of the nose landing gear strut tube in order to improve the strength of the welded part of the nose landing gear strut tube, and decided to apply it for all of the nose landing gear to be newly manufactured and to be replaced after 2017.

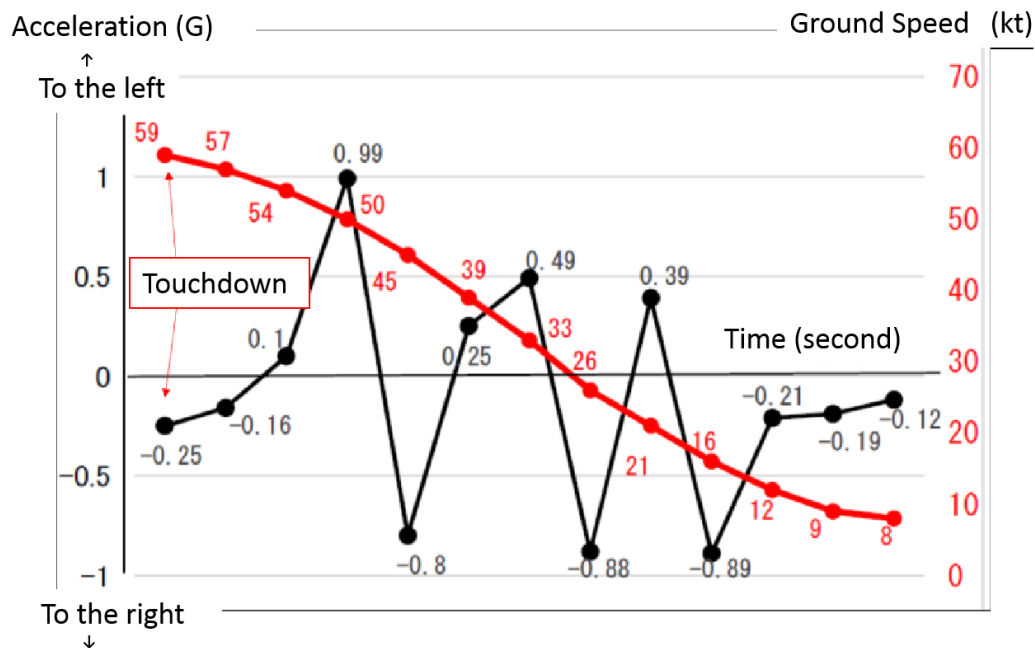
Figure 5 Lateral Acceleration and Ground Speed variations
(Measuring values: once per second)

From the 29 times to vacate from the taxing T2 by the control of the Captain, the lateral acceleration after the touchdown was within the range of 0.14 G to 0.99 G. The variation of lateral acceleration and ground speed after the touchdown at the time to mark the 0.99 G for the lateral acceleration are as shown in Figure 5. Furthermore, including this case, the similar landing cases with wide swing of lateral acceleration to + and – were saved as in Table 1.

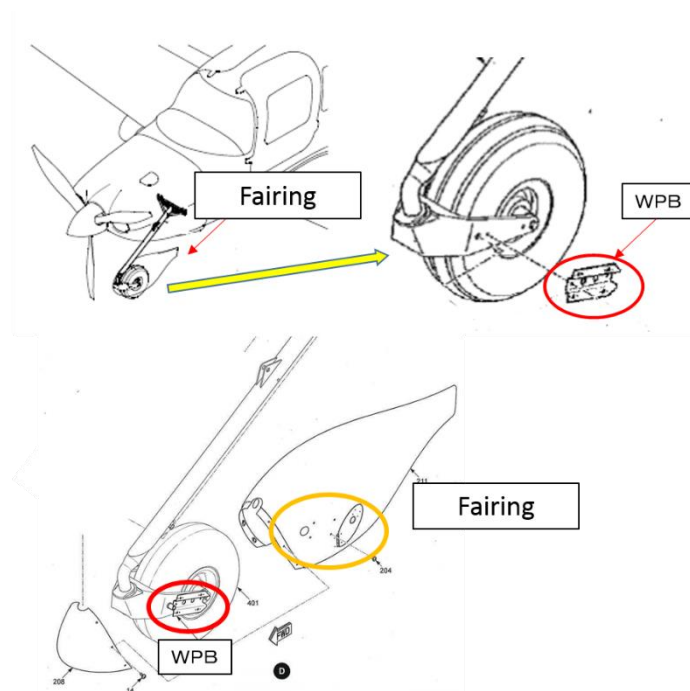
Figure 6 Fairing and WPB

The fairing for the nose landing gear of the Aircraft was fixed on the nose landing gear via WPB (Wheel Pant Bracket). This WPB could be deformed when the high stress applied to the nose landing gear, the Maintenance company kept the replacement records of the WPB of the Aircraft as described in Table 2.

Furthermore, as described in 2.12.2, because there were records to replace the WPB three times within a short while, it is somewhat likely that the Aircraft repeated landings with applying high stress onto the nose landing gear.
