AIRCRAFT SERIOUS INCIDENT INVESTIGATION REPORT

**Nakanihon Air Service Co., Ltd.
J A 0 2 A H**

February 29, 2024

CASE WHERE A SLUNG LOAD CARRIED EXTERNAL TO AN AIRCRAFT WAS RELEASED UNINTENTIONALLY NAKANIHON AIR CO., LTD. EUROCOPTER AS 350 B3 (ROTORCRAFT), JA02AH ONO CITY, FUKUI PREFECTURE AT APPROXIMATELY 13:08 JST, OCTOBER 24, 2022

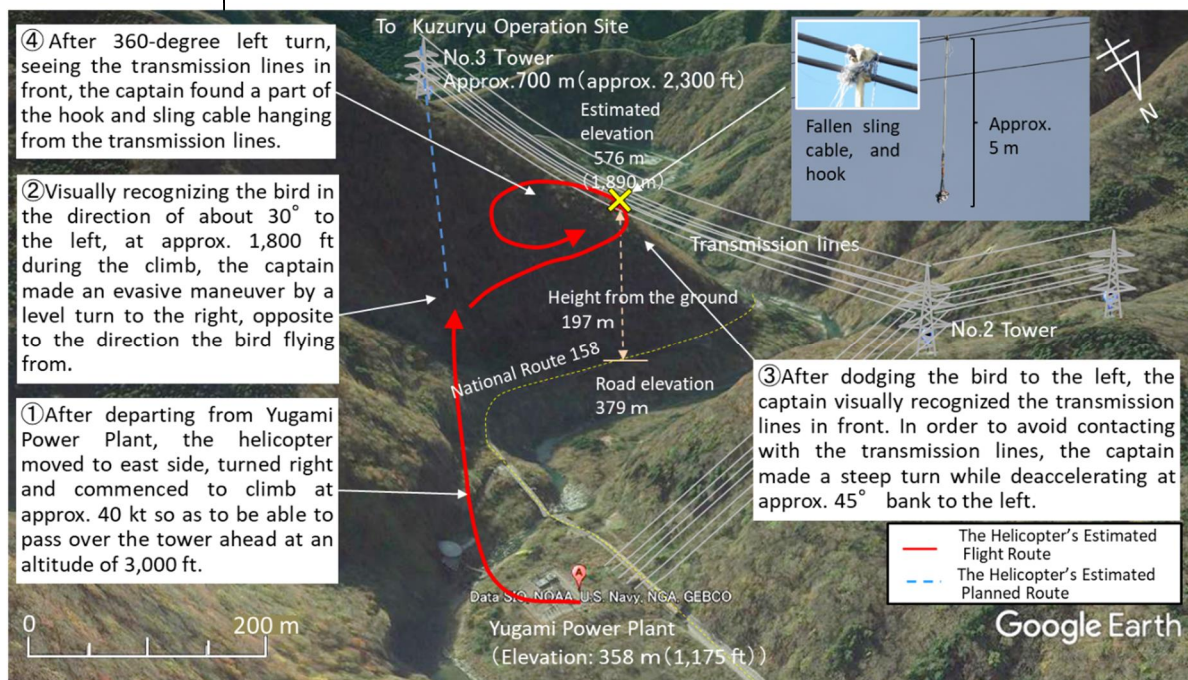
Figure 2: The helicopter's estimated flight route when it fell the hanging object

This serious incident occurred at around 13:08 on October 24, 2022, at an altitude of about 1,900 ft, directly above National Route 158 (Latitude 35°56'26"N, Longitude 136°38'19"E).

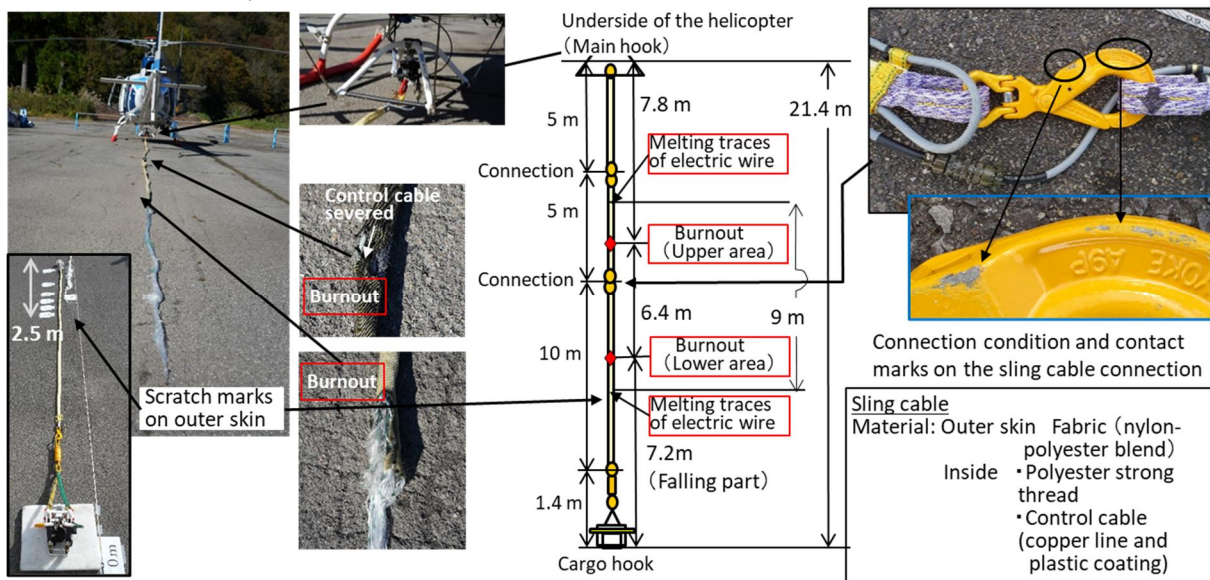
As shown in Figure 3, there were two black burnt areas on the sling cable (6.4 m apart). The upper burnt area was 7.8 m from the lower part of the helicopter, and the lower burnt area was 7.2 m from the cargo hook, and the area side lower than the lower burnt area was fractured. Besides, there were new scratch marks without rust on the hook at the connection between 10 m sling cable and 5 m sling cable. Furthermore, there were two melting marks of plastic coating (9 m apart) on the control cable, in addition to the two burnt areas.

Figure 3: Sling Cable Damage Condition

D. The sling cable was burnt out at the upper and lower contact points, and in the lower burnt area (see Figure 3 and Attached Figure) the inner polyester fibers were broken as if to be torn apart up and down. The broken lower part of sling cable lifted the transmission lines from below due to the inertial force of the fallen hook, additionally, the upper part of the fallen sling cable wrapped around the two upper and middle transmission lines as if to cover them doubly.

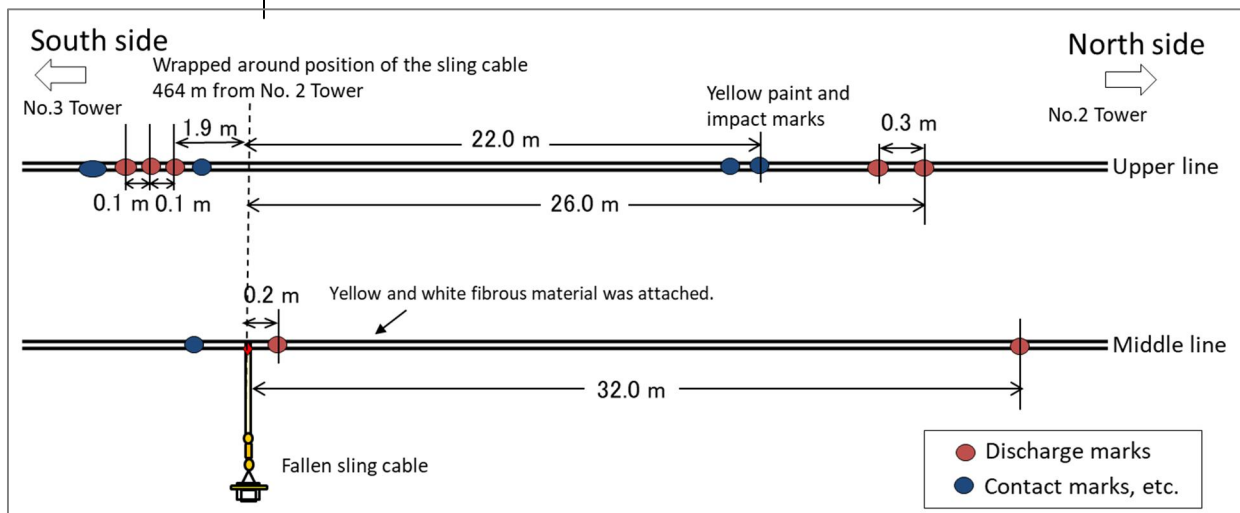
The fallen sling cable was wrapping around the upper and middle lines of the transmission lines on the east side at the position of 464 m from No.2 tower located on the north side. To the north from that position, at 26 m on the upper transmission line and at 32 m on the middle transmission line, there were discharge marks, respectively. Besides, at the position of 22 m to the north of the upper transmission line, there were yellow paint and impact marks, which was the same color of the sling cable connection, (see Figure 8). Furthermore, yellow and white fibrous material was slightly attached on the middle transmission line on the north side from the position where the sling cable wrapped around.

Figure 6: Discharge Marks and Impact Marks, etc. on Transmission Lines

There were discharge marks and contact marks on the surfaces of the upper and middle lines of the transmission 4 lines on the east side, as shown in Figure 6. Besides, at 22 m on the east side upper line north of the drop position (its wrapped around position) of the sling cable, there were yellow paint and impact marks, which was the same color of the sling cable connection, furthermore, yellow and white fibrous material, which was the materials for the outer skin of sling cable, was attached on the middle line on the north side from the drop position of the sling cable. Based on these traces and the burnout condition of the sling cable, in an extremely short time during the steep turn, the underslung sling cable more likely contacted with the transmission lines on the east

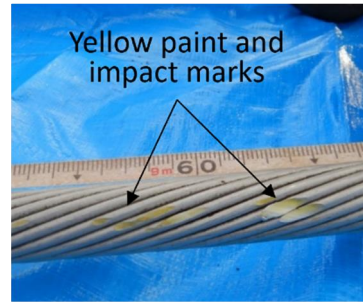
Figure 8: Contact Marks on Transmission Line Surface

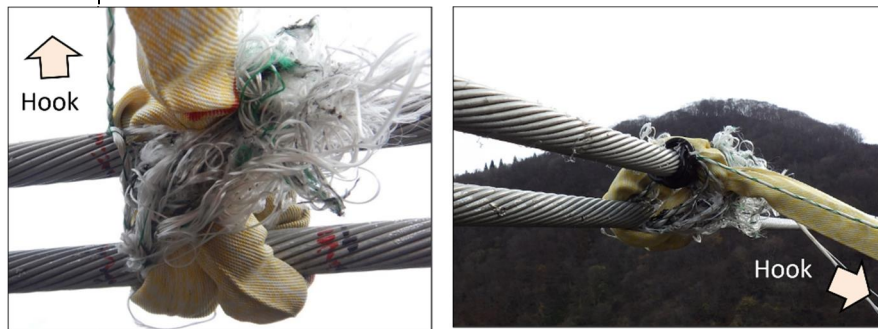
Regarding the condition of the tangled sling cable, its approximately 5 m including the cargo hook at the bottom was hanging from transmission lines, and the upper part of approximately 2 m wrapped around the upper and middle of the transmission lines on the east side circuit as if to cover them doubly.

Figure 9: Tangled Sling Cable on Transmission Lines
(The photo taken during removal work)

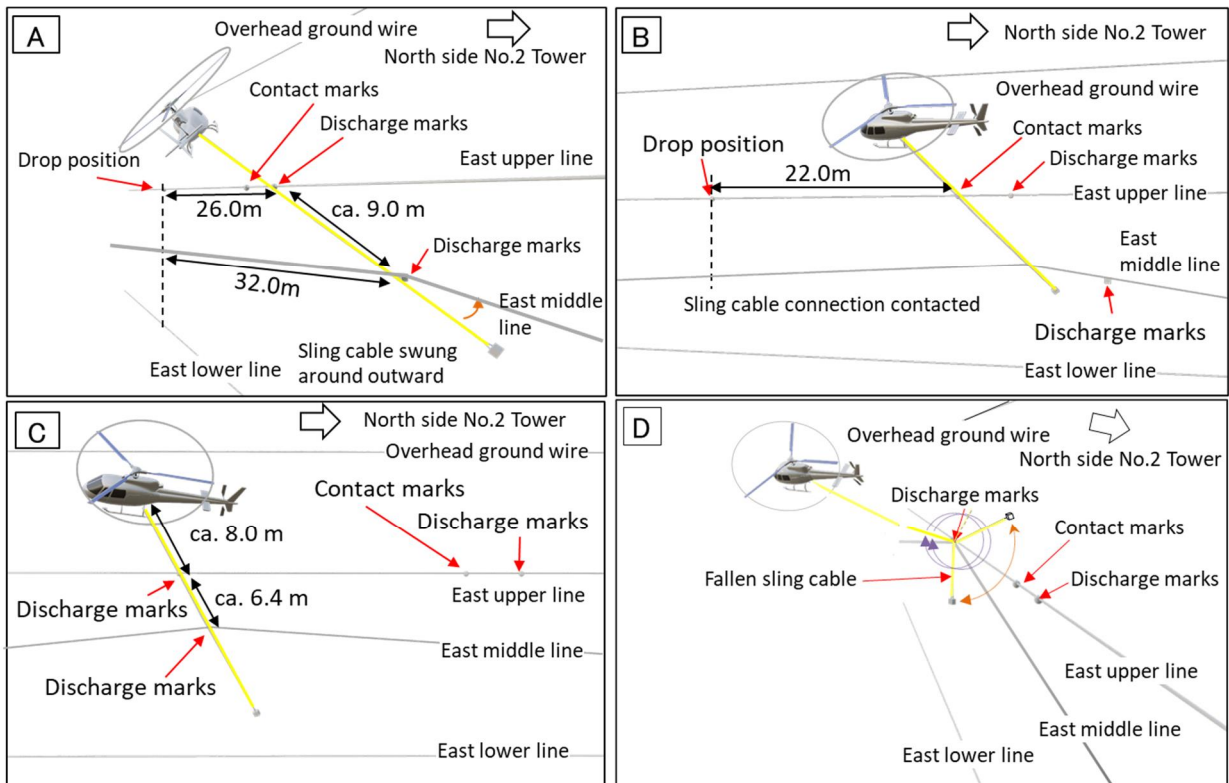
Figure 10: Sling Cable Status from the Contact with Transmission Lines to the Fracture

A. It is probable that when the helicopter made a steep turn in order to avoid the transmission lines, the underslung sling cable swung around greatly according to the change in the bank angle of the helicopter, and insulation breakdown occurred at the two locations (approximately 9 m apart between the two points) on the upper transmission line, approximately 26 m north and on the middle transmission lines, approximately 32 m north of the location where the lower part of the sling cable fell, and discharged an electrical current. It is more likely that as the sling cable contacted with the middle line initially, its voltage was applied to the sling cable, and when the sling cable approached the upper line, it discharged. At this time, the high voltage was temporarily shut down by a safety device.

B. Starting from the contact point with the middle line, the sling cable lifted the middle line due to inertial force, additionally, the sling cable connection contacted with the upper line like colliding with it. As a result, the upper line probable moved to the west like swinging.

overhead ground wire, and the sling cable continues to make rubbing contact with the midline, during which high voltage was probable restored. When the spacing between the upper and middle lines came to 6.4 m, the upper line contacted as if to be pressed against the sling cable, and at the upper and lower contact points, excessive current flowed to the control cable inside the sling cable, short-circuit occurred at the contact points, resulting in catching fire. From then on, it is probable that the high voltage was cut off by a safety device.

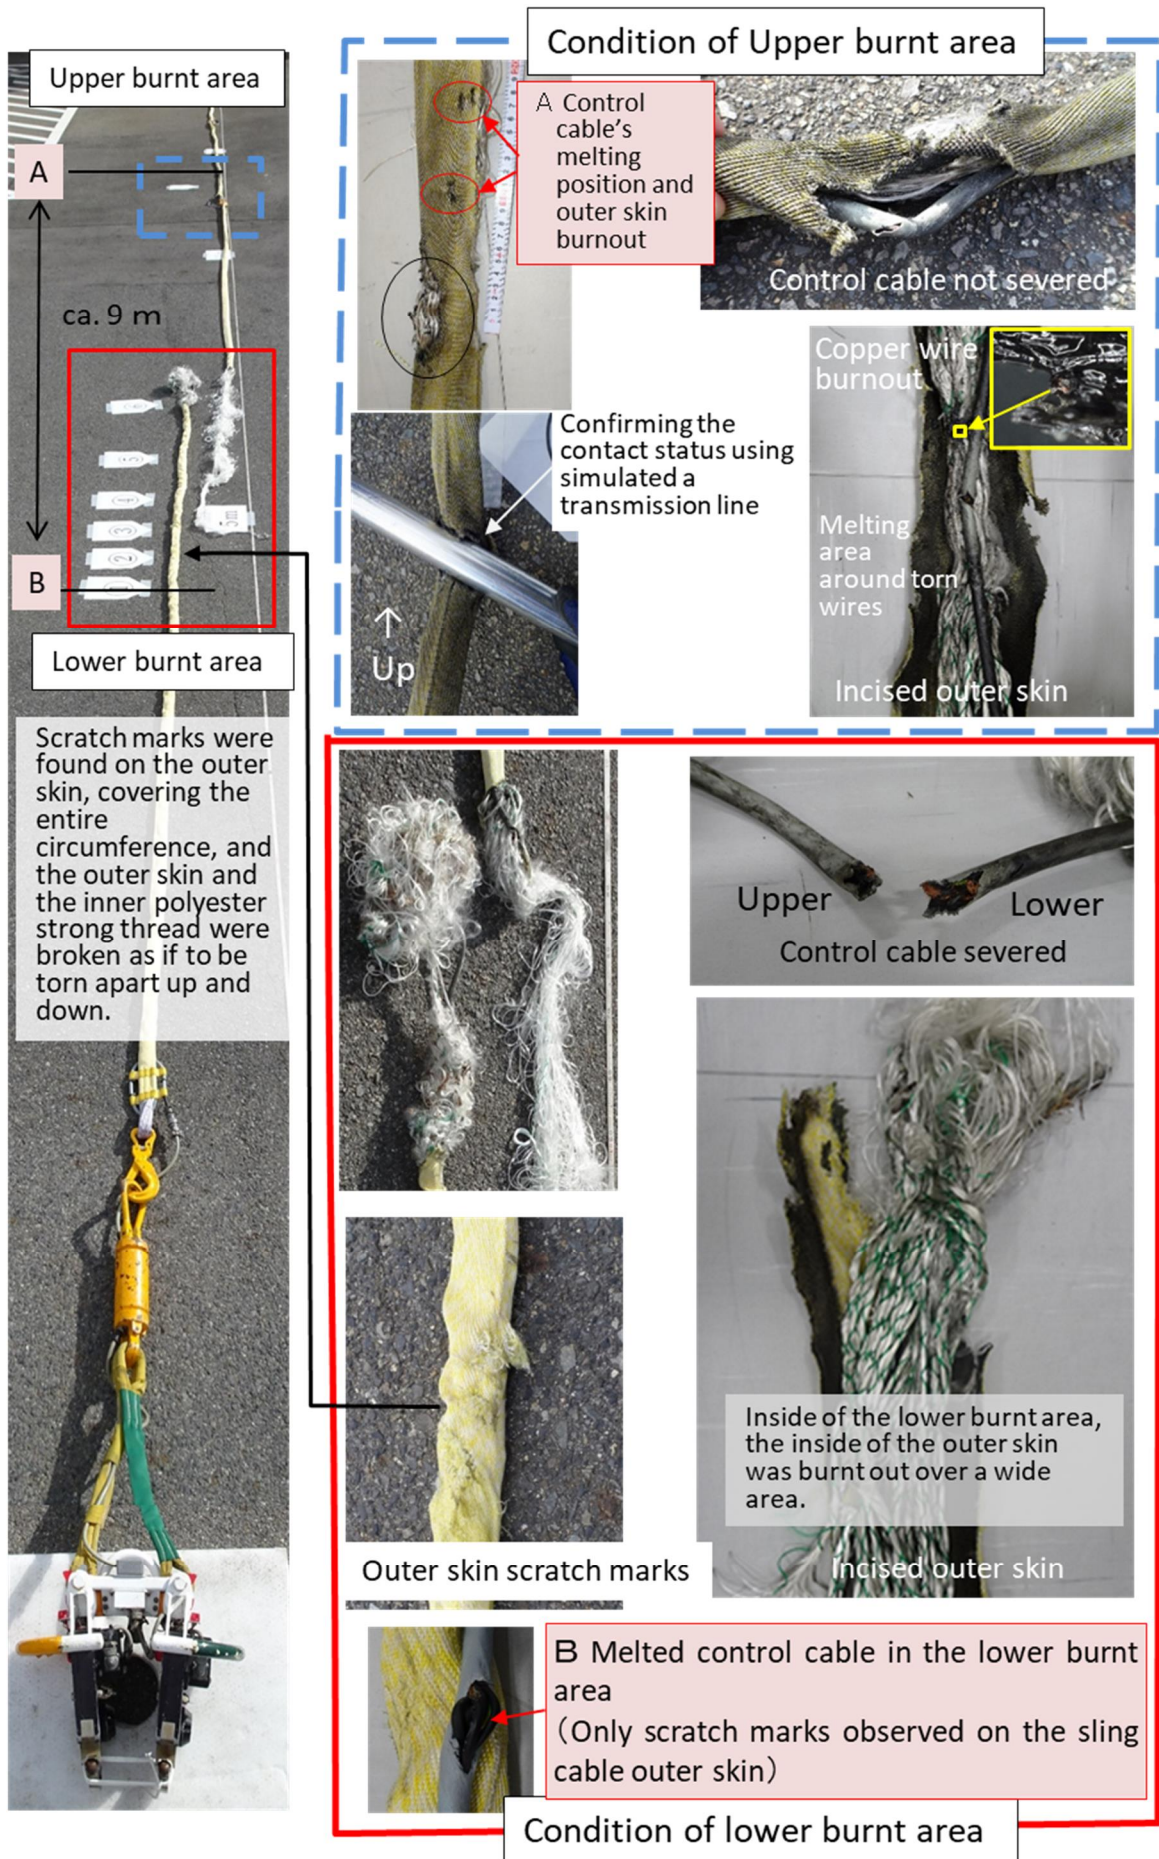
Appended Figure: Sling cable damage condition

As shown in Appended Figure, the sling cable was not broken in the upper burnt area, and there was a burnt mark the same width as the transmission line as if to be caused by being pressed against the sling cable from one side and contact, in addition, the polyester strong thread around the internal control cable was melted. In the lower burnt area, there were scratch marks on the outer skin that cover the entire circumference, and the outer skin and the inner polyester strong thread were broken as if to be torn apart up and down. Besides, the internal control cable was burnt and severed, but in the polyester strong thread around the severed section, there were almost no melting marks as in the upper burnt area. Furthermore, in the outer skin of the broken sling cable, there were scratch marks within approximately 2.5 m from the lower burnt area.
